**APPENDIX A**  
**INVENTORY OF ZONES AND ITEMS**

## INVENTORY SHEETS

## **ZONE1 THE WATERFRONT AND CALLAN POINT**

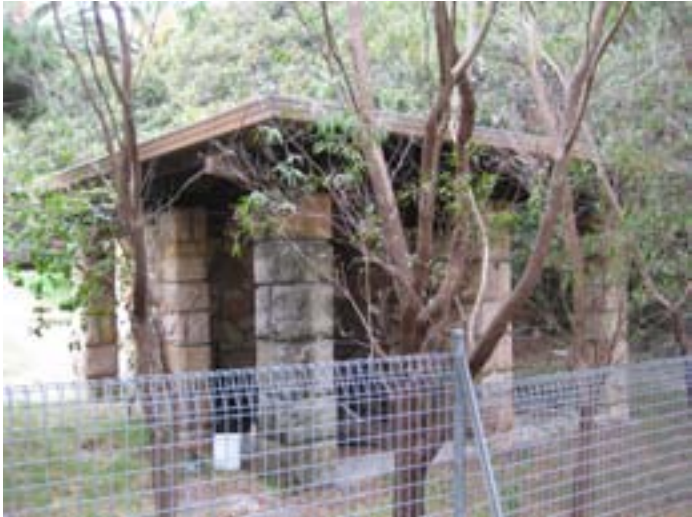
<b>ZONE 1 – THE WATERFRONT AND CALLAN POINT</b>	
<b>ITEM No.</b> B486  <b>ORIGINAL NAME:</b>  <b>CURRENT USE:</b>	<b>CONSTRUCTION DATE:</b>  <b>ARCHITECT / BUILDER:</b> Unknown  <b>HERITAGE LISTINGS:</b> <input type="checkbox"/> National Estate <input checked="" type="checkbox"/> S170 List <input type="checkbox"/> National Trust <input type="checkbox"/> Leichhardt LEP <input type="checkbox"/> State Heritage Inventory
<b>BUILDING:</b>  <b>LOCATION:</b>	<b>B 486 GARDEN STRUCTURE</b>  GRID: H3 ZONE: 1
<b>DESCRIPTION:</b>  Open garden structure with a flat roof supported off rectangular stone piers. Structure divided into compartments. Timber fascia to roof.

<b>CONDITION:</b>	Good
<b>HISTORY:</b>	Unresearched
<b>REFERENCES:</b>	Site inspection.
<b>SIGNIFICANCE:</b>	Neutral. Minimal significance as part of development of repatriation hospital. Potentially intrusive but now adequately screened.
<b>GUIDELINES:</b>	Retain, recycle, replace or remove as practicable. If removed, record prior to demolition and revegetate the area with appropriate planting

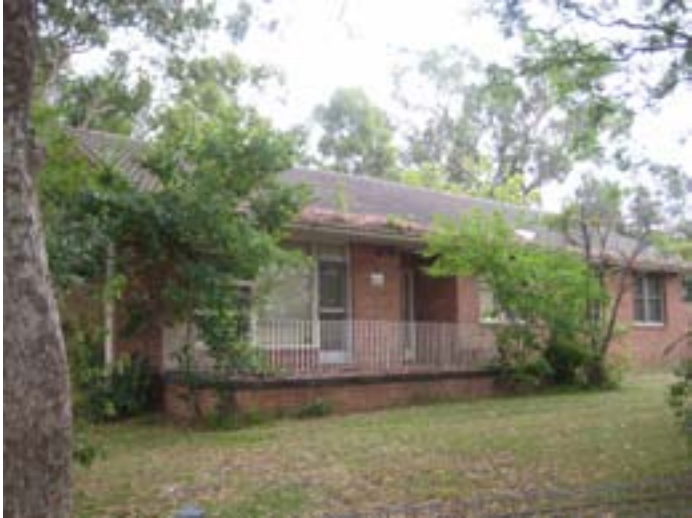
<b>ZONE 1 – THE WATERFRONT AND CALLAN POINT</b>		
<p><b>ITEM Nos.</b> B490, B491, B492 and B493</p> <p><b>ORIGINAL NAME:</b> Residences</p> <p><b>CURRENT USE:</b> Unoccupied</p>	<p><b>CONSTRUCTION DATE:</b> c. 1960-65</p> <p><b>ARCHITECT / BUILDER:</b> Unknown</p>	<p><b>HERITAGE LISTINGS:</b></p> <p><input type="checkbox"/> National Estate</p> <p><input type="checkbox"/> S170 List</p> <p><input type="checkbox"/> National Trust</p> <p><input type="checkbox"/> Leichhardt LEP</p> <p><input type="checkbox"/> State Heritage Inventory</p>
<p><b>BUILDING:</b></p> <p><b>LOCATION:</b></p>	<p><b>B 492 &amp; B 493 BAYVIEW COTTAGES, B 490 &amp; B 491 ASSOCIATED GARAGES</b></p> <p>GRID: I 3 ZONE: 1</p>	
<p><b>DESCRIPTION:</b></p> <p>Pair of light yellow-brown brick houses with pitched tiled roofs and brick gables, timber framed windows. Simple rectangular plan with patio enclosed by wrought metal balustrade at front of dwellings.</p> <p>Similarly detailed simple garages associated with each residence.</p>

<p><b>CONDITION:</b></p>	<p>Good</p>	
<p><b>HISTORY:</b></p>	<p>Built c. 1960-65.</p>	
<p><b>REFERENCES:</b></p>	<p>Leong (80)</p>	
<p><b>SIGNIFICANCE:</b></p>	<p>Intrusive</p>	
<p><b>GUIDELINES:</b></p>	<p>Remove as practicable and revegetate the area. Take care to prevent damage to European rock carving and Aboriginal relics which may be hidden below the soil surface and contact the NPWS should any Aboriginal relics be found. If retained undertake maintenance of building fabric. If removed record prior to demolition. If replaced any new development must conform to the requirements of the Callan Park Act.</p>

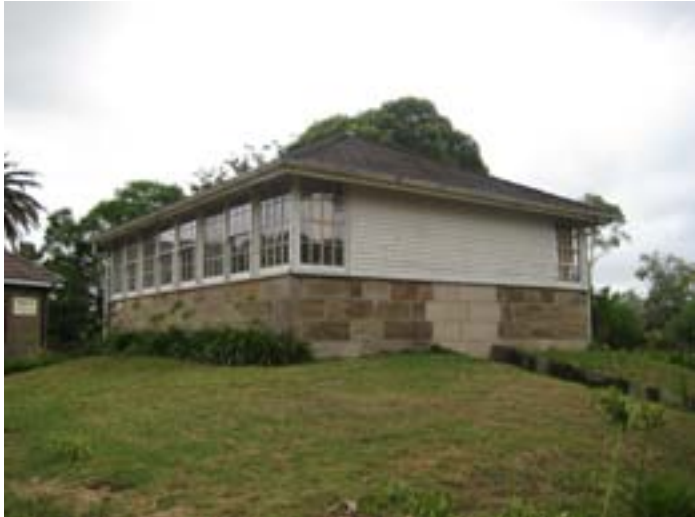
<b>ZONE 1 – THE WATERFRONT AND CALLAN POINT</b>		
<p><b>ITEM Nos.</b> B494</p> <p><b>ORIGINAL NAME:</b> Recreation / Activities Building, Building 92A Ward F Annex</p> <p><b>CURRENT USE:</b> Vacant</p>	<p><b>CONSTRUCTION DATE:</b> Before 1877</p> <p><b>ARCHITECT / BUILDER:</b> Unknown</p>	<p><b>HERITAGE LISTINGS:</b></p> <p><input type="checkbox"/> National Estate</p> <p><input checked="" type="checkbox"/> S170 List</p> <p><input type="checkbox"/> National Trust</p> <p><input type="checkbox"/> Leichhardt LEP</p> <p><input type="checkbox"/> State Heritage Inventory</p>
<p><b>BUILDING:</b></p>	<p><b>B494</b></p>	
<p><b>LOCATION:</b></p>	<p>GRID: 13 ZONE: 1</p>	
<p><b>DESCRIPTION:</b></p> <p>Pleasant rectangular building, stone to sill height with multi-paned timber windows above. Hipped roof covered in asbestos cement shingles with rare asbestos cement cappings. Vented timber eaves linings. Timber weatherboard wall lining above stone base east elevation, evidence of early opening below (cement render wall lining lined to resemble stone coursing.</p>

<p><b>CONDITION:</b></p>	<p>Good – general maintenance required</p>	
<p><b>HISTORY:</b></p>	<p>Unknown but a building was in this location on the 1877 site plan. Garry Owen summer house was originally in this area. This building does not date from this early period (circa 1840), however may be an early building altered or consist of the materials from an earlier building.</p>	
<p><b>REFERENCES:</b></p>	<p>JTCW</p>	
<p><b>SIGNIFICANCE:</b></p>	<p>High - requires further investigation. If found to be Garry Owen summer house is of greater significance.</p>	
<p><b>GUIDELINES:</b></p>	<p>Retain and conserve using appropriate methodologies and materials. Consider reconstruction of the door opening and windows in east elevation. An appropriate use for the building should be found that does not compromise its heritage significance.</p>

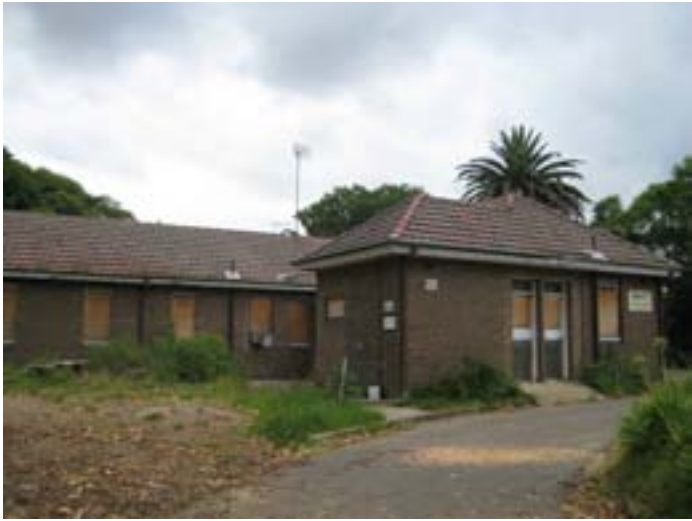
<b>ZONE 1 – THE WATERFRONT AND CALLAN POINT</b>		
<p><b>ITEM No.</b> B495</p> <p><b>ORIGINAL NAME:</b> Ward F, Repatriation Section, Building 92</p> <p><b>CURRENT USE:</b> Unoccupied</p>	<p><b>CONSTRUCTION DATE:</b> c. 1933-35</p> <p><b>ARCHITECT / BUILDER:</b> Unknown</p>	<p><b>HERITAGE LISTINGS:</b></p> <p><input type="checkbox"/> National Estate</p> <p><input checked="" type="checkbox"/> S170 List</p> <p><input type="checkbox"/> National Trust</p> <p><input type="checkbox"/> Leichhardt LEP</p> <p><input type="checkbox"/> State Heritage Inventory</p>
<p><b>BUILDING:</b></p>	<b>B 495 FLANDERS HOUSE</b>	
<p><b>LOCATION:</b></p>	GRID: H3 ZONE: 1	
<p><b>DESCRIPTION:</b></p> <p>Single storey U-shaped brick building with hipped roof covered with terracotta tiles and vented timber eaves linings. Prominent location isolated from other buildings and screened by trees. Windows have been covered over. Garden with stone terracing on northern side.</p> <p>B486 to north west is a single storey brick building with a hipped roof covered with terracotta tiles, timber framed windows.</p>

<p><b>CONDITION:</b></p>	Fair – general maintenance required	
<p><b>HISTORY:</b></p>	Built c. 1933-35	
<p><b>REFERENCES:</b></p>	Leong (51)	
<p><b>SIGNIFICANCE:</b></p>	Low. Minimal significance as part of development of repatriation hospital. Potentially intrusive but now adequately screened.	
<p><b>GUIDELINES:</b></p>	Retain, recycle, replace or remove as practicable. The site is visually prominent and if replaced any new development must conform to the requirements of the Callan Park Act. If replaced, the new development should revegetate the area with appropriate planting or be in the form of a discreet building within a natural setting. If removed record prior to demolition.

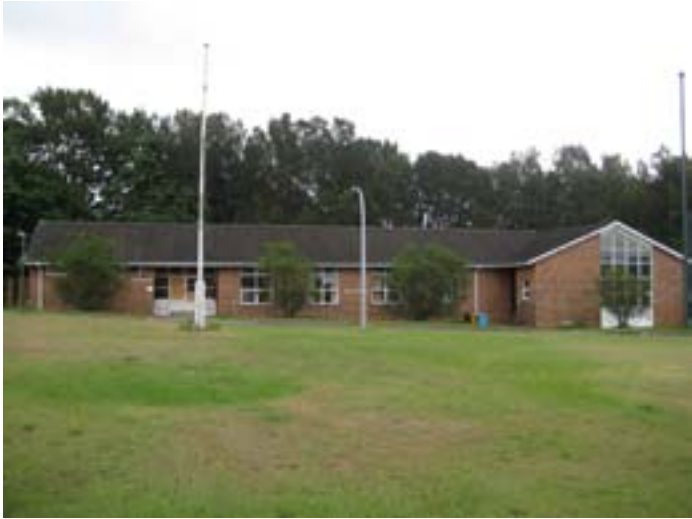
<b>ZONE 1 – THE WATERFRONT AND CALLAN POINT</b>		
<p><b>ITEM No. B 504</b></p> <p><b>ORIGINAL NAME:</b> Administration / Recreation Hall; 26 Repatriation Division Administration (Psychogeriatrics)/Recreation Hall</p> <p><b>CURRENT USE:</b> Unoccupied</p>	<p><b>CONSTRUCTION DATE:</b> 1960-65</p> <p><b>ARCHITECT / BUILDER:</b> Unknown Government Architect E.H. Farmer</p>	<p><b>HERITAGE LISTINGS:</b></p> <p><input type="checkbox"/> National Estate</p> <p><input type="checkbox"/> S170 List</p> <p><input type="checkbox"/> National Trust</p> <p><input type="checkbox"/> Leichhardt LEP</p> <p><input type="checkbox"/> State Heritage Inventory</p>
<p><b>BUILDING:</b></p>	<b>B 504 OCCUPATIONAL THERAPIST / RECREATION HALL</b>	
<p><b>LOCATION:</b></p>	GRID: E5 ZONE: 1	
<p><b>DESCRIPTION:</b></p> <p>Single storey L shaped Brick building with gabled tile roof. Timber framed windows, balconettes on north and south sides of hall at northern end of building. Extensive areas of glazing in timber and aluminium frames on western side looking onto shallow terrace and grounds. Interiors appear to be intact.</p>

<p><b>CONDITION:</b></p>	Fair. Timber fascias, bargeboards and other fabric are deteriorating.	
<p><b>HISTORY:</b></p>	Built 1960-65	
<p><b>REFERENCES:</b></p>	Leong (54) MH2/448	
<p><b>SIGNIFICANCE:</b></p>	Low.	
<p><b>GUIDELINES:</b></p>	Retain and conserve, adapt to new uses that do not compromise the building's intact fabric and spaces. In the short term ensure the building is weather tight. Repair damaged and deteriorating fabric using appropriate materials, profiles and methodologies. Conserve and sympathetically adapt interiors as required. Upgrade garden setting.

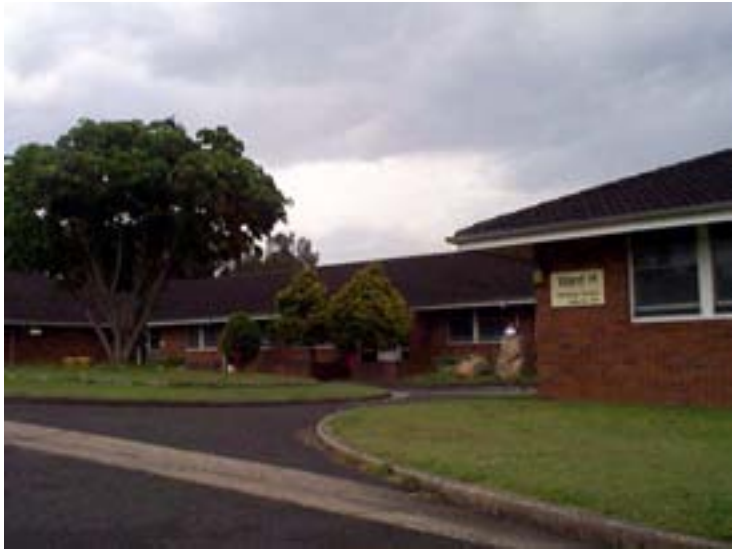
<b>ITEM No. B 505</b>  <b>ORIGINAL NAME:</b> 27 Ward H  <b>CURRENT USE:</b> Unoccupied		<b>CONSTRUCTION DATE:</b> 1960-65  <b>ARCHITECT / BUILDER:</b> Unknown	<b>HERITAGE LISTINGS:</b> <input type="checkbox"/> National Estate <input type="checkbox"/> S170 List <input type="checkbox"/> National Trust <input type="checkbox"/> Leichhardt LEP <input type="checkbox"/> State Heritage Inventory
<b>BUILDING:</b>  <b>LOCATION:</b>	<b>B 505 HASTINGS HOUSE</b>  GRID: E4 ZONE: 1		
<b>DESCRIPTION:</b>  Single storey H shaped red brick building with hipped tiled roof. Deep eaves overhangs, timber framed windows.  Some consciously laid out landscaping on southern side of building.

<b>CONDITION:</b>	Fair. Roof is showing some structural deterioration.		
<b>HISTORY:</b>	Built 1960-65		
<b>REFERENCES:</b>	Leong (53) MH2/220-6 JTCW		
<b>SIGNIFICANCE:</b>	Intrusive in waterfront setting.		
<b>GUIDELINES:</b>	Retain, recycle, replace or remove as practicable. In any redevelopment landscape should be dominant. If removed record prior to demolition. If replaced any new development must conform to the requirements of the Callan Park Act.

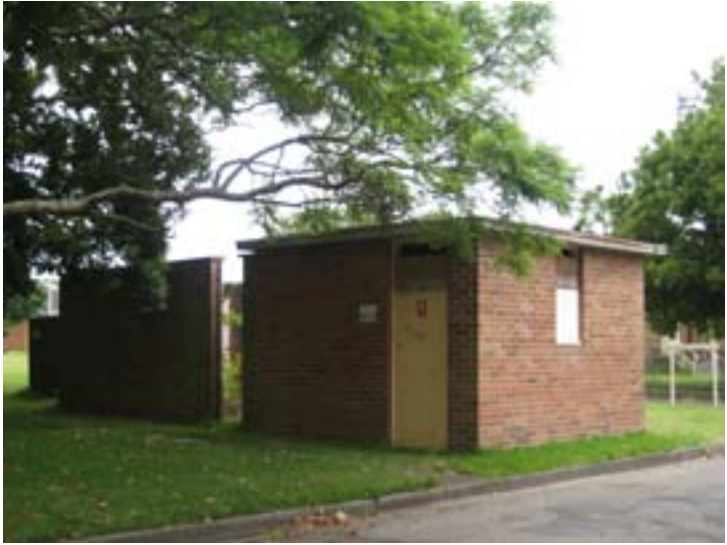
<b>ZONE 1 – THE WATERFRONT AND CALLAN POINT</b>		
<b>ITEM No. B 513</b>  <b>ORIGINAL NAME:</b>  <b>CURRENT USE:</b> Electrical Substation	<b>CONSTRUCTION DATE:</b> Circa 1960s  <b>ARCHITECT / BUILDER:</b> Unknown	<b>HERITAGE LISTINGS:</b> <input type="checkbox"/> National Estate <input checked="" type="checkbox"/> S170 List <input type="checkbox"/> National Trust <input type="checkbox"/> Leichhardt LEP <input type="checkbox"/> State Heritage Inventory
<b>BUILDING:</b>  <b>LOCATION:</b>	<b>B 513 SUBSTATION</b>  GRID: F5 ZONE: 1	
<b>DESCRIPTION:</b>  Pair of brick structures consisting of a square flat roofed building and an open court enclosed by high walls. Similar to Item B4C in Zone 4.

<b>CONDITION:</b>	Fair.	
<b>HISTORY:</b>	Probably constructed in the 1960s around the same time as other buildings in the immediate vicinity (B504, B505, B512 and B514).	
<b>REFERENCES:</b>		
<b>SIGNIFICANCE:</b>	Intrusive.

<b>GUIDELINES:</b>	Retain, recycle, replace or remove as practicable. If removed record prior to demolition.

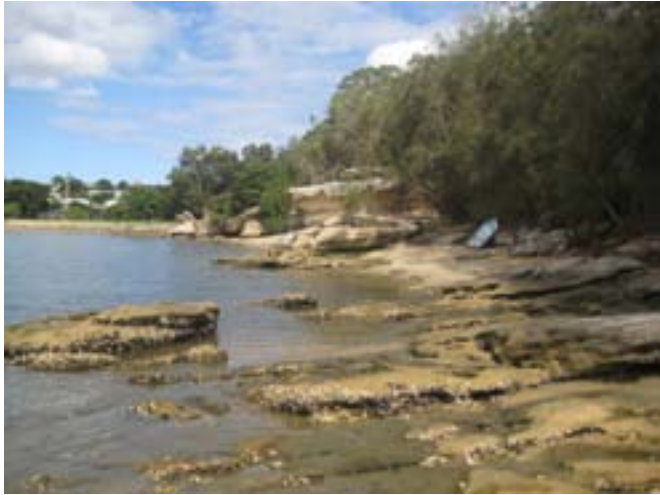
ZONE 1 – THE WATERFRONT AND CALLAN POINT	
<b>ITEM No. 6A</b>  <b>ORIGINAL NAME:</b>  <b>CURRENT USE:</b>	<b>CONSTRUCTION DATE:</b>  <b>ARCHITECT / BUILDER:</b>  <b>HERITAGE LISTINGS:</b> <input type="checkbox"/> National Estate <input type="checkbox"/> S170 List <input type="checkbox"/> National Trust <input type="checkbox"/> Leichhardt LEP <input type="checkbox"/> State Heritage Inventory
<b>ITEM:</b>  <b>LOCATION:</b>	<b>6A NATURAL SHORELINE</b>  GRID: 12 ZONE: 1
<b>DESCRIPTION:</b> Rocky cliffs and outcrops, sandy beach, mud flats and rock shelves at water's edge, some fill introduced on top of cliffs and roads, buildings and gardens edge cliff top. Fitness track runs across cliff top.

<b>CONDITION:</b>	Substantially intact.
<b>HISTORY:</b>	-
<b>REFERENCES:</b>	1991 DPWS Heritage Study.
<b>SIGNIFICANCE:</b>	Significant as rare remnant of natural shoreline and landform and as original setting for asylum and Garry Owen Estate. Earth fill, building and garden developments are intrusive on its significance.

<b>GUIDELINES:</b>	Preserve. Remove intrusive fill, rubbish and building developments and restore natural profiles as far as possible. Take care to prevent damage to any rock carvings or Aboriginal relics which may be hidden beneath the soil surface. Contact the NPWS if any Aboriginal relics are found.

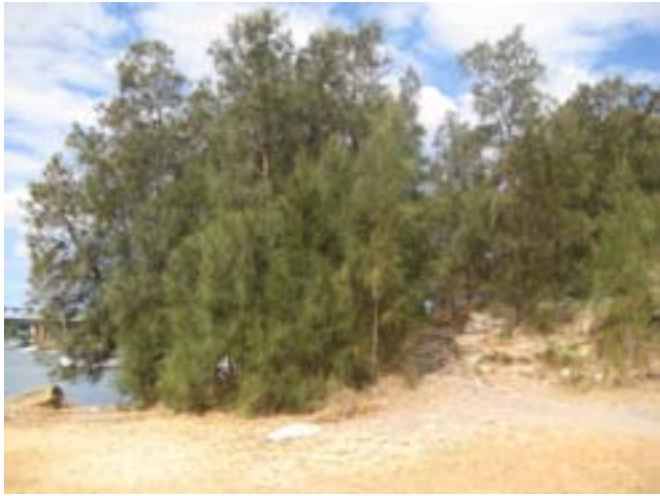
<b>ZONE 1 – THE WATERFRONT AND CALLAN POINT</b>		
<b>ITEM No. 6B</b>  <b>ORIGINAL NAME:</b>  <b>CURRENT USE:</b>	<b>CONSTRUCTION DATE:</b>  <b>ARCHITECT / BUILDER:</b>	<b>HERITAGE LISTINGS:</b> <input type="checkbox"/> National Estate <input type="checkbox"/> S170 List <input type="checkbox"/> National Trust <input type="checkbox"/> Leichhardt LEP <input type="checkbox"/> State Heritage Inventory
<b>ITEM:</b>  <b>LOCATION:</b>	<b>6B INDIGENOUS VEGETATION</b>  GRID: I 2, H2 ZONE: 1	
<b>DESCRIPTION:</b>  Small group of indigenous She Oak, Rough Barked apple and Bangalay with possible indigenous shrub (unidentified sp) and areas of Kangaroo Grass, Lomandra and other native grasses above the cliffs.

<b>CONDITION:</b>	Part intact. Modified and simplified communities through disturbance.	
<b>HISTORY:</b>	Regenerate from original species.	
<b>REFERENCES:</b>	1991 DPWS Heritage Study	
<b>SIGNIFICANCE:</b>	Significant as rare remnant of indigenous vegetation and representative components of original setting for the asylum and Garry Owen Estate.

<b>GUIDELINES:</b>	Maintain. Remove weeds and regenerate/revegetate with seed from indigenous plants. Replace introduced species with indigenous species where appropriate throughout the point area. Encourage development of indigenous plant and animal communities. Note NPWS should be contacted prior to any disturbance on or near Aboriginal midden sites and care should be taken around European carvings to avoid damage.

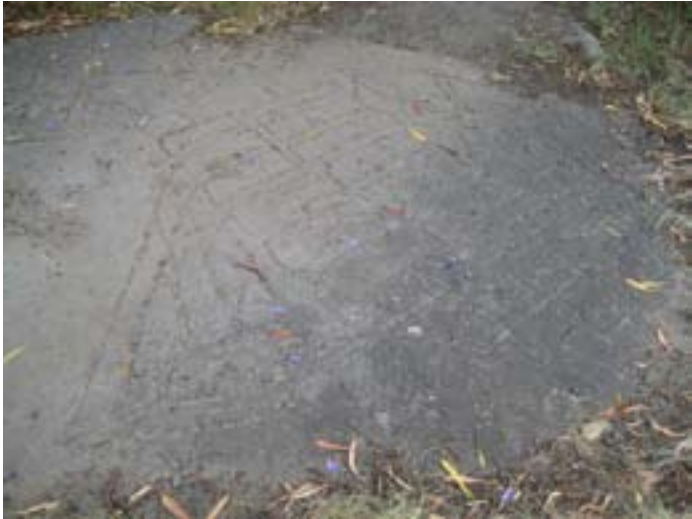
<b>ZONE 1 – THE WATERFRONT AND CALLAN POINT</b>		
<b>ITEM No:</b> 6D  <b>ORIGINAL NAME:</b> Rock carvings  <b>CURRENT USE:</b>	<b>CONSTRUCTION DATE:</b>  <b>ARCHITECT / BUILDER:</b> Unknown	<b>HERITAGE LISTINGS:</b> <input type="checkbox"/> National Estate <input type="checkbox"/> S170 List <input type="checkbox"/> National Trust <input type="checkbox"/> Leichhardt LEP <input type="checkbox"/> State Heritage Inventory
<b>ITEM:</b>  <b>LOCATION:</b>	<b>6D ROCK CARVINGS</b>  GRID: H2, I 2-3 ZONE: 1	
<b>DESCRIPTION:</b>  Extensive range of subjects including ships, figures, globes, fish, an animal (possibly alpaca), heads, stars (similar to compass roses) and many numerals (possible dates) and hand lettering (some doesn't seem to make sense. Others possibly in French).

<b>CONDITION:</b>	Exposed carvings intact, some hidden beneath grass and gardens. Some exposed to foot traffic and vandalism.

<b>HISTORY:</b>	Believed carved by one man who lived on a boat in Iron Cove. Patients may have been responsible for some carvings. It is possible that there were aboriginal carvings on the site but no evidence is visible.	
<b>REFERENCES:</b>	John Clegg. Sydney University. Article "Sydney Rock Art" by John Clegg pp119-122 in <i>The Moving Frontier</i> (edited by Peter Stanbury). Reed. Sydney 1977. <i>Sydney Morning Herald</i> Column 8 item and reply 1960s. J.S. Kerr, <i>Out Of Sight Out Of Mind</i> . 1991 DPWS Heritage Study	
<b>SIGNIFICANCE:</b>	Significant as 'outsider art'; as record of social history; as a rare and exceptional item and as a factor in the local sense of place.	
<b>GUIDELINES:</b>	Preserve in accordance with Burra Charter. Redirect public path away from surface carvings and provide sensitively designed barriers to prevent foot traffic over the carvings. Protect hidden and exposed carvings during any clearing, revegetation, demolition or construction work. Before any disturbance of the area carry out assessment by qualified historical archaeologist. Consider careful installation of interpretive signage.

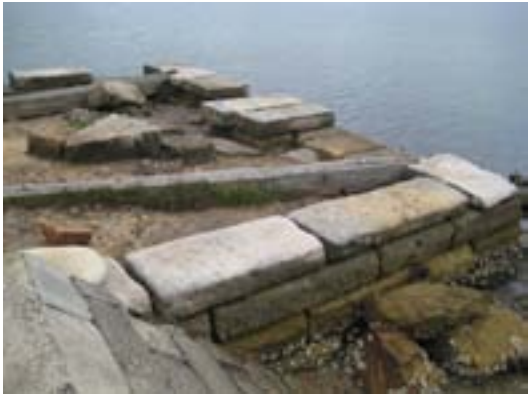
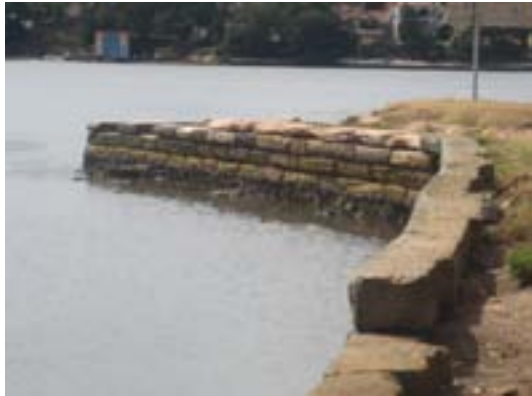
<b>ZONE 1 – THE WATERFRONT AND CALLAN POINT</b>		
<b>ITEM No. 6E</b>  <b>ORIGINAL NAME:</b> Sea wall and boat wharf  <b>CURRENT USE:</b> Sea wall, wharf disused	<b>CONSTRUCTION DATE:</b>  <b>ARCHITECT / BUILDER:</b> Unknown	<b>HERITAGE LISTINGS:</b> <input type="checkbox"/> National Estate <input type="checkbox"/> S170 List <input type="checkbox"/> National Trust <input type="checkbox"/> Leichhardt LEP <input type="checkbox"/> State Heritage Inventory
<b>ITEM:</b>  <b>LOCATION:</b>	<b>6E SEA WALL &amp; BOAT WHARF</b>  GRID: H2, G3 ZONE: 1	
<b>DESCRIPTION:</b>  Battered sandstone block seawall edging land fill areas.		
<div style="display: flex; justify-content: space-around;">

</div>		
<b>CONDITION:</b>	Generally intact.	
<b>HISTORY:</b>	Age of wall unresearched. Possibly early 1900s construction added to or replaced in 1940s to 1960s.	
<b>REFERENCES:</b>	1991 DPWS Heritage Study. 1903 photo of original boatshed. Plate 46 Powell. Site plan 1893, Site plan 1931-51, Site plan 1965.

<b>SIGNIFICANCE:</b>	Significance as early site developments reflecting importance of water travel and relationship with Gladesville Hospital.	
<b>GUIDELINES:</b>	Restore damaged sections. Retain boat wharf as relic or redevelop for modern use reflective of its original purpose.

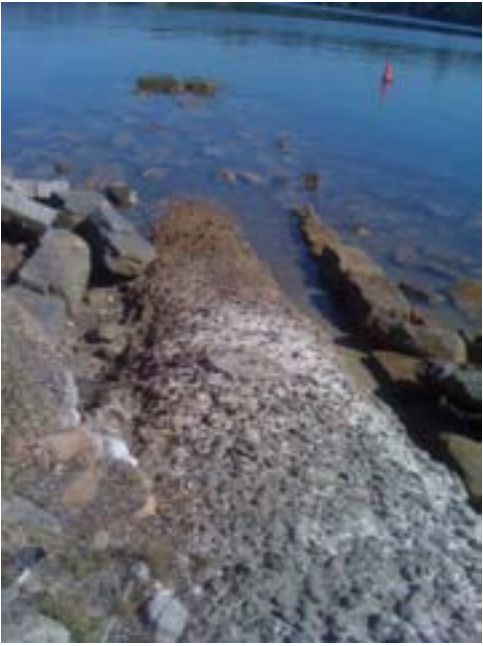
<b>ZONE 1 – THE WATERFRONT AND CALLAN POINT</b>		
<b>ITEM No. 6f</b>  <b>ORIGINAL NAME:</b> Sewer outlet  <b>CURRENT USE:</b> Disused	<b>CONSTRUCTION DATE:</b> Circa 1880  <b>ARCHITECT / BUILDER:</b> Unknown	<b>HERITAGE LISTINGS:</b> <input type="checkbox"/> National Estate <input type="checkbox"/> S170 List <input type="checkbox"/> National Trust <input type="checkbox"/> Leichhardt LEP <input type="checkbox"/> State Heritage Inventory
<b>ITEM:</b>  <b>LOCATION:</b>	<b>6F SEWER OUTLET</b>  GRID: H2 ZONE: 1	
<b>DESCRIPTION:</b>  Ruins of sandstone sewer outfall extending into Iron Cove.

<b>CONDITION:</b>	In ruined state.	
<b>HISTORY:</b>	Originally asylum sewer discharging into Iron Cove. Later used for stormwater.	
<b>REFERENCES:</b>	1991 DPWS Heritage Study. 1877 site plan	
<b>SIGNIFICANCE:</b>	Significant as an item of original asylum design and early sewage system.	
<b>GUIDELINES:</b>	Preserve as ruins.

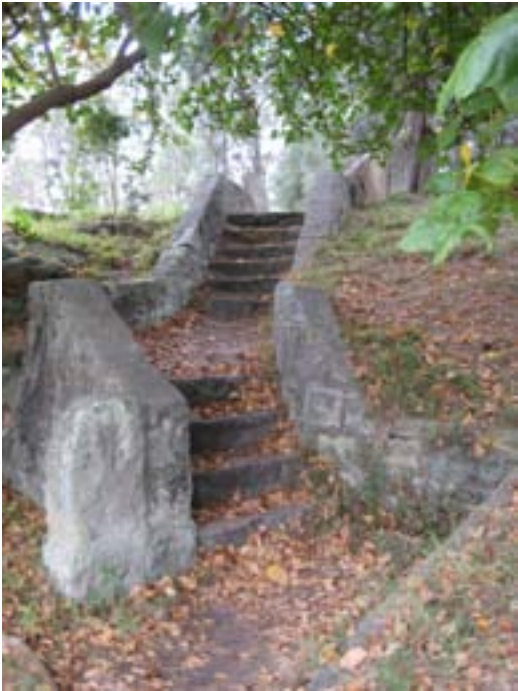
<b>ZONE 1 – THE WATERFRONT AND CALLAN POINT</b>		
<b>ITEM No.</b> 6G  <b>ORIGINAL NAME:</b>  <b>CURRENT USE:</b> Stair, retaining wall.	<b>CONSTRUCTION DATE:</b> Circa 1905  <b>ARCHITECT / BUILDER:</b> Unknown	<b>HERITAGE LISTINGS:</b> <input type="checkbox"/> National Estate <input type="checkbox"/> S170 List <input type="checkbox"/> National Trust <input type="checkbox"/> Leichhardt LEP <input type="checkbox"/> State Heritage Inventory
<b>ITEM:</b>  <b>LOCATION:</b>	<b>6G STONE STAIRS &amp; WALLS</b>  GRID: H2 ZONE: 1	
<b>DESCRIPTION:</b>  Dry stone wall and stone staircase.

<b>CONDITION:</b>	Intact	
<b>HISTORY:</b>	Likely to have been built in association with swimming pool construction in the mid 1900s.	
<b>REFERENCES:</b>	1991 DPWS Heritage Study. Site plan 1931 and site plan 1965.	
<b>SIGNIFICANCE:</b>	No evidence of heritage significance, however sympathetic with development area of the point.

<b>GUIDELINES:</b>	Retain and conserve.

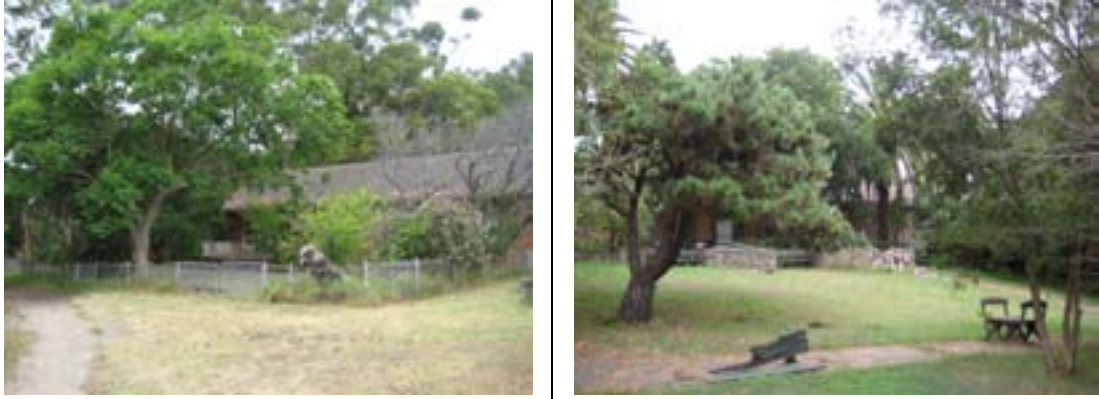
<b>ZONE 1 – THE WATERFRONT AND CALLAN POINT</b>	
<b>ITEM No. 6 I</b>  <b>ORIGINAL NAME:</b>  <b>CURRENT USE:</b>	<b>CONSTRUCTION DATE:</b> <b>1930s-1960s</b>  <b>ARCHITECT / BUILDER:</b> Unknown  <b>HERITAGE LISTINGS:</b> <input type="checkbox"/> National Estate <input type="checkbox"/> S170 List <input type="checkbox"/> National Trust <input type="checkbox"/> Leichhardt LEP <input type="checkbox"/> State Heritage Inventory
<b>ITEM:</b>  <b>LOCATION:</b>	<b>6 I RESIDENTIAL AND WARD GARDENS</b>  GRID: H 1-2 ZONE: 1
<b>DESCRIPTION:</b>  Fenced gardens attached to residences and ward buildings.

<b>CONDITION:</b>	Intact.
<b>HISTORY:</b>	Installed in 1930s to 1960s overlaying rock carvings and rock outcrop.
<b>REFERENCES:</b>	1991 DPWS Heritage Study.
<b>SIGNIFICANCE:</b>	Intrusive on heritage significance of natural landform, vegetation and rock carvings.
<b>GUIDELINES:</b>	Remove. Take care to prevent damage to any European carvings or Aboriginal relics which may be hidden below the soil surface and contact the NPWS if any Aboriginal relics are found.

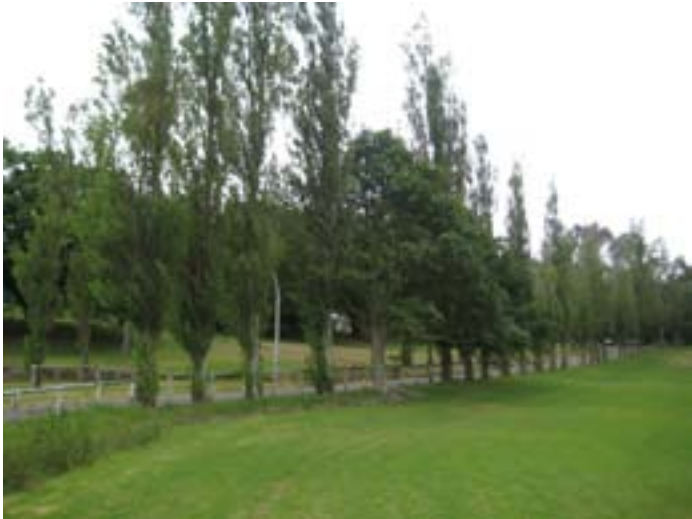
<b>ZONE 1 – THE WATERFRONT AND CALLAN POINT</b>	
<b>ITEM No. 6L</b>  <b>ORIGINAL NAME:</b>  <b>CURRENT USE:</b>	<b>CONSTRUCTION DATE:</b> circa 1960-1970  <b>ARCHITECT / BUILDER:</b>  <b>HERITAGE LISTINGS:</b> <input type="checkbox"/> National Estate <input type="checkbox"/> S170 List <input type="checkbox"/> National Trust <input type="checkbox"/> Leichhardt LEP <input type="checkbox"/> State Heritage Inventory
<b>ITEM:</b>  <b>LOCATION:</b>	6L POPLAR AVENUE  GRID: G3-I 3 ZONE: 1
<b>DESCRIPTION:</b>  Avenue of Lombardy Poplars along Waterfront Drive.

<b>CONDITION:</b>	Fair.
<b>HISTORY:</b>	Planted after 1952. Possibly in early 1960s or 1970s.
<b>REFERENCES:</b>	1991 DPWS Heritage Study. 1952 aerial photo.
<b>SIGNIFICANCE:</b>	Intrudes on the significant character of the early asylum period.
<b>GUIDELINES:</b>	Remove as practicable.

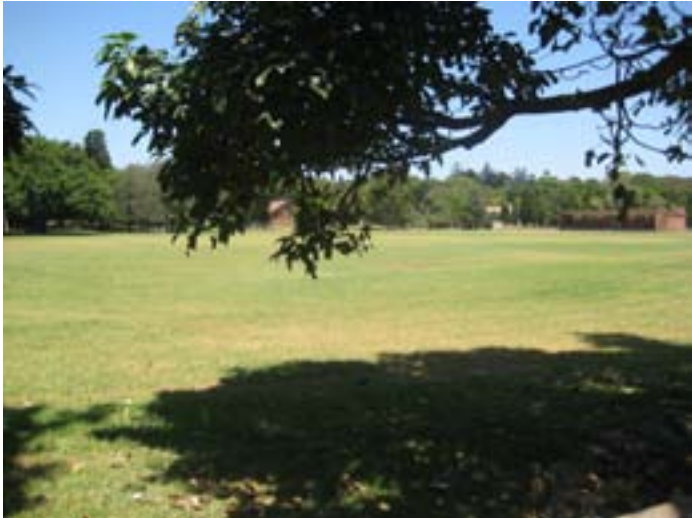
<b>ZONE 1 – THE WATERFRONT AND CALLAN POINT</b>	
<b>ITEM No. 7A</b>  <b>ORIGINAL NAME:</b>  <b>CURRENT USE:</b> Recreational	<b>CONSTRUCTION DATE:</b> 1880-1942  <b>ARCHITECT / BUILDER:</b> Unknown  <b>HERITAGE LISTINGS:</b> <input type="checkbox"/> National Estate <input type="checkbox"/> S170 List <input type="checkbox"/> National Trust <input type="checkbox"/> Leichhardt LEP <input type="checkbox"/> State Heritage Inventory
<b>ITEM:</b>  <b>LOCATION:</b>	<b>7A RECLAIMED LAND</b>  GRID: L4-H4, C4-D4 ZONE: 1
<b>DESCRIPTION:</b>  Flat lawn area now used as football oval.

<b>CONDITION:</b>	Intact
<b>HISTORY:</b>	Area G4-H4 – former swamp and inlet reclaimed for vegetable growing in 1880s to early 1900s and canal formed in early 1900s. Area C4-D4 reclaimed in 1942.
<b>REFERENCES:</b>	1991 DPWS Heritage Study.
<b>SIGNIFICANCE:</b>	Early asylum development reflecting the need for large scale food production for asylum subsistence and representative of Charles Moore's design. Edge of reclaimed area reflects part of original shoreline. 1942 reclamation not of heritage significance.

<b>GUIDELINES:</b>	Preserve. Maintain open character. Future development should reflect original shoreline presently evident as a relatively natural embankment behind the oval, and maintain integrity of significance by revegetating with indigenous species. Current recreational use is sympathetic to significance.

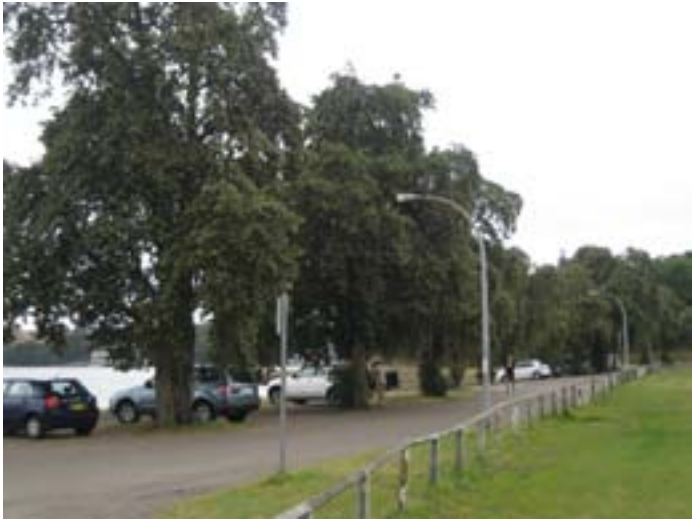
<b>ZONE 1 – THE WATERFRONT AND CALLAN POINT</b>	
<b>ITEM No.</b> 7M  <b>ORIGINAL NAME:</b> Norfolk Island hibiscus  <b>CURRENT USE:</b>	<b>CONSTRUCTION DATE:</b> Planted 1880s-1890s  <b>ARCHITECT / BUILDER:</b> Charles Moore  <b>HERITAGE LISTINGS:</b> <input type="checkbox"/> National Estate <input type="checkbox"/> S170 List <input type="checkbox"/> National Trust <input type="checkbox"/> Leichhardt LEP <input type="checkbox"/> State Heritage Inventory
<b>ITEM:</b>  <b>LOCATION:</b>	7M NORFOLK ISLAND HIBISCUS  GRID: F4-G4 ZONE: 1
<b>DESCRIPTION:</b>  Row with some of original trees missing.

<b>CONDITION:</b>	Fair to good
<b>HISTORY:</b>	Planted late 1880s to 1890s along newly formed shoreline.
<b>REFERENCES:</b>	1991 DPWS Heritage Study.
<b>SIGNIFICANCE:</b>	Significant as original asylum plantings representing the species selection of Charles Moore.
<b>GUIDELINES:</b>	Maintain. Remove carparking from beneath trees. Carry out tree surgery and improve growing conditions. Replant missing trees.
