### **ZONE 3 KIRKBRIDE ENTRANCE GARDEN AND EMBANKMENT TO KING GEORGE PARK**

CALLAN PARK  
CONSERVATION MANAGEMENT PLAN

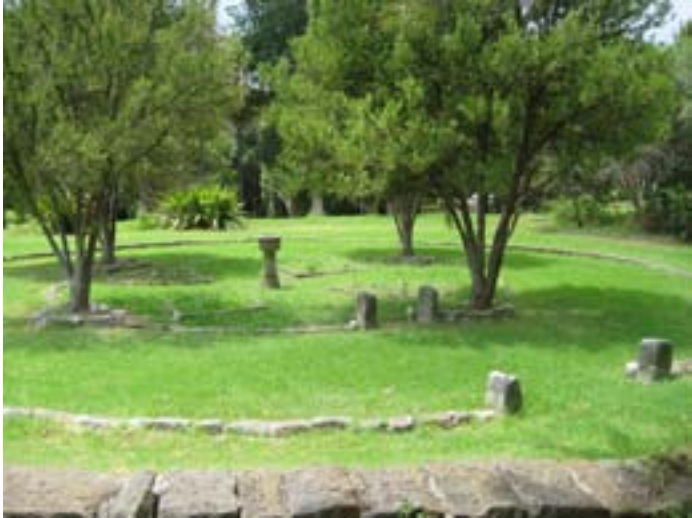
<b>ZONE 3 – KIRKBRIDE ENTRANCE GARDEN and EMBANKMENT TO KING GEORGE PARK</b>	
<b>ITEM No.</b> 1D  <b>ORIGINAL NAME:</b>  <b>CURRENT USE:</b>	<b>CONSTRUCTION DATE:</b> 1903-1920s  <b>ARCHITECT / BUILDER:</b> Flower beds constructed by patients.  <b>HERITAGE LISTINGS:</b> <input checked="" type="checkbox"/> National Estate <input checked="" type="checkbox"/> S170 List <input checked="" type="checkbox"/> National Trust <input checked="" type="checkbox"/> Leichhardt LEP <input type="checkbox"/> State Heritage Register
<b>ITEM:</b>  <b>LOCATION:</b>	<b>1D SUNKEN GARDEN</b>  GRID: K7 ZONE: 3
<b>DESCRIPTION:</b>  Circular, sunken garden edge by stone wall and hedge with openings. Circular stone edges and 4 flower beds and 4 cypress and central stone pedestal, all set in lawn.

<b>CONDITION:</b>	Substantially intact as sunken garden.
<b>HISTORY:</b>	Originally an informal pond at the head of the creek, in Charles Moore's design, formalised in 1903 plan (possible Maiden influence) and filled in late 1920s following drawings. Flower beds built by patients

<b>REFERENCES:</b>	1991 DPWS Heritage Study. Site Inspection, c. 192- photo panorama in Powell. 1930 aerial photo.
<b>SIGNIFICANCE:</b>	Sunken Garden is significant in that it represents the visual focus and structural form of the original design and as a complete work by patients reflecting their participation in gardening as therapy.
<b>GUIDELINES:</b>	Restore enclosing retaining walls and hedges and physical relationship to Kirkbride Way as shown in c.1920 photo panorama in Powell. 1930 aerial photo.  Restore enclosing retaining walls and hedges and physical relationship to Kirkbride Way as shown in c.1920 photo panorama. Preserve patient garden and restore the formal pond as an important design element in relation to the Kirkbride Block.

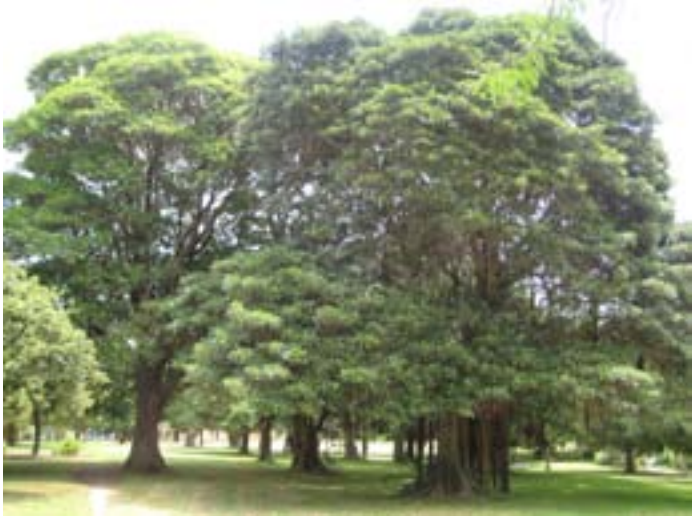
<b>ZONE 3 – KIRKBRIDE ENTRANCE GARDEN and EMBANKMENT TO KING GEORGE PARK</b>	
<b>ITEM No.</b> 1G  <b>ORIGINAL NAME:</b>  <b>CURRENT USE:</b>	<b>CONSTRUCTION DATE:</b>  <b>DESIGNER / BUILDER:</b> Charles Moore  <b>HERITAGE LISTINGS:</b> <input checked="" type="checkbox"/> National Estate <input checked="" type="checkbox"/> S170 List <input checked="" type="checkbox"/> National Trust <input checked="" type="checkbox"/> Leichhardt LEP <input type="checkbox"/> State Heritage Register
<b>ITEM:</b>  <b>LOCATION:</b>	1G AVENUE TO ORIGINAL CARRIAGE DRIVE  GRID: J8-L8 ZONE: 3
<b>DESCRIPTION:</b>  Port Jackson Figs in curved rows with evidence of road base land flattening in parts.

<b>CONDITION:</b>	Fair to good.
<b>HISTORY:</b>	Charles Moore designed an avenue beside the carriageway of Figs and Pines. Pines were removed probably in the late 1920s.
<b>REFERENCES:</b>	1991 DPWS Heritage Study. c.1920 photo panorama, c. 1903 phot, 1897 site plan.

<b>SIGNIFICANCE:</b>	Trees and archaeological evidence are significant as evidence of original major design element in Victorian picturesque landscape and representative of the work of Charles Moore. The existing trees maintain the integrity of the original alignment.
<b>GUIDELINES:</b>	Search for and document further evidence of original carriage drive. Potential to build new pathway along alignment in materials sympathetic to the original character, and utilise this path as a major pedestrian entrance to the Kirkbride Block, otherwise preserve. Replant missing figs and possibly add some <i>Pinus radiata</i> .

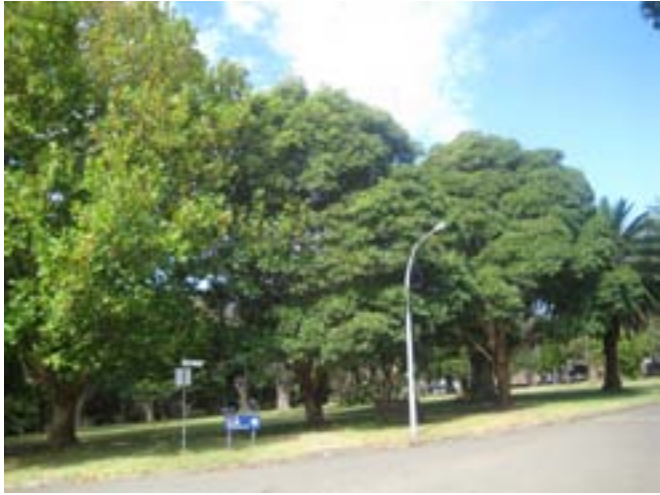
<b>ZONE 3 – KIRKBRIDE ENTRANCE GARDEN and EMBANKMENT TO KING GEORGE PARK</b>		
<b>ITEM No. 11</b>  <b>ORIGINAL NAME:</b>  <b>CURRENT USE:</b>	<b>CONSTRUCTION DATE:</b>  <b>ARCHITECT / BUILDER:</b>	<b>HERITAGE LISTINGS:</b> <input checked="" type="checkbox"/> National Estate <input checked="" type="checkbox"/> S170 List <input checked="" type="checkbox"/> National Trust <input checked="" type="checkbox"/> Leichhardt LEP <input type="checkbox"/> State Heritage Register
<b>ITEM:</b>  <b>LOCATION:</b>	<b>11 INDIVIDUAL TREES AND SHRUBS</b>  GRID: K7, K8 ZONE: 3	
<b>DESCRIPTION:</b>  Trees of varying ages and mixed species of trees and some shrubs.

<b>CONDITION:</b>	Fair to good.	
<b>HISTORY:</b>	Late 1880s and 1890s tree and shrub planting representative of species selection of Charles Moore also influenced by James Maiden infilled with subsequent individual plantings throughout 1900s and particularly 1960s and 1970s.

<b>REFERENCES:</b>	1991 DPWS Heritage Study. Plate 56. Powell	
<b>SIGNIFICANCE:</b>	Older trees significant as representative elements in Victorian landscape, however integrity diminished by later plantings which reduce former spatial variations.	
<b>GUIDELINES:</b>	Undertake further research to survey existing trees and establish age. Remove intrusive or recent plantings to restore Victorian picturesque landscape of 1880s to 1900. Maintain significant trees. Restore definition between developed garden areas and broad site landscape.

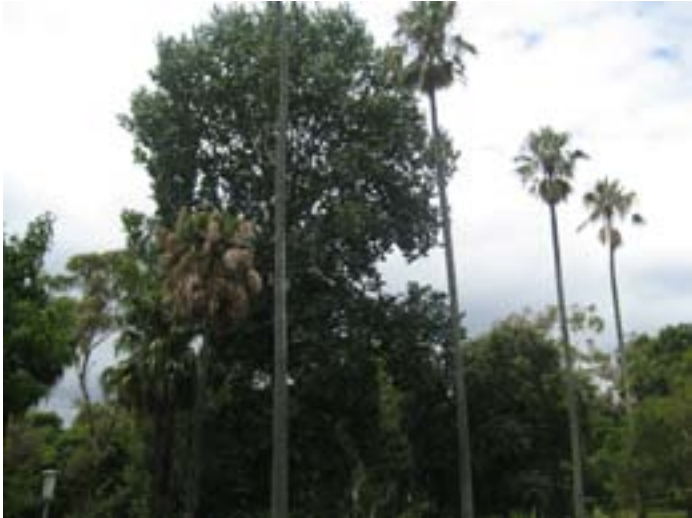
<b>ZONE 3 – KIRKBRIDE ENTRANCE GARDEN and EMBANKMENT TO KING GEORGE PARK</b>	
<b>ITEM No.</b> 1K  <b>ORIGINAL NAME:</b>  <b>CURRENT USE:</b>	<b>CONSTRUCTION DATE:</b> Planted in 1920s  <b>ARCHITECT / BUILDER:</b>  <b>HERITAGE LISTINGS:</b> <input checked="" type="checkbox"/> National Estate <input checked="" type="checkbox"/> S170 List <input checked="" type="checkbox"/> National Trust <input checked="" type="checkbox"/> Leichhardt LEP <input type="checkbox"/> State Heritage Register
<b>ITEM:</b>  <b>LOCATION:</b>	<b>1K PALM ROWS</b>  GRID: K6 ZONE: 3
<b>DESCRIPTION:</b>  Uniform row of palms ( <i>Phoenix reclinata</i> ) edging path and row of Cabbage Tree Palms.

<b>CONDITION:</b>	Fair to good
<b>HISTORY:</b>	Added in 1920s
<b>REFERENCES:</b>	1991 DPWS Heritage Study. c.1920 photo panorama in Powell
<b>SIGNIFICANCE:</b>	Significant as 1920s layer of garden design prerepresentative of growing use of plams with minmal intrusion on the significance of the former gardens.

<b>GUIDELINES:</b>	Maintain and undertake tree surgery on deformed individuals. Replace dying palms.

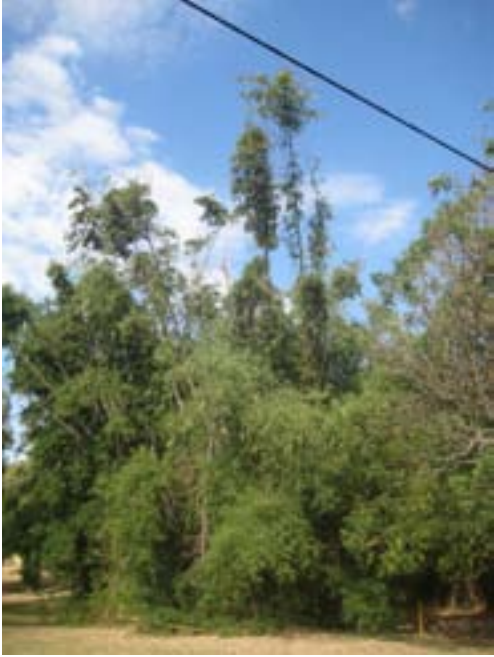
<b>ZONE 3 – KIRKBRIDE ENTRANCE GARDEN and EMBANKMENT TO KING GEORGE PARK</b>		
<b>ITEM No.</b> 1J <b>ORIGINAL NAME:</b> <b>CURRENT USE:</b>	<b>CONSTRUCTION DATE:</b> <b>ARCHITECT / BUILDER:</b>	<b>HERITAGE LISTINGS:</b> <input checked="" type="checkbox"/> National Estate <input checked="" type="checkbox"/> S170 List <input checked="" type="checkbox"/> National Trust <input checked="" type="checkbox"/> Leichhardt LEP <input type="checkbox"/> State Heritage Register
<b>ITEM:</b>	<b>1J INFORMAL TREE GROUPINGS</b>	
<b>LOCATION:</b>	GRID: K7 ZONE: 3	
<b>DESCRIPTION:</b> Timber Bamboo, Willow, Weeping Lily-pilly and other species informally grouped along the formal creek line.

<b>CONDITION:</b>	Good	
<b>HISTORY:</b>	This area remained undeveloped grassland with Willows and Eucalypts along the creek in the early 1900s. Existing mature Willows and Weeping Lily-pilly are typical species used by Charles Moore.

<b>REFERENCES:</b>	1991 DPWS Heritage Study.	
<b>SIGNIFICANCE:</b>	Some significance as reflection of early informal landscape which was a visual contrast to the formal gardens in the original gardens layout. The integrity of this significance is undermined by later tree plantings.	
<b>GUIDELINES:</b>	Retain as practicable.

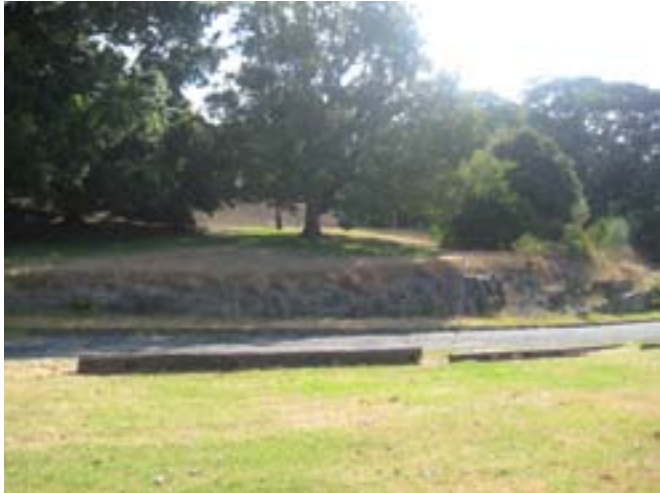
<b>ZONE 3 – KIRKBRIDE ENTRANCE GARDEN and EMBANKMENT TO KING GEORGE PARK</b>		
<b>ITEM No.</b> 4E  <b>ORIGINAL NAME:</b>  <b>CURRENT USE:</b> -	<b>CONSTRUCTION DATE:</b>  <b>ARCHITECT / BUILDER:</b>	<b>HERITAGE LISTINGS:</b> <input checked="" type="checkbox"/> National Estate <input checked="" type="checkbox"/> S170 List <input checked="" type="checkbox"/> National Trust <input checked="" type="checkbox"/> Leichhardt LEP <input type="checkbox"/> State Heritage Register
<b>ITEM:</b>  <b>LOCATION:</b>	<b>4E ROCK OUTCROP</b>  GRID: I3-4 ZONE: 3	
<b>DESCRIPTION:</b>  Natural bedrock outcrop, part covered by fill in some areas.

<b>CONDITION:</b>	Part covered by fill, substantially intact.	
<b>HISTORY:</b>		
<b>REFERENCES:</b>	1991 DPWS Heritage Study.	
<b>SIGNIFICANCE:</b>	Significant as remnant of natural landform and rugged setting for asylum and Garry Owen House.	
<b>GUIDELINES:</b>	Preserve and clear away fill to expose more bedrock and revegetate with indigenous species. During excavation be sensitive to potential for uncovering of aboriginal middens and carvings. Protect any such findings and notify National Parks and Wildlife Service.
