## **ZONE 5 CENTRAL SLOPE**

**INVENTORY OF INDIVIDUAL ITEMS**

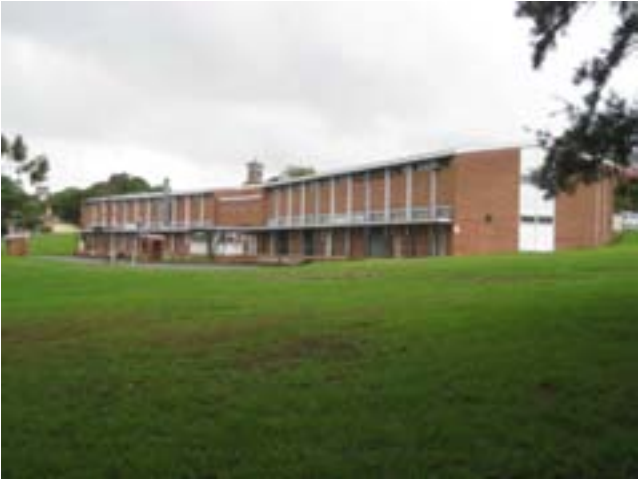
<b>ZONE 5 – CENTRAL SLOPE</b>	
<b>ITEM No. B201</b>  <b>ORIGINAL NAME:</b> Buildings 35, 36 Stores and Pharmacy  <b>CURRENT USE:</b>	<b>CONSTRUCTION DATE:</b> c. 1965  <b>ARCHITECT / BUILDER:</b> Unknown (Possibly Government Architect Ted Farmer)
<b>HERITAGE LISTINGS:</b> <input type="checkbox"/> National Estate <input type="checkbox"/> S170 List <input type="checkbox"/> National Trust <input type="checkbox"/> Leichhardt LEP <input type="checkbox"/> State Heritage Register	
<b>BUILDING:</b>  <b>LOCATION:</b>	<b>B201 STORES</b>  GRID: F7 ZONE: 5
<b>DESCRIPTION:</b>  Industrial scaled building with steel frame and brick walls, shallow pitched gabled metal deck roof; two very large rectangular blocks with linking element.

<b>CONDITION:</b>	Good
<b>HISTORY:</b>	Built c. 1965
<b>REFERENCES:</b>	Leong (43) MH2/316 JTCW
<b>SIGNIFICANCE:</b>	None, highly intrusive in style and particularly in siting
<b>GUIDELINES:</b>	Retain, recycle or preferably remove. Landscape could soften buildings impact though buildings size makes screening difficult. Painting in a recessive colour would help reduce intrusion. If replaced any new development should allow landscape to be dominant and should be smaller in scale; it must conform to the requirements of the Callan Park Act. If removed record prior to demolition.

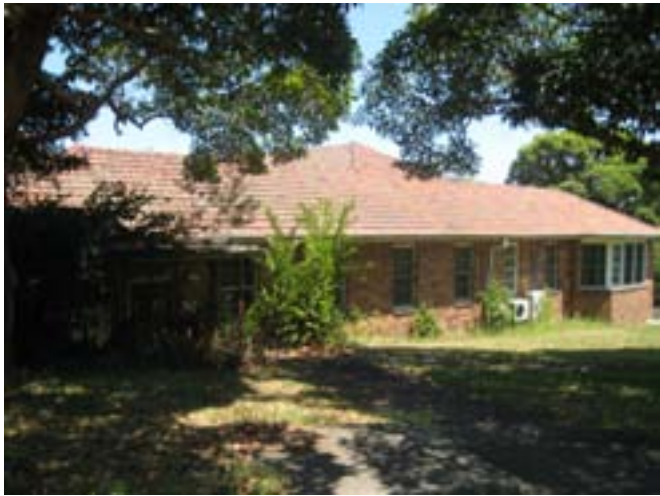
<b>ZONE 5 – CENTRAL SLOPE</b>		
<p><b>ITEM No. B208</b></p> <p><b>ORIGINAL NAME:</b> Male Admission Ward 16 (later Male Ward 9, Laundry), Building 39</p> <p><b>CURRENT USE:</b> Unoccupied</p>	<p><b>CONSTRUCTION DATE:</b> c.1948</p> <p><b>ARCHITECT / BUILDER:</b> Unknown</p>	<p><b>HERITAGE LISTINGS:</b></p> <p><input type="checkbox"/> National Estate</p> <p><input type="checkbox"/> S170 List</p> <p><input type="checkbox"/> National Trust</p> <p><input type="checkbox"/> Leichhardt LEP</p> <p><input type="checkbox"/> State Heritage Register</p>
<p><b>BUILDING:</b></p>	<p><b>B 208</b></p>	
<p><b>LOCATION:</b></p>	<p>GRID: H6-7 ZONE: 5</p>	
<p><b>DESCRIPTION:</b></p> <p>Long and rambling single storey brick and hipped terracotta tiled roof building. Two wings with central entry. Timber and aluminium doors and windows.</p>

<p><b>CONDITION:</b></p>	<p>Good</p>	
<p><b>HISTORY:</b></p>	<p>Built c.1948 (working drawing signed 11 November 1948).</p>

<p><b>REFERENCES:</b></p>	<p>Leong (28) MH2/6-18, JTCW, DPWS 1991 &amp; Public Works 1993, Aerial photo 1951.</p>	
<p><b>SIGNIFICANCE:</b></p>	<p>Intrusive, sited high and directly in front of the central axis of the Kirkbride Unit.</p>	
<p><b>GUIDELINES:</b></p>	<p>Retain, recycle, or preferably remove as practicable. Intrusiveness could be reduced by screen planting to give the effect of bush in views to and from Kirkbride. This area should be left open in any redevelopment but if development occurs it must conform to the requirements of the Callan Park Act. If removed record prior to demolition.</p>

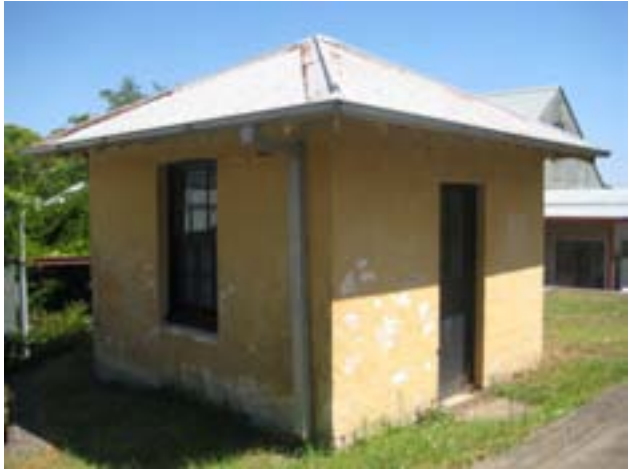
<b>ZONE 5 – CENTRAL SLOPE</b>		
<p><b>ITEM Nos.</b> B401</p> <p><b>ORIGINAL NAME:</b> Ward 15; Building 50C</p> <p><b>CURRENT USE:</b> Unoccupied</p>	<p><b>CONSTRUCTION DATE:</b> Unknown</p> <p><b>ARCHITECT / BUILDER:</b> Unknown</p>	<p><b>HERITAGE LISTINGS:</b></p> <p><input type="checkbox"/> National Estate</p> <p><input checked="" type="checkbox"/> S170 List</p> <p><input type="checkbox"/> National Trust</p> <p><input type="checkbox"/> Leichhardt LEP</p> <p><input type="checkbox"/> State Heritage Register</p>
<p><b>BUILDING:</b></p>	<p><b>B401</b></p>	
<p><b>LOCATION:</b></p>	<p>GRID: G9 ZONE: 5</p>	
<p><b>DESCRIPTION:</b></p> <p>Tiny square building. Rendered brick with rendered finish, hipped corrugated iron roof with exposed rafters in eaves. Two timber doors on opposite sides, 2 timber windows on other sides.</p> <p>Awkwardly placed beside early 1990s development. Close to road side and elevated by lowered landscaping of new buildings.</p>

<p><b>CONDITION:</b></p>	<p>Fair. Window sill joinery badly deteriorated, cracks in wall surfaces and rust in roof linings and cappings. Painted wall surfaces are also deteriorating.</p>	
<p><b>HISTORY:</b></p>	<p>Unknown - appears to be early farm building. Doors and window indicate intended for use by people (rather than store) possibly for supervision and controlling entry into orchard or farm.</p>	
<p><b>REFERENCES:</b></p>	<p>DPWS (1991), site inspection.</p>	
<p><b>SIGNIFICANCE:</b></p>	<p>Moderate significance as part of a group of utility/farm buildings demonstrating the early use of the site and contributing to the pastoral character of the area. Design gives indication of former use.</p>	
<p><b>GUIDELINES:</b></p>	<p>Retain and conserve according to Burra Charter principles. Carefully repair deteriorating fabric using appropriate materials and profiles.</p>

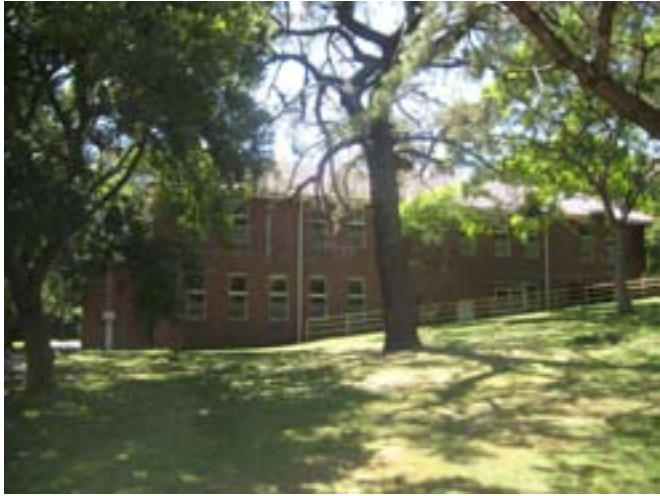
<b>ZONE 5 – CENTRAL SLOPE</b>		
<p><b>ITEM No. B496</b></p> <p><b>ORIGINAL NAME:</b> Ward G Repatriation Hospital, Building 89, Foundation House</p> <p><b>CURRENT USE:</b> Unoccupied.</p>	<p><b>CONSTRUCTION DATE:</b> c. 1945</p> <p><b>ARCHITECT / BUILDER:</b> Unknown (Possibly Government Architect Cobden Parkes)</p>	<p><b>HERITAGE LISTINGS:</b></p> <p><input type="checkbox"/> National Estate</p> <p><input type="checkbox"/> S170 List</p> <p><input type="checkbox"/> National Trust</p> <p><input type="checkbox"/> Leichhardt LEP</p> <p><input type="checkbox"/> State Heritage Register</p>
<p><b>BUILDING:</b></p>	<p><b>B 496</b></p>	
<p><b>LOCATION:</b></p>	<p>GRID: H5 ZONE: 5</p>	
<p><b>DESCRIPTION:</b></p> <p>Two storey brick building with internal courtyard with hipped terracotta tiled roof. Some original timber framed windows, although many replaced by aluminium framed sashes. Original timber doors, particularly French doors on north side associated with flat roofed verandah supported off rectangular brick piers. Metal balustrades across many windows. Circular window ground floor west side. Building set into steep hillside, so reducing its bulk in views from Kirkbride from north west.</p>

<p><b>CONDITION:</b></p>	<p>Good</p>	
<p><b>HISTORY:</b></p>	<p>Built c. 1945</p>	
<p><b>REFERENCES:</b></p>	<p>Leong (50), MH2/419-420, JTCW</p>	
<p><b>SIGNIFICANCE:</b></p>	<p>Low. Minimal, part of development of repatriation hospital and well built example but not of particular value.</p>	
<p><b>GUIDELINES:</b></p>	<p>Retain, recycle, replace or remove as required. Any replacement should similarly allow landscape to dominate and must conform to the requirements of the Callan Park Act. If removed record prior to demolition.</p>

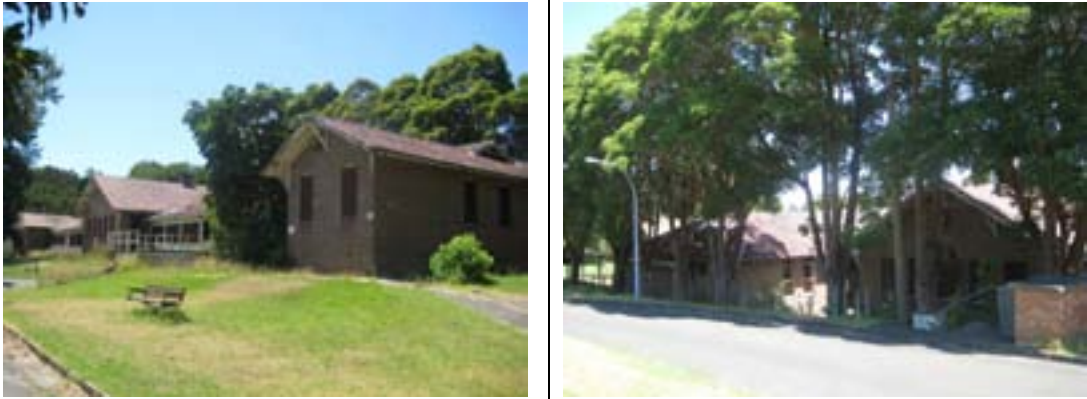
<b>ZONE 5 – CENTRAL SLOPE</b>		
<b>ITEM No. B497</b>  <b>ORIGINAL NAME:</b> Ward B, Building 90  <b>CURRENT USE:</b> Disused	<b>CONSTRUCTION DATE:</b> early 1920s? (plans dated 1918)  <b>ARCHITECT / BUILDER:</b> Unknown	<b>HERITAGE LISTINGS:</b> <input type="checkbox"/> National Estate <input checked="" type="checkbox"/> S170 List <input type="checkbox"/> National Trust <input type="checkbox"/> Leichhardt LEP <input type="checkbox"/> State Heritage Register
<b>BUILDING:</b> <b>LOCATION:</b>	<b>B497</b> GRID: G5 ZONE: 5	
<b>DESCRIPTION:</b>  Long single storey brick (commons) building with glazed terracotta tiled roof. Timber windows with each sash divided into 9 panes (windows boarded over). Rafter ends exposed, eaves lined with timber boards. Service courts at rear of building. Verandahs enclosed and toilet blocks altered. Originally similar to B502 in Zone 7. Well screened by trees. Harbour Bridge War Memorial constructed by patients to north of building and is carefully related to it.

<b>CONDITION:</b>	Fair. Damp problems, some deteriorating roof and rainwater fabric.	
<b>HISTORY:</b>	Built early 1920s? Plans are dated 1918, appears on 1931 aerial photo.	
<b>REFERENCES:</b>	Leong (49), MH2/370, JTCW	
<b>SIGNIFICANCE:</b>	Low. Significance as first building of repatriation hospital though not of great architectural value.	
<b>GUIDELINES:</b>	Retain and conserve according to Burra Charter principles. Adaptive reuse should be sympathetic to the building. Maintain and enhance the relationship between the building and the Harbour Bridge War Memorial and the building and its setting within the site. Requires maintenance, especially gutters, downpipes and stormwater drains. Verandahs should be reinstated and intrusive accretions removed.

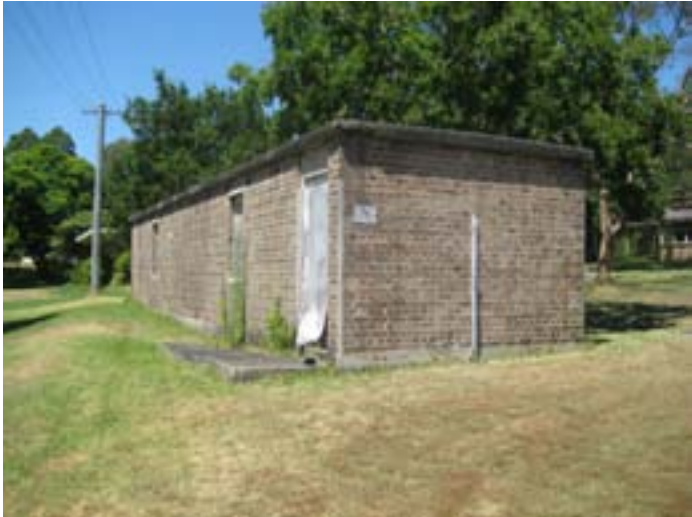
<b>ZONE 5 – CENTRAL SLOPE</b>	
<p><b>ITEM No.</b> B510</p> <p><b>ORIGINAL NAME:</b> Bomb Shelter; Gardener's Shed.</p> <p><b>CURRENT USE:</b> Unoccupied</p>	<p><b>CONSTRUCTION DATE:</b> c. 1940</p> <p><b>ARCHITECT / BUILDER:</b> Unknown</p> <p><b>HERITAGE LISTINGS:</b></p> <ul style="list-style-type: none"> <li><input type="checkbox"/> National Estate</li> <li><input checked="" type="checkbox"/> S170 List</li> <li><input type="checkbox"/> National Trust</li> <li><input type="checkbox"/> Leichhardt LEP</li> <li><input type="checkbox"/> State Heritage Register</li> </ul>
<p><b>BUILDING:</b></p> <p><b>LOCATION:</b></p>	<p>B510 BOMB SHELTER</p> <p>GRID: E-F 5 ZONE: 5</p> <p>(See also: B498 Zone 1; B293, B601, B706, B707 and B708 Zone 4; B295 Zone 5)</p>
<p><b>DESCRIPTION:</b></p> <p>Long rectangular flat roofed, brick and concrete structures.</p>

<b>CONDITION:</b>	Average
<b>HISTORY:</b>	c. 1940

<b>REFERENCES:</b>	Site inspection; DPWS (1991)
<b>SIGNIFICANCE:</b>	Moderate. Indicative of provisions for war.
<b>GUIDELINES:</b>	Retain, remove as practicable. Some are intrusive elements. Retain one as example at minimum. If removed record prior to demolition.

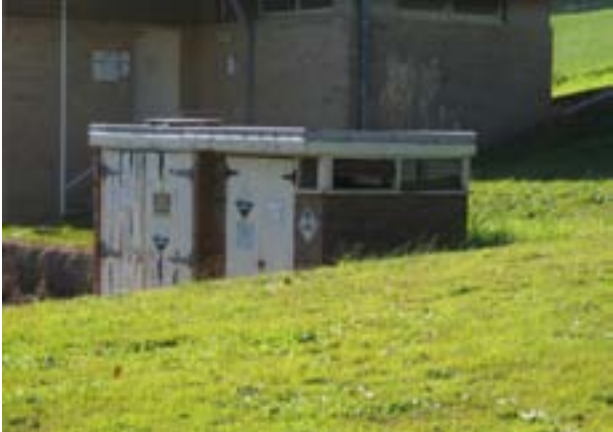
<b>ZONE 5 – CENTRAL SLOPE</b>	
<b>ITEM No. B515A</b>  <b>ORIGINAL NAME:</b>  <b>CURRENT USE: Pool pump house</b>	<b>CONSTRUCTION DATE:</b>  <b>ARCHITECT / BUILDER</b> Unknown  <b>HERITAGE LISTINGS:</b> <input type="checkbox"/> National Estate <input type="checkbox"/> S170 List <input type="checkbox"/> National Trust <input type="checkbox"/> Leichhardt LEP <input type="checkbox"/> State Heritage Register
<b>BUILDING:</b>  <b>LOCATION:</b>	<b>B515A SWIMMING POOL PUMP HOUSE</b>  GRID: F7 ZONE: 5
<b>DESCRIPTION:</b>  Small brick building with flat roof covered by steel decking. Pairs of timber doors on one side, high openings beneath roof with louvres.

<b>CONDITION:</b>	Fair.
<b>HISTORY:</b>	Probably built at the same time as the swimming pool.
<b>REFERENCES:</b>	
<b>SIGNIFICANCE:</b>	None, intrusive in style.
<b>GUIDELINES:</b>	Retain, recycle or preferably remove. If removed record prior to demolition.

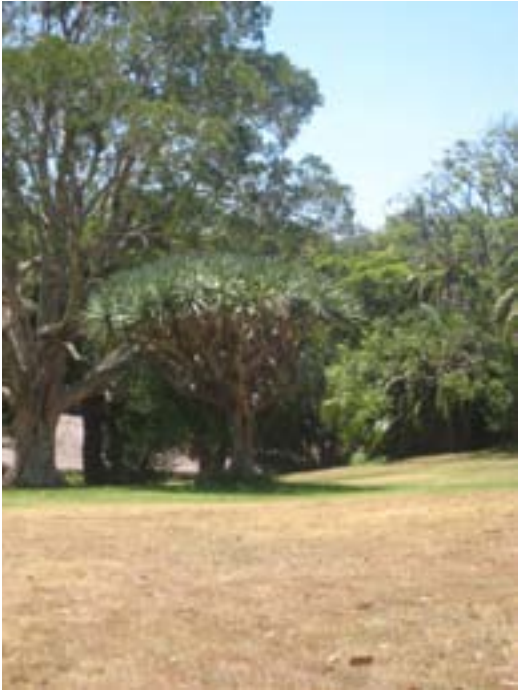
<b>ZONE 5 – CENTRAL SLOPE</b>	
<b>ITEM No. 8D</b>  <b>ORIGINAL NAME:</b>  <b>CURRENT USE:</b>	<b>DATE: Circa 1880s</b>  <b>DESIGNER / BUILDER:</b>
<b>HERITAGE LISTINGS:</b> <input type="checkbox"/> National Estate <input checked="" type="checkbox"/> S170 List <input type="checkbox"/> National Trust <input type="checkbox"/> Leichhardt LEP <input type="checkbox"/> State Heritage Register	
<b>ITEM:</b>  <b>LOCATION:</b>	ORIGINAL TREES  GRID: G6 ZONE: 5
<b>DESCRIPTION:</b>  Individual trees in grass including Dragon’s Blood and large Fig tree. Remains of early path to gardener’s cottage (B205) evident near Dragon’s Blood Tree.

<b>CONDITION:</b>	Good
<b>HISTORY:</b>	Evident on 1930 aerial photo. Species representative of 1880s to 1890s plantings.
<b>REFERENCES:</b>	1991 DPWS Heritage Study: Aerial photo 1930, Site inspection
<b>SIGNIFICANCE:</b>	Significant as planting of original asylum period. Evidence of early pathway significant to original design.

<b>GUIDELINES:</b>	Retain and conserve original trees. Document evidence of path.
<b>ZONE 5 – CENTRAL SLOPE</b>

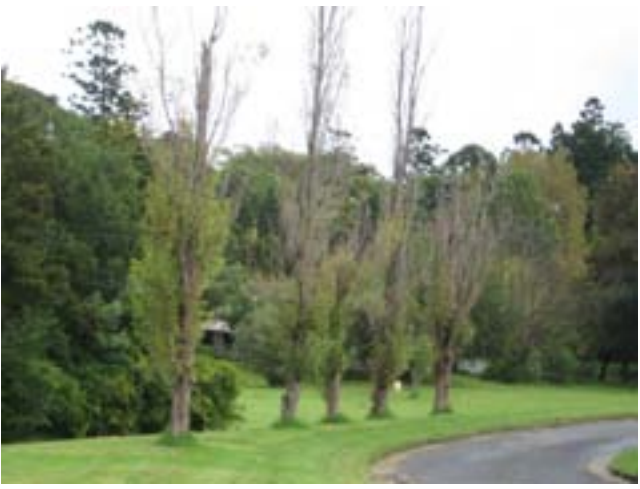
ZONE 5 – CENTRAL SLOPE	
<b>ITEM No. 8H</b>  <b>ORIGINAL NAME:</b>  <b>CURRENT USE:</b>	<b>DATE: Circa 1960</b>  <b>DESIGNER / BUILDER:</b>  <b>HERITAGE LISTINGS:</b> <input type="checkbox"/> National Estate <input checked="" type="checkbox"/> S170 List <input type="checkbox"/> National Trust <input type="checkbox"/> Leichhardt LEP <input type="checkbox"/> State Heritage Register
<b>ITEM:</b>  <b>LOCATION:</b>	POPLAR ROWS  GRID: F9 ZONE: 5
<b>DESCRIPTION:</b>  Row of Lombardy Poplar.

<b>CONDITION:</b>	Fair to poor
<b>HISTORY:</b>	Planted about 1960.
<b>REFERENCES:</b>	1991 DPWS Heritage Study: Powell
<b>SIGNIFICANCE:</b>	Intrudes on significant fabric and on original asylum design concept.
<b>GUIDELINES:</b>	Remove as practicable.

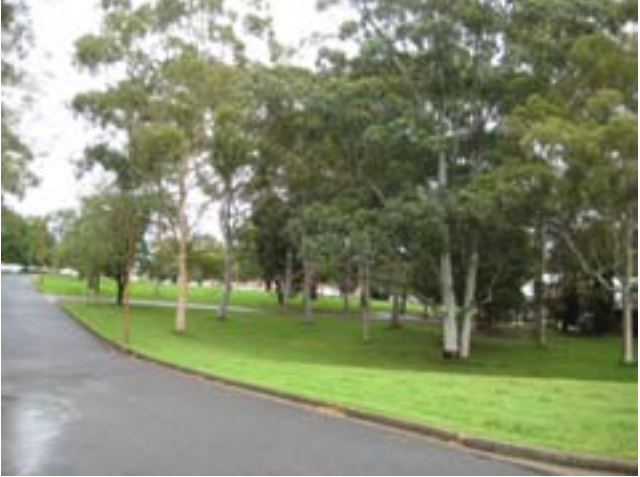
<b>ZONE 5 – CENTRAL SLOPE</b>		
<b>ITEM No. 8L</b>  <b>ORIGINAL NAME:</b>  <b>CURRENT USE:</b>	<b>DATE: Possibly 1970s</b>  <b>DESIGNER / BUILDER:</b>	<b>HERITAGE LISTINGS:</b> <input type="checkbox"/> National Estate <input checked="" type="checkbox"/> S170 List <input type="checkbox"/> National Trust <input type="checkbox"/> Leichhardt LEP <input type="checkbox"/> State Heritage Register
<b>ITEM:</b>  <b>LOCATION:</b>	LIQUIDAMBAR AVENUE & EUCALPT ROWS  GRID: E9-10 ZONE: 5	
<b>DESCRIPTION:</b>  Liquidambar avenue to nursery access road and plantation of Lemon-Scented Gums.

<b>CONDITION:</b>	Good	
<b>HISTORY:</b>	Unresearched. Likely to be planted in 1970s.	
<b>REFERENCES:</b>	1991 DPWS Heritage Study: Aerial photo 1952. Site plan 1965.	
<b>SIGNIFICANCE:</b>	No evidence of heritage significance.	
<b>GUIDELINES:</b>	Retain and integrate into upgraded landscaping works where practicable.

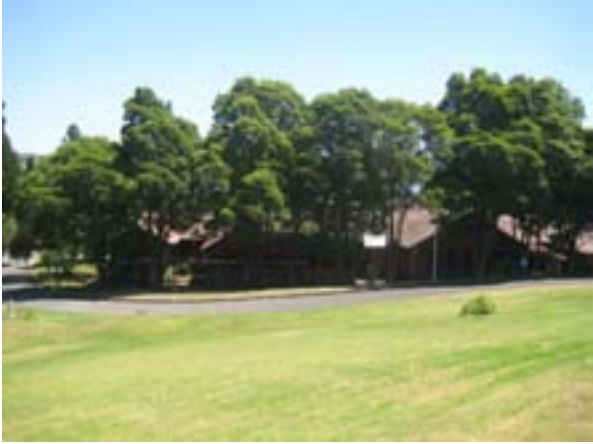
<b>ZONE 5 – CENTRAL SLOPE</b>	
<b>ITEM No. 7P</b>  <b>ORIGINAL NAME:</b>  <b>CURRENT USE:</b>	<b>DATE:</b> planted late 1930s/1940s  <b>DESIGNER / BUILDER:</b>  <b>HERITAGE LISTINGS:</b> <input type="checkbox"/> National Estate <input checked="" type="checkbox"/> S170 List <input type="checkbox"/> National Trust <input type="checkbox"/> Leichhardt LEP <input type="checkbox"/> State Heritage Register
<b>ITEM:</b>  <b>LOCATION:</b>	BRUSH BOX ROWS  GRID: G5 ZONE: 5
<b>DESCRIPTION:</b>  Row of Brush Box along section of Military Drive.

<b>CONDITION:</b>	Good.
<b>HISTORY:</b>	Originally planted in late 1930s or 1940s behind Building B497 and extending to end of the canal section of row removed for road construction.
<b>REFERENCES:</b>	1991 DPWS Heritage Study; Interpretation of site plans 1931-51 and 1965.
<b>SIGNIFICANCE:</b>	No evidence of heritage significance.
<b>GUIDELINES:</b>	Over time break down lineal formation and incorporate into future informal tree plantings as appropriate. Remove section of brush box row adjoining significant tree group at end of canal.

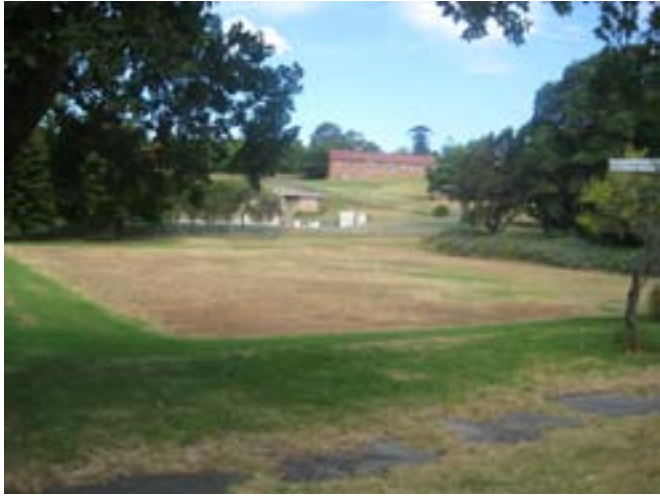
<b>ZONE 5 – CENTRAL SLOPE</b>		
<b>ITEM No. 7K</b>  <b>ORIGINAL NAME:</b> Bowling green  <b>CURRENT USE:</b> Disused	<b>CONSTRUCTION DATE:</b> 1960s.  <b>DESIGNER / BUILDER:</b>	<b>HERITAGE LISTINGS:</b> <input type="checkbox"/> National Estate <input checked="" type="checkbox"/> S170 List <input type="checkbox"/> National Trust <input type="checkbox"/> Leichhardt LEP <input type="checkbox"/> State Heritage Register
<b>ITEM:</b>  <b>LOCATION:</b>	BOWLING GREEN  GRID: F6 ZONE: 5	
<b>DESCRIPTION:</b>  Raised earth platform, with plumbago hedge on southern side. B509 defines western edge.

<b>CONDITION:</b>	Intact. Lawn is maintained.	
<b>HISTORY:</b>	Built 1960s.	
<b>REFERENCES:</b>	1991 DPWS Heritage Study; Site plan 1965.	
<b>SIGNIFICANCE:</b>	Intrudes on significant fabric and character.	
<b>GUIDELINES:</b>	Retain as open space. Landscape in accordance with conservation policies.

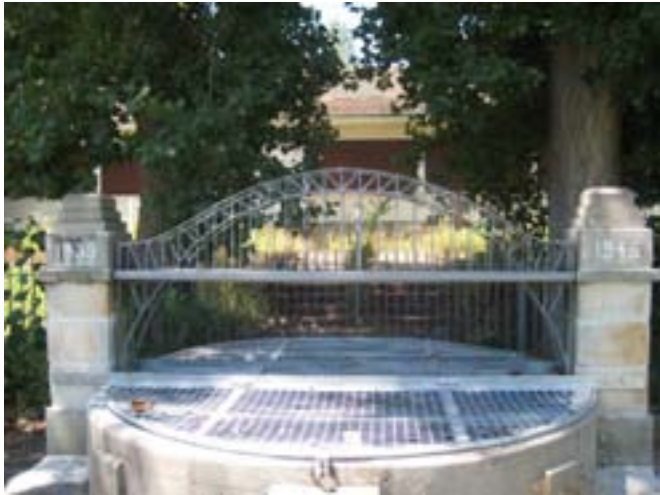
<b>ZONE 5 – CENTRAL SLOPE</b>		
<p><b>ITEM No. 70</b></p> <p><b>ORIGINAL NAME:</b> War memorial</p> <p><b>CURRENT USE:</b> War memorial</p>	<p><b>CONSTRUCTION DATE:</b> unveiled 4 August 1931</p> <p><b>DESIGNER / BUILDER:</b> Design attributed to Douglas Grant; construction attributed to World War I veteran patients.</p>	<p><b>HERITAGE LISTINGS:</b></p> <p><input type="checkbox"/> National Estate</p> <p><input checked="" type="checkbox"/> S170 List</p> <p><input type="checkbox"/> National Trust</p> <p><input type="checkbox"/> Leichhardt LEP</p> <p><input type="checkbox"/> State Heritage Register</p>
<p><b>ITEM:</b></p> <p><b>LOCATION:</b></p>	<p>WAR MEMORIAL</p> <p>GRID: G5 ZONE: 5</p>	
<p><b>DESCRIPTION:</b></p> <p>Scale model of Sydney Harbour Bridge with stone pylons, beneath which is a circular concrete basin. Years 1914 and 1918 inscribed on south side (facing former B ward, B497) and years 1939 and 1945 inscribed on north side. Bronze plaques on south sides of pylons commemorate unveiling by Governor Game and erection of memorial by patients of B Ward. Memorial is aligned with steps leading up to the western section of B497. The basin has been enclosed by a metal security grille.</p>

<p><b>CONDITION:</b></p>	<p>Good. Security grille over basin detracts from the memorial.</p>	
<p><b>HISTORY:</b></p>	<p>Erected by returned servicemen housed in Convalescent Ward B (B497), but has also been attributed to Aboriginal ex-serviceman Douglas Grant. It was unveiled by the Governor of NSW, Sir Phillip Game, on 4 August 1931. "1939" and "1945" inscriptions on north side are later modifications.</p>	
<p><b>REFERENCES:</b></p>	<p>1991 DPWS Heritage Study; "Military Cottages", <i>Sydney Morning Herald</i> 4 August 1931, p.6; C D Coulthard-Clark, "Grant, Douglas (1885?-1951)" in <i>Australian Dictionary of Biography</i>, Volume 9.</p>	
<p><b>SIGNIFICANCE:</b></p>	<p>Significant as war memorial associated with significant Aboriginal ex-serviceman Douglas Grant and erected by patients. An unusual 'folly' landscape element that reinforces the associations between building B 497 and the repatriation phase of Callan Park.</p>

<p><b>GUIDELINES:</b></p>	<p>Retain and conserve in existing location. Investigate less intrusive methods of making the basin secure. Integrate with B497 through careful landscaping.</p>

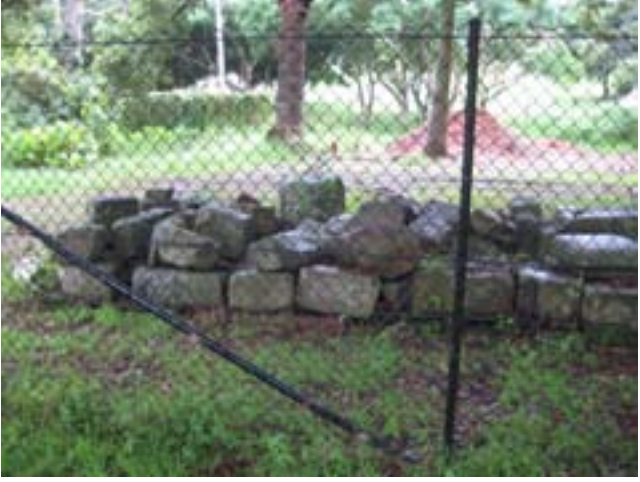
<b>ZONE 5 – CENTRAL SLOPE</b>		
<b>ITEM No. 11D</b> <b>ORIGINAL NAME:</b> <b>CURRENT USE:</b>	<b>CONSTRUCTION DATE:</b>  <b>ARCHITECT / BUILDER:</b>	<b>HERITAGE LISTINGS:</b> <input type="checkbox"/> National Estate <input type="checkbox"/> S170 List <input type="checkbox"/> National Trust <input type="checkbox"/> Leichhardt LEP <input type="checkbox"/> State Heritage Register
<b>ITEM:</b> <b>LOCATION:</b>	<b>11D GATE POST CAPITAL</b>  GRID: E6 ZONE: 5	
<b>DESCRIPTION:</b>  One carved stone and many uncarved sandstone blocks in various conditions. Blocks are located in a secure compound to the south of B506

<b>CONDITION:</b>	Intact stones, apparently in good condition.	
<b>HISTORY:</b>	Constructed as part of Kirkbride Block. Demolished when gateway widened in internal court. In 2002 located in vicinity of B196 (Grid D7, Zone 7).	
<b>REFERENCES:</b>	Historic Buildings Group Report on Kirkbride Block (Item B2.01)

<b>SIGNIFICANCE:</b>	Significant as original fabric from the Kirkbride Block.	
<b>GUIDELINES:</b>	Retain all stone and relocate to Kirkbride Block for eventual reconstruction of gateway.
