ZONE 7 BROUGHTON HALL

ZONE 7 BROUGHTON HALL
INVENTORY OF INDIVIDUAL ITEMS

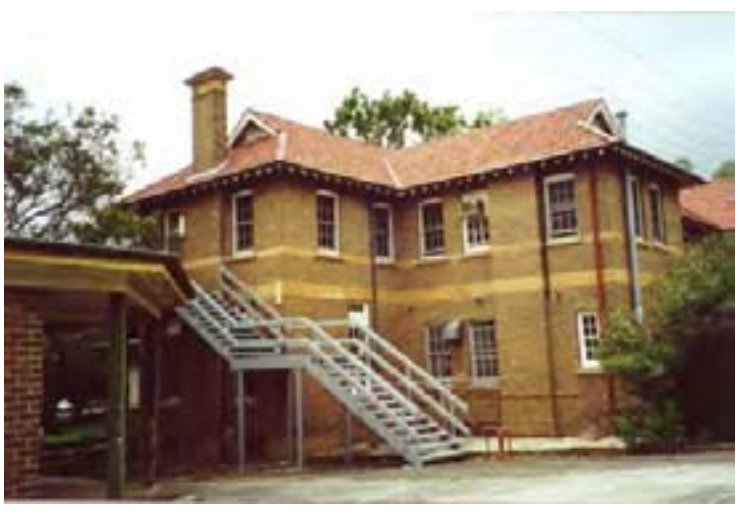
ZONE 7 – BROUGHTON HALL		
<p>ITEM No. B121</p> <p>ORIGINAL NAME: Ward 2 Dormitory Block, Building 14 Ward 24</p> <p>CURRENT USE: WHOS</p>	<p>CONSTRUCTION DATE: c. 1920</p> <p>ARCHITECT / BUILDER. NSW Government Architect's Office under George Mc Rae.</p>	<p>HERITAGE LISTINGS:</p> <p><input type="checkbox"/> National Estate</p> <p><input checked="" type="checkbox"/> S170 List</p> <p><input type="checkbox"/> National Trust</p> <p><input type="checkbox"/> Leichhardt LEP</p> <p><input type="checkbox"/> State Heritage Register</p>
<p>BUILDING:</p> <p>LOCATION:</p>	<p>B121- WARD 24</p> <p>GRID: C8-9 ZONE: 7</p>	
<p>CONDITION:</p>	<p>Fair to good, intact with minor additions including enclosed verandah.</p>	
<p>DESCRIPTION:</p> <p>Two storey building with Federation era aesthetic. Brick walls with stone string course and sills, complex terracotta tiled roof with gablet vents and rafters exposed in eaves. Arched opening to entrance. Multi-paned double hung windows and extensive verandah on garden side with fine turned timber columns.</p>

<p>HISTORY:</p>	<p>Built c. 1920. Drawing signed by G. M. Blair 1908 and passed by G. M. Blair 13 September 1918. 1908 is well prior to government use of site, so the building may have been intended for elsewhere.</p>	
<p>REFERENCES:</p>	<p>Leong (67). MHI/628-9, JTCW</p>	
<p>SIGNIFICANCE:</p>	<p>High. One of most important elements of the Broughton Hall group, enclosing garden and consistent in materials, design and scale. Finely crafted and designed building. Accomplished example of type. Note that external metal stairs are intrusive.</p>	
<p>GUIDELINES:</p>	<p>Retain and conserve according to Burra Charter principles (including adaptive reuse). Respect group values in any work. If practicable, remove unsympathetic verandah enclosure. General maintenance required, including rainwater goods. Remove redundant services from external walls.</p> <p>The design of the external fire stairs should be integrated with the building as appropriate for intended use.</p>

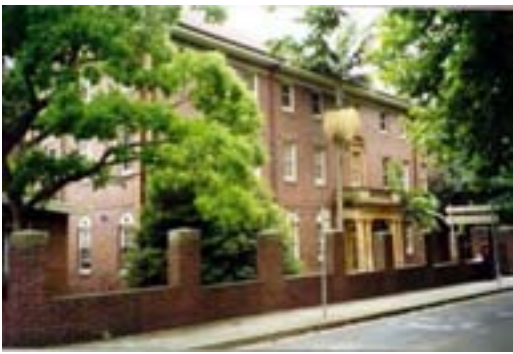
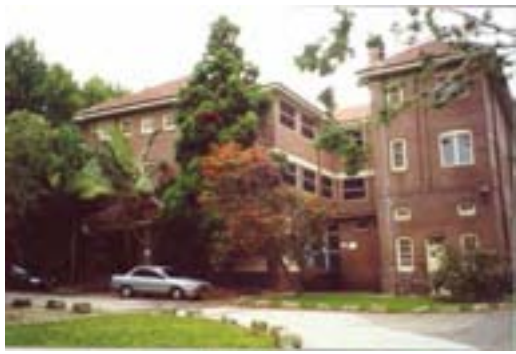
ZONE 7 – BROUGHTON HALL		
<p>ITEM No. B125</p> <p>ORIGINAL NAME: Administration Block and Nurses' Quarters (later Domestic Services, Chaplains, Nurses' Home, Outdoor Supervisor), Building 10, 11 and 13 Broughton Hall Offices</p> <p>CURRENT USE: Mental Health Co-ordinating Council offices</p>	<p>CONSTRUCTION DATE: c. 1927-29</p> <p>ARCHITECT / BUILDER: Unknown (probably NSW Government Architect's Office under Richard Wells).</p>	<p>HERITAGE LISTINGS:</p> <p><input type="checkbox"/> National Estate</p> <p><input checked="" type="checkbox"/> S170 List</p> <p><input type="checkbox"/> National Trust</p> <p><input type="checkbox"/> Leichhardt LEP</p> <p><input type="checkbox"/> State Heritage Register</p>
<p>BUILDING:</p> <p>LOCATION:</p>	<p>B125 MENTAL HEALTH CO-ORDINATING COUNCIL</p> <p>GRID: C9 ZONE: 7</p>	
<p>DESCRIPTION:</p> <p>Three storey brick building with hipped terracotta tiled roof. Georgian Revival detailing with rendered arch over ground floor windows with medallion. Finely detailed classical sandstone porch to street frontage. Symmetrically composed. Fence designed with building but metal panels now removed.</p>

</div>		
<p>CONDITION:</p>	<p>Good, largely intact.</p> <p>Note some bricks and copings have been removed from the surrounding wall in addition to all iron panels between piers.</p>	
<p>HISTORY:</p>	<p>Built c. 1927 – 29</p>	
<p>REFERENCES:</p>	<p>Leong (68), MHI/146-7, JTCW</p>	
<p>SIGNIFICANCE:</p>	<p>High. Part of Broughton Hall Group. Forms corner to enclosure of gardens. Group of consistent design, materials and scale.</p>	
<p>GUIDELINES:</p>	<p>Conserve and adapt according to Burra Charter principles. Routine maintenance required. Reconstruct missing elements such as windows and repair fabric to match existing. Remove redundant services from external wall surfaces.</p> <p>Reconstruct missing elements of the enclosing walls along Church Street and Glover Street.</p>

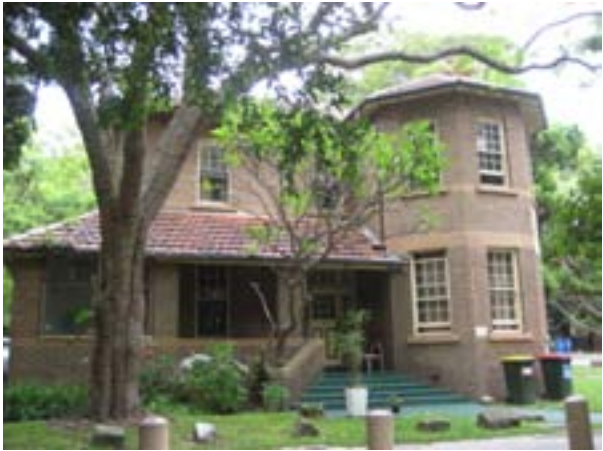
ZONE 7 – BROUGHTON HALL		
<p>ITEM No. 126</p> <p>ORIGINAL NAME: Medical Superintendent's Quarters, Building 9</p> <p>CURRENT USE: WHOS – music therapy</p>	<p>CONSTRUCTION DATE: c.1920</p> <p>ARCHITECT / BUILDER: NSW Government Architect's Office under Gorrie McLeish Blair</p>	<p>HERITAGE LISTINGS:</p> <p><input type="checkbox"/> National Estate</p> <p><input checked="" type="checkbox"/> S170 List</p> <p><input type="checkbox"/> National Trust</p> <p><input type="checkbox"/> Leichhardt LEP</p> <p><input type="checkbox"/> State Heritage Register</p>
<p>BUILDING:</p>	<p>B126 TREE TOPS</p>	
<p>LOCATION:</p>	<p>GRID: C9 ZONE: 7</p>	
<p>DESCRIPTION:</p> <p>Two storey Federation period house. Brick with stone string course and sills, hipped terracotta tiled roof with rafters exposed at eaves. Projecting bay and verandah facing garden, multi-paned double hung timber windows.</p>

<p>CONDITION:</p>	<p>Fair and generally intact, including internally, with minor alterations. Sections of roofing and rainwater goods deteriorating.</p> <p>Note some bricks and stone cappings have been removed from the surrounding wall in addition to all iron panels between piers.</p>

<p>HISTORY:</p>	<p>Built c. 1920. Drawings dated 1918 and signed design architect, G. M. Blair, Principal Design Architect 1.12.18. Built in different location to that shown on original site plan.</p>	
<p>REFERENCES:</p>	<p>Leong (72), MH1/145, JTCW</p>	
<p>SIGNIFICANCE:</p>	<p>High. Part of Broughton Hall Group. With other buildings forms "wall" enclosing gardens. Part of group with consistent design, scale and materials. Well built example.</p>	
<p>GUIDELINES:</p>	<p>Retain and conserve according to Burra Charter principles. Undertake repairs to deteriorating roof areas and rainwater goods. Initiate a regular maintenance program. Reinstate open verandahs.</p>

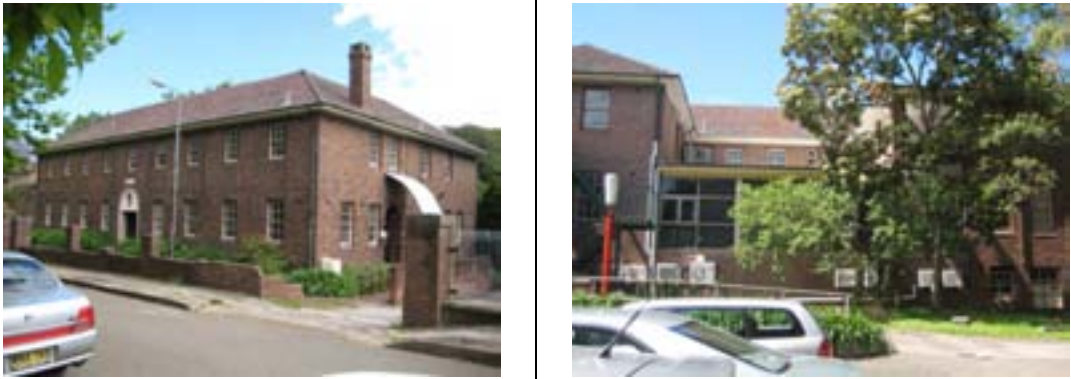
ZONE 7 – BROUGHTON HALL		
<p>ITEM No. B127</p> <p>ORIGINAL NAME: Occupation Therapy Unit & Nurses Quarter (later Health Surveyors), Building 8 Library and Education Centre</p> <p>CURRENT USE: NSW Ambulance</p>	<p>CONSTRUCTION DATE: 1932-33</p> <p>ARCHITECT / BUILDER: Unknown but probably NSW Government Architect's Office under Edwin Smith.</p>	<p>HERITAGE LISTINGS:</p> <p><input type="checkbox"/> National Estate</p> <p><input checked="" type="checkbox"/> S170 List</p> <p><input type="checkbox"/> National Trust</p> <p><input type="checkbox"/> Leichhardt LEP</p> <p><input type="checkbox"/> State Heritage Register</p>
<p>BUILDING:</p>	B127	
<p>LOCATION:</p>	GRID: C-D9 ZONE: 7	
<p>DESCRIPTION:</p> <p>Two storey brick building with hipped terracotta tiled roof and enclosed verandah on garden frontage. Cement rendered arch containing decorative cartouche to main entry off Church Street.</p>

<p>CONDITION:</p>	<p>Good, intact (minor alterations). Intrusive canopy on eastern side.</p> <p>Note some bricks and stone cappings have been removed from the surrounding wall in addition to all iron panels between piers.</p>

<p>HISTORY:</p>	Built 1932-3	
<p>REFERENCES:</p>	Leong (73), MH1/16, JTCW	
<p>SIGNIFICANCE:</p>	Moderate. Part of Broughton Hall Group. With other buildings forms "wall" enclosing gardens. Part of group with consistent design scale and materials. Well built and designed, symmetrically composed.	
<p>GUIDELINES:</p>	<p>Retain and conserve according to Burra Charter principles. Remove intrusive accretions such as the awning on the eastern side and verandah enclosures. Initiate a regular maintenance program. Remove plant growing in chimney. Relocate air conditioning equipment to a less intrusive location.</p> <p>Reconstruct missing elements of the enclosing boundary wall along Church Street.</p>

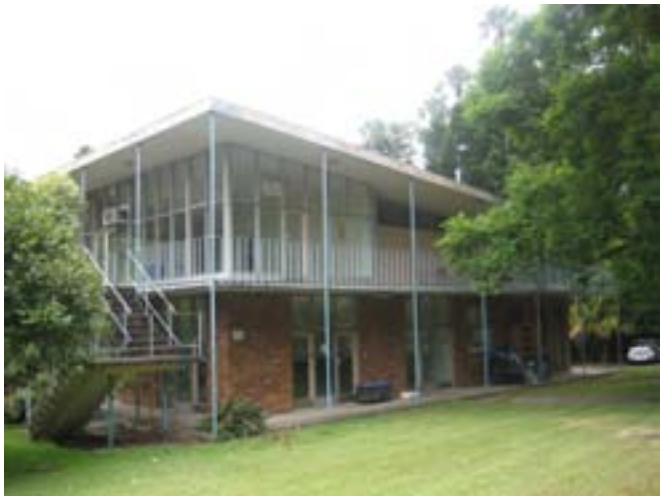
ZONE 7 – BROUGHTON HALL		
<p>ITEM No. B129</p> <p>ORIGINAL NAME: Canteen, Building 16 Daintree House, Jacaranda Lodge, and staff amenities</p> <p>CURRENT USE:</p>	<p>CONSTRUCTION DATE: c. 1960</p> <p>ARCHITECT / BUILDER: Unknown</p>	<p>HERITAGE LISTINGS:</p> <p><input type="checkbox"/> National Estate</p> <p><input type="checkbox"/> S170 List</p> <p><input type="checkbox"/> National Trust</p> <p><input type="checkbox"/> Leichhardt LEP</p> <p><input type="checkbox"/> State Heritage Register</p>
<p>BUILDING:</p> <p>LOCATION:</p>	<p>B129 DAINTREE LODGE</p> <p>GRID: D8-9 ZONE: 7</p>	
<p>DESCRIPTION:</p> <p>Two storey brick building with extensive areas of glazing and low pitched “butterfly” profile roof. Siting disregards garden design and building inconsistent with group.</p>

<p>CONDITION:</p>	<p>Good</p>	
<p>HISTORY:</p>	<p>Built c. 1960</p>	
<p>REFERENCES:</p>	<p>Leong (75), MH1/62-63, JTCW</p>

<p>SIGNIFICANCE:</p>	<p>Low - characteristic post-World War II building showing Modernist architectural influence. Intrusive on original garden setting.</p>	
<p>GUIDELINES:</p>	<p>Retain, recycle or remove. If retained, conserve according to Burra Charter principles. If removed, return site to garden and record prior to removal.</p>

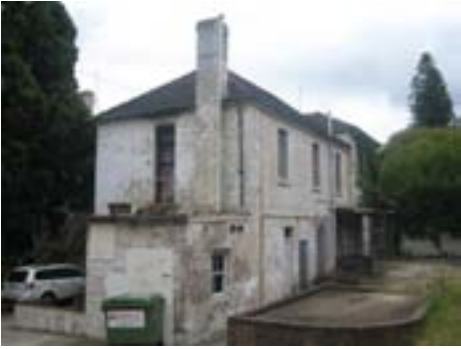
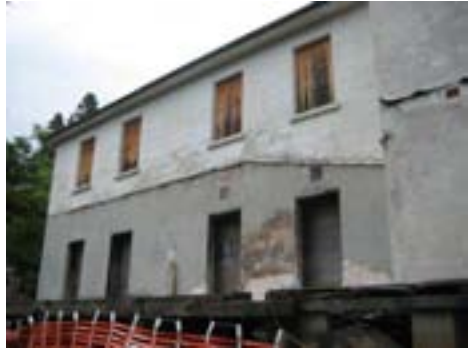
ZONE 7 – BROUGHTON HALL		
<p>ITEM No. B130</p> <p>ORIGINAL NAME: Broughton House (original homestead) later Rivendell, Building 6</p> <p>CURRENT USE: Vacant</p>	<p>CONSTRUCTION DATE: c. 1841-2</p> <p>ARCHITECT / BUILDER: Built by John Ryan Brenan</p>	<p>HERITAGE LISTINGS:</p> <p><input type="checkbox"/> National Estate</p> <p><input checked="" type="checkbox"/> S170 List</p> <p><input type="checkbox"/> National Trust</p> <p><input type="checkbox"/> Leichhardt LEP</p> <p><input checked="" type="checkbox"/> State Heritage Register</p>
<p>BUILDING:</p> <p>LOCATION:</p>	<p>B130 BROUGHTON HOUSE (RIVENDELL)</p> <p>GRID: D9 ZONE: 7</p>	
<p>DESCRIPTION:</p> <p>Two storey painted rendered brick building, stone foundations, hipped roof now clad in concrete tiles (formerly slate), timber windows (boarded up) and may have retained fine internal joinery. Extensive alterations and additions (see Leong).</p>

</div>		
<p>CONDITION:</p>	<p>Very poor – extensively damaged by fire, many additions and alterations. Note some bricks and stone cappings have been removed from the surrounding wall in addition to all iron panels between piers.</p>	
<p>HISTORY:</p>	<p>Built by John Ryan Brenan c. 1841-2 as investment and sold soon after. Owned by Keep family 1864-1912 who added to, altered and developed the renowned gardens.</p>	
<p>REFERENCES:</p>	<p>Leong (77), PWD MH1/3, RGD DP 50893, SMH 31 December 1842, p4/c.</p>	
<p>SIGNIFICANCE:</p>	<p>High. Original building on the site which gave its name to the Psychiatric Clinic. Grand Victorian house with classical Georgian details historically linked to Garry Owen. Severe lack of integrity reduces significance. Part of Broughton Hall Group.</p>	
<p>GUIDELINES:</p>	<p>Retain and conserve the building according to the principles of the Burra Charter. A conservation management plan is required for the building. Urgent action includes the following:</p> <ul style="list-style-type: none"> • ensure waterproofing and soundness of roof; • ensure discharging of stormwater away from foundations and repair of gutters, downpipes and stormwater drains, • vermin proofing and treatment of active termites by baiting. <p>This should be done while decisions are being made about the building's future and use. NB: See Leong for detailed description and assessment.</p> <p>Reconstruct missing elements of the boundary wall along Church Street.</p>

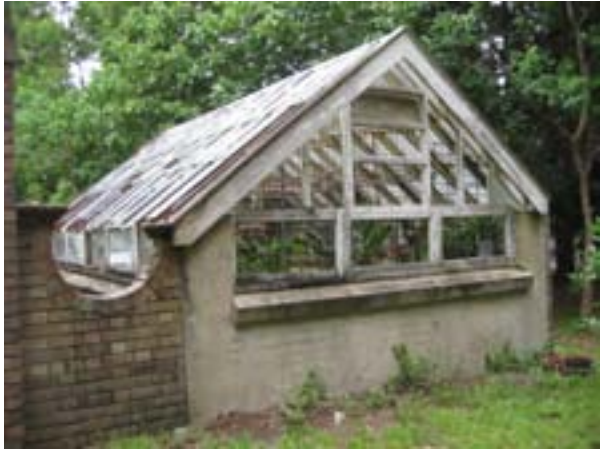
ZONE 7 – BROUGHTON HALL		
ITEM No. B134 ORIGINAL NAME: Glasshouse CURRENT USE: Glasshouse	CONSTRUCTION DATE: After early 1930s ARCHITECT / BUILDER:	HERITAGE LISTINGS: <input type="checkbox"/> National Estate <input type="checkbox"/> S170 List <input type="checkbox"/> National Trust <input type="checkbox"/> Leichhardt LEP <input type="checkbox"/> State Heritage Register
BUILDING: LOCATION:	B134 GLASSHOUSE GRID: D8 ZONE: 7	
DESCRIPTION: Rectilinear building with rendered brick base, timber framed windows and gabled glass roof. Roof glazing is supported by steel sections.

CONDITION:	Poor. Roof glazing has been broken in places and some glass is insecure.	
HISTORY:	Constructed after the formal pond attributed to Evan Jones, which was probably constructed during the 1930s.	
REFERENCES:		
SIGNIFICANCE:	Low.	
GUIDELINES:	Retain, recycle or remove. If removed, record prior to demolition.

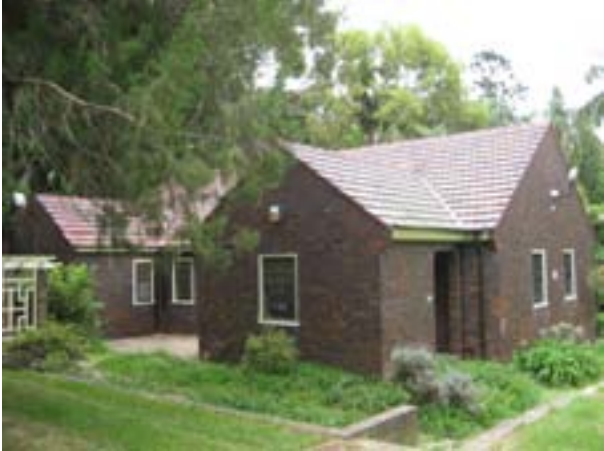
ZONE 7 – BROUGHTON HALL		
<p>ITEM No. B135</p> <p>ORIGINAL NAME: Medical Superintendent's Residence, Building R2</p> <p>CURRENT USE: Offices</p>	<p>CONSTRUCTION DATE: c.1933-35</p> <p>ARCHITECT / BUILDER: NSW Government Architect's Office under Edwin Smith</p>	<p>HERITAGE LISTINGS:</p> <p><input type="checkbox"/> National Estate</p> <p><input type="checkbox"/> S170 List</p> <p><input type="checkbox"/> National Trust</p> <p><input type="checkbox"/> Leichhardt LEP</p> <p><input type="checkbox"/> State Heritage Register</p>
<p>BUILDING:</p> <p>LOCATION:</p>	<p>B135 THE ARBOUR</p> <p>GRID: D8 ZONE: 7</p>	
<p>DESCRIPTION:</p> <p>Single storey dwelling in dark brick with pitched tiled roof. Verandah on north façade has been partially and unsympathetically infilled. Fine brick detailing to gable ends (corbels) and window heads.</p>

<p>CONDITION:</p>	<p>Average to good. Joinery needs repairs, arch bars rusting.</p>

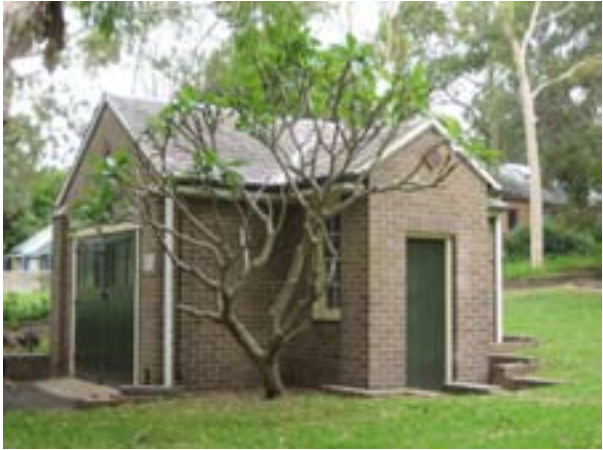
ZONE 7 – BROUGHTON HALL		
<p>ITEM No. B136</p> <p>ORIGINAL NAME: Garage, Building R2A</p> <p>CURRENT USE: Unused</p>	<p>CONSTRUCTION DATE: c. 1930s</p> <p>ARCHITECT / BUILDER: Unknown</p>	<p>HERITAGE LISTINGS:</p> <p><input type="checkbox"/> National Estate</p> <p><input type="checkbox"/> S170 List</p> <p><input type="checkbox"/> National Trust</p> <p><input type="checkbox"/> Leichhardt LEP</p> <p><input type="checkbox"/> State Heritage Register</p>
<p>BUILDING:</p> <p>LOCATION:</p>	<p>B136 GARAGE</p> <p>GRID: D8 ZONE: 7</p>	
<p>DESCRIPTION:</p> <p>Well detailed single storey brick building of domestic character, with slate roof and timber windows. Building has gabled ends on the north and south facades, and a small central wing on the west façade also with slate roof and gabled end. Recently refurbished.</p>

<p>CONDITION:</p>	<p>Good</p>	
<p>HISTORY:</p>	<p>Unknown.</p>	
<p>REFERENCES:</p>	<p>Site inspection</p>

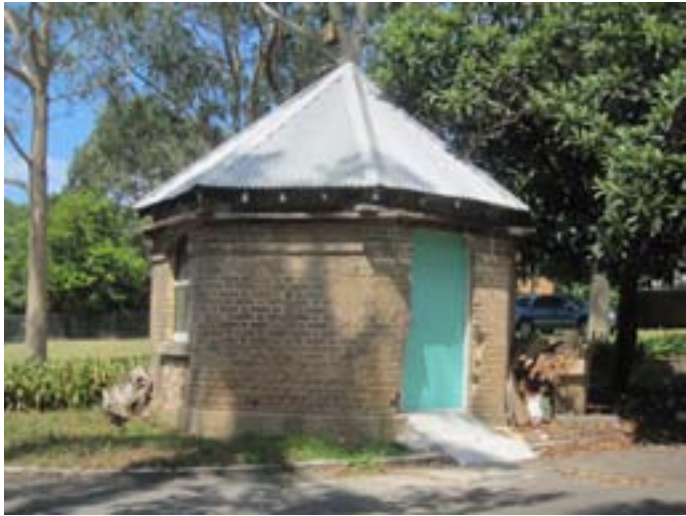
ZONE 7 – BROUGHTON HALL		
<p>ITEM No. B137</p> <p>ORIGINAL NAME: Summer House</p> <p>CURRENT USE: WC.</p>	<p>CONSTRUCTION DATE: circa 1880s</p> <p>ARCHITECT / BUILDER: Unknown</p>	<p>HERITAGE LISTINGS:</p> <p><input type="checkbox"/> National Estate</p> <p><input checked="" type="checkbox"/> S170 List</p> <p><input type="checkbox"/> National Trust</p> <p><input type="checkbox"/> Leichhardt LEP</p> <p><input type="checkbox"/> State Heritage Register</p>
<p>BUILDING:</p> <p>LOCATION:</p>	<p>B137 SUMMER HOUSE</p> <p>GRID: D8 ZONE: 7</p>	
<p>DESCRIPTION:</p> <p>Octagonal summer house of finely detailed brick construction with corrugated iron roof - formerly slate or shingled (from spacing of battens). Single doorway opposite niche (false window). Two window openings on opposite sides. Boarded ceiling. Construction consistent with nineteenth century date.</p>

<p>CONDITION:</p>	<p>Fair.</p>	
<p>HISTORY:</p>	<p>Built as garden pavilion as part of early garden design. Extant before 1890. Inappropriately adapted as w.c. at beginning of 2011.</p>

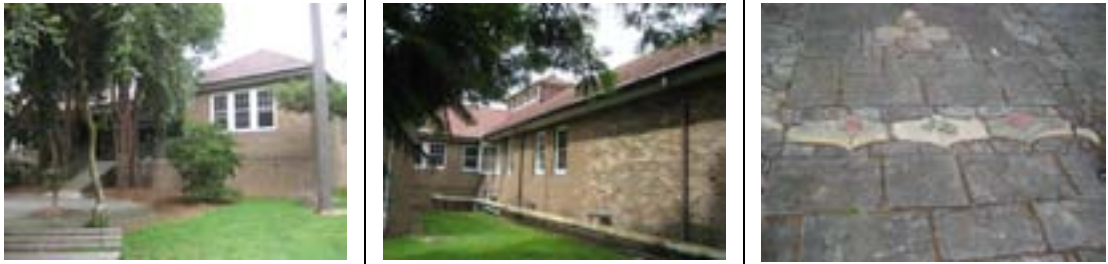
ZONE 7 – BROUGHTON HALL		
<p>ITEM No. B192</p> <p>ORIGINAL NAME: Kitchen Block, Building 17 Western Suburb & Marrickville Hospital Medical Records / Old Medical Records</p> <p>CURRENT USE: WHOS - Cafeteria</p>	<p>CONSTRUCTION DATE: c. 1932</p> <p>ARCHITECT / BUILDER: Unknown</p>	<p>HERITAGE LISTINGS:</p> <p><input type="checkbox"/> National Estate</p> <p><input checked="" type="checkbox"/> S170 List</p> <p><input type="checkbox"/> National Trust</p> <p><input type="checkbox"/> Leichhardt LEP</p> <p><input type="checkbox"/> State Heritage Register</p>
<p>BUILDING:</p> <p>LOCATION:</p>	<p>B192 COMMUNITY CAFE</p> <p>GRID: C8 ZONE: 7</p>	
<p>DESCRIPTION:</p> <p>Single storey brick building with terracotta tiled roof and cast iron columns similar to those in Kirkbride Block to covered way along the western facade. Symmetrical eastern façade with wide recessed verandah (left image). Clerestory window above western section with hipped tiled roof (central image). In commanding central position but not of individual architectural value. Paving in forecourt on east side has decorative elements and was probably laid by patients (right image).</p>

<p>CONDITION:</p>	<p>Good</p>	
<p>HISTORY:</p>	<p>Built c. 1932</p>	
<p>REFERENCES:</p>	<p>Leong (66), MH1/1&6, JTCW Aerial 1931</p>	
<p>SIGNIFICANCE:</p>	<p>Moderate significance. Part of Broughton Hall Group, enclosing garden and consistent in design, scale and materials including symmetrical composition. Building itself not of particular aesthetic value. Paving on east side is evidence of former patient activity.</p>	
<p>GUIDELINES:</p>	<p>Retain and conserve according to Burra Charter principles, including paving on eastern side.</p>

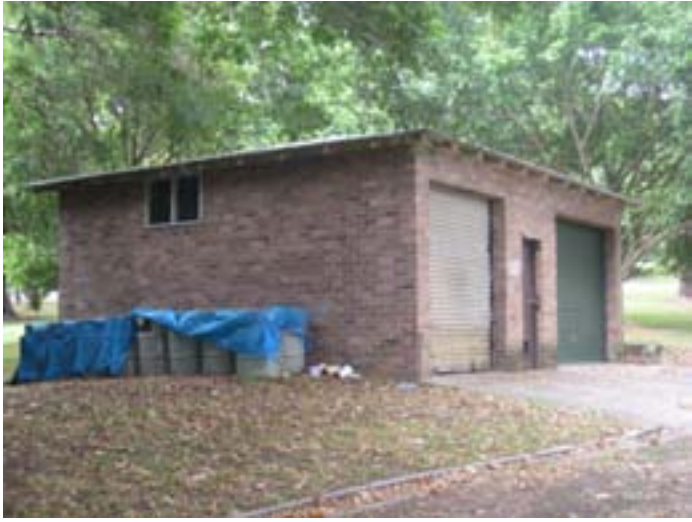
ZONE 7 – BROUGHTON HALL		
<p>ITEM No. B196</p> <p>ORIGINAL NAME: Storage, Building 21A</p> <p>CURRENT USE: Storage</p>	<p>CONSTRUCTION DATE: c. 1931</p> <p>ARCHITECT / BUILDER: Unknown</p>	<p>HERITAGE LISTINGS:</p> <p><input type="checkbox"/> National Estate</p> <p><input type="checkbox"/> S170 List</p> <p><input type="checkbox"/> National Trust</p> <p><input type="checkbox"/> Leichhardt LEP</p> <p><input type="checkbox"/> State Heritage Register</p>
<p>BUILDING:</p> <p>LOCATION:</p>	<p>B196 GARAGE, STORAGE</p> <p>GRID: D7 ZONE: 7</p>	
<p>DESCRIPTION:</p> <p>Small brick shed with corrugated steel roof and two steel roller doors on the north elevation in Broughton Hall gardens. Exposed rafter ends.</p>

<p>CONDITION:</p>	<p>Poor</p>	
<p>HISTORY:</p>	<p>Unknown; c. 1931</p>	
<p>REFERENCES:</p>	<p>Inspection JTCW</p>	
<p>SIGNIFICANCE:</p>	<p>Intrusive in landscaped setting.</p>	
<p>GUIDELINES:</p>	<p>The building should be removed and the Broughton Hall garden restored. Record prior to removal.</p>

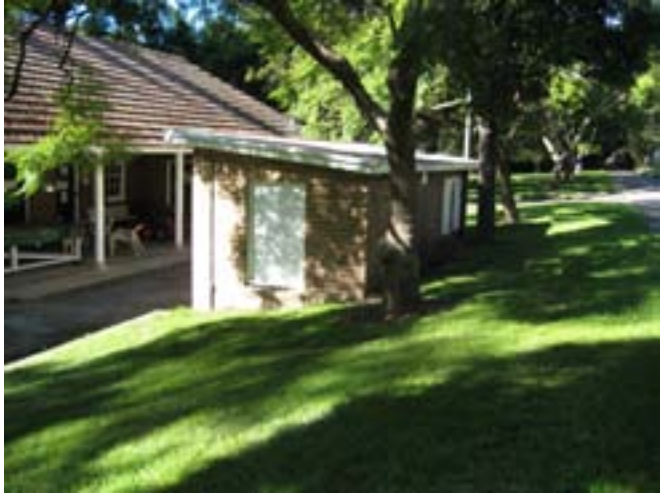
ZONE 7 – BROUGHTON HALL	
<p>ITEM No. B197</p> <p>ORIGINAL NAME: Storage</p> <p>CURRENT USE: Gardener's Store and WC.</p>	<p>CONSTRUCTION DATE: c. 1960</p> <p>ARCHITECT / BUILDER: Unknown</p> <p>HERITAGE LISTINGS:</p> <ul style="list-style-type: none"> <input type="checkbox"/> National Estate <input type="checkbox"/> S170 List <input type="checkbox"/> National Trust <input type="checkbox"/> Leichhardt LEP <input type="checkbox"/> State Heritage Register
<p>BUILDING:</p> <p>LOCATION:</p>	<p>B197 GARDENER'S STORE AND WC.</p> <p>GRID: D7 ZONE: 7</p>
<p>DESCRIPTION:</p> <p>Small brick structure with mono-pitch roof covered by corrugated steel. Relatively large window openings have been boarded over.</p>

<p>CONDITION:</p>	<p>Good.</p>
<p>HISTORY:</p>	<p>Unknown, circa 1960.</p>
<p>REFERENCES:</p>	<p>Inspection JTCW</p>
<p>SIGNIFICANCE:</p>	<p>Intrusive in landscaped setting.</p>
<p>GUIDELINES:</p>	<p>Retain or remove. Record prior to removal.</p>

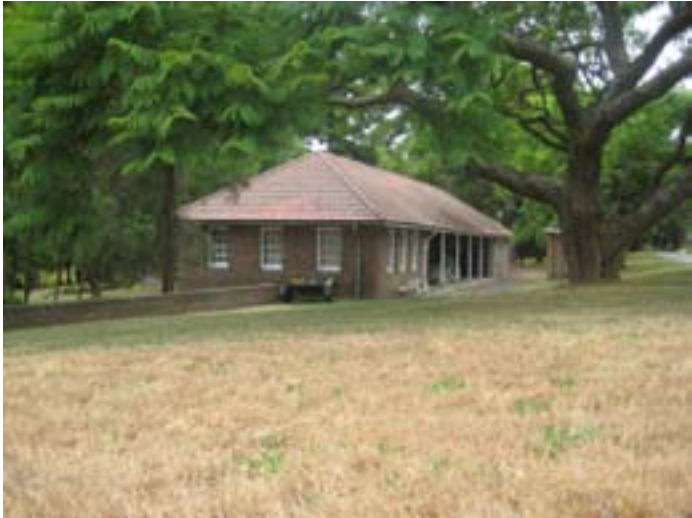
ZONE 7 – BROUGHTON HALL		
ITEM No. B198 ORIGINAL NAME: Workshop/Store, Building 21 CURRENT USE: Workshop	CONSTRUCTION DATE: c. 1937 ARCHITECT / BUILDER: Unknown	HERITAGE LISTINGS: <input type="checkbox"/> National Estate <input checked="" type="checkbox"/> S170 List <input type="checkbox"/> National Trust <input type="checkbox"/> Leichhardt LEP <input type="checkbox"/> State Heritage Register
BUILDING: LOCATION:	B198 WORKSHOP GRID: D7 ZONE: 7	
DESCRIPTION: Small single storey brick building in Broughton Hall Gardens. Terracotta tiled hipped roof and recessed verandah on west façade. Isolated from other buildings.

CONDITION:	Average. Roof and windows in need of maintenance.	
HISTORY:	c. 1937	
REFERENCES:	Leong (60) JTCW	
SIGNIFICANCE:	Low. Minimal heritage significance.	
GUIDELINES:	Retain, recycle, or remove as practicable. If replaced have regard to setting in Broughton Hall Gardens. General maintenance required if retained. If removed record prior to demolition.

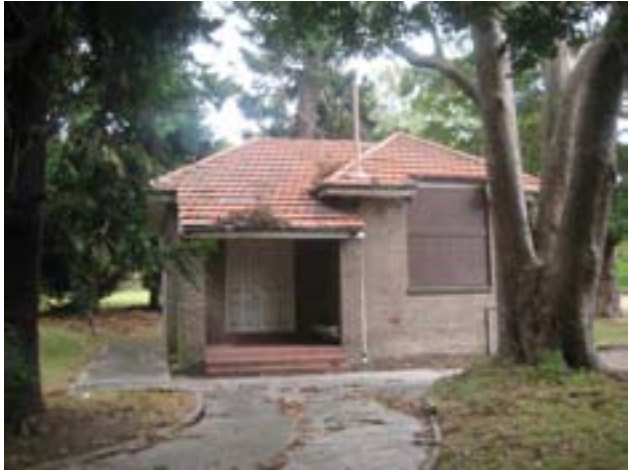
ZONE 7 – BROUGHTON HALL		
<p>ITEM No. B199</p> <p>ORIGINAL NAME: Mortuary, Chapel, Building 22</p> <p>CURRENT USE: Disused</p>	<p>CONSTRUCTION DATE: c. 1927</p> <p>ARCHITECT / BUILDER: Unknown</p>	<p>HERITAGE LISTINGS:</p> <p><input type="checkbox"/> National Estate</p> <p><input checked="" type="checkbox"/> S170 List</p> <p><input type="checkbox"/> National Trust</p> <p><input type="checkbox"/> Leichhardt LEP</p> <p><input type="checkbox"/> State Heritage Register</p>
<p>BUILDING:</p> <p>LOCATION:</p>	<p>B199 BROUGHTON HALL CHAPEL</p> <p>GRID: D7 ZONE: 7</p>	
<p>DESCRIPTION:</p> <p>Small brick and tile building with windows boarded up on the east façade and bricked in on the north façade (also door). Verandah on east side.</p>

<p>CONDITION:</p>	<p>Poor. Roof is deteriorating.</p>	
<p>HISTORY:</p>	<p>Built c. 1927, altered 1960.</p>	
<p>REFERENCES:</p>	<p>Leong (57), MH1/159</p>	
<p>SIGNIFICANCE:</p>	<p>Low. Minimal heritage significance.</p>

<p>GUIDELINES:</p>	<p>Retain, recycle or remove as practicable. If replaced have regard to garden setting and record prior to demolition. Normal maintenance required.</p>

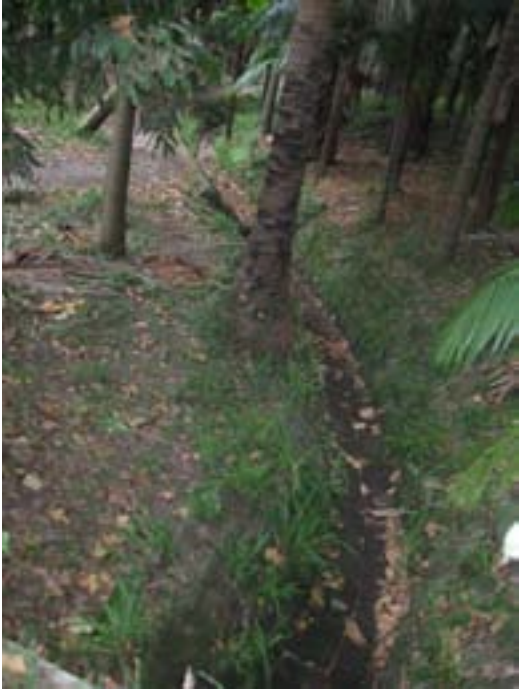
ZONE 7 – BROUGHTON HALL		
ITEM No. 11C ORIGINAL NAME: CURRENT USE:	CONSTRUCTION DATE: ARCHITECT / BUILDER:	HERITAGE LISTINGS: <input type="checkbox"/> National Estate <input checked="" type="checkbox"/> S170 List <input type="checkbox"/> National Trust <input type="checkbox"/> Leichhardt LEP <input type="checkbox"/> State Heritage Register
ITEM: LOCATION:	11C STONE LINED CREEK GRID: D7-8 ZONE: 7	
DESCRIPTION: Creek lined with battered sandstone block walls.

CONDITION:	Intact.	
HISTORY:	Believed formed in mid to late 1800s.	
REFERENCES:	1991 DPWS Heritage Study.	
SIGNIFICANCE:	Significant as represents natural spring fed watercourse and as an element of early garden design.	
GUIDELINES:	Preserve. Conserve according to Burra Charter principles.

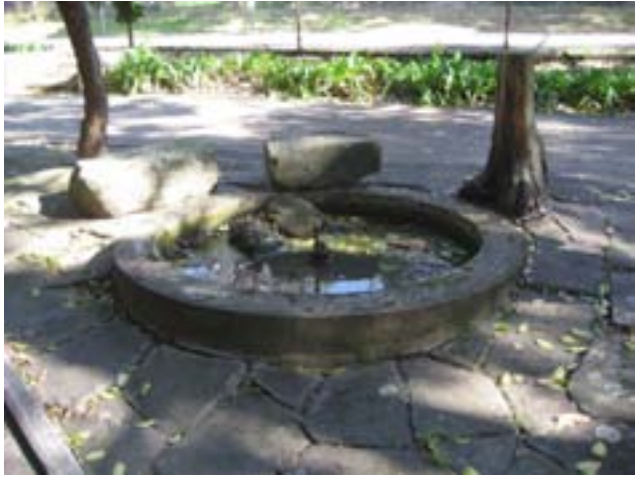
ZONE 7 – BROUGHTON HALL		
<p>ITEM No. 11E ORIGINAL NAME: Circular Stone Pond CURRENT USE: Disused</p>	<p>CONSTRUCTION DATE: Late nineteenth century ARCHITECT / BUILDER: Unknown</p>	<p>HERITAGE LISTINGS: <input type="checkbox"/> National Estate <input checked="" type="checkbox"/> S170 List <input type="checkbox"/> National Trust <input type="checkbox"/> Leichhardt LEP <input type="checkbox"/> State Heritage Register</p>
<p>ITEM: LOCATION:</p>	<p>11E CIRCULAR STONE POND GRID: D8 ZONE: 7</p>	
<p>DESCRIPTION: Small circular pond built of individually shaped stone blocks. Formerly about two courses high, now one course high above pavement level. Single central water spout.</p>

<p>CONDITION:</p>	<p>Fair only. Appears to have had top course of stone removed.</p>	
<p>HISTORY:</p>	<p>Believed to have been constructed in mid to late nineteenth century as part of the original Estate garden.</p>	
<p>REFERENCES:</p>	<p>1991 DPWS Heritage Study; Powell.</p>

<p>SIGNIFICANCE:</p>	<p>Significant as a garden element from the early estate garden. Has the potential to be a fine example of its kind.</p>	
<p>GUIDELINES:</p>	<p>Preserve. Restore missing stone. Where practicable upgrade existing surrounds to form a sympathetic context for the original character of the pond.</p>

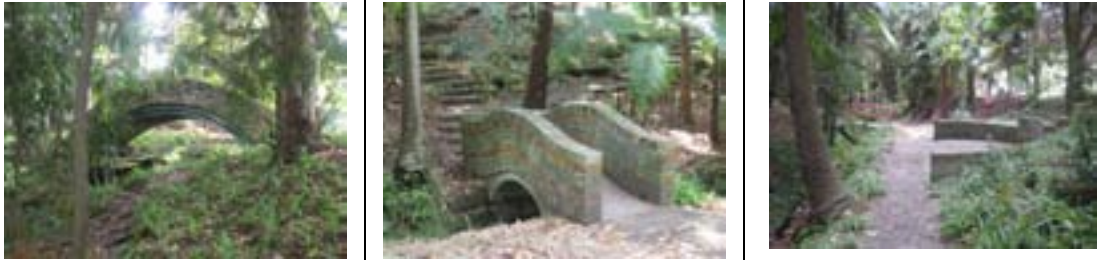
ITEM:	11F BRIDGES, PATHS AND PAVED AREAS IN GULLY	
LOCATION:	GRID: D7-8 ZONE: 7	
DESCRIPTION:		
<p>One large semicircular arch of brick and concrete over a side stream and one small decoratively shaped and patterned brick bridge, gently curved both over the main channel. Paths of compacted earth with series of winding narrow brick paths all informally laid out. (Bricks may be from demolition of Kalouan 1932). Several paved seating and viewing areas in brick and stone overlook the creek.</p>

CONDITION:	Intact.	
HISTORY:	Bridges, paths and seating bays probably added in 1920s and 1930s by Dr. Evan Jones as therapeutic walks.	
REFERENCES:	Powell. 1991 DPWS Heritage Study.	
SIGNIFICANCE:	Significant as a layout overlaid on earlier domestic gardens representing the change to institutional use and reflecting the 1920s interpretation of the principle that quiet gardens and walks were an aid in mental care.

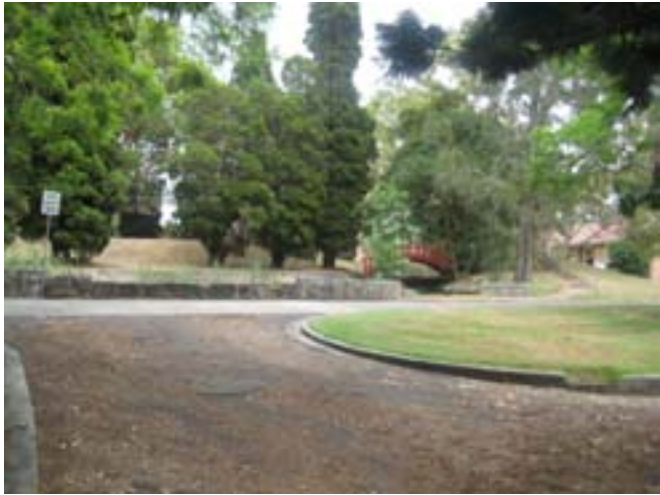
ZONE 7 – BROUGHTON HALL		
ITEM No. 11G ORIGINAL NAME: CURRENT USE:	CONSTRUCTION DATE: ARCHITECT / BUILDER:	HERITAGE LISTINGS: <input type="checkbox"/> National Estate <input checked="" type="checkbox"/> S170 List <input type="checkbox"/> National Trust <input type="checkbox"/> Leichhardt LEP <input type="checkbox"/> State Heritage Register
ITEM: LOCATION:	11G ROAD NETWORK GRID: D7-9 ZONE: 7	
DESCRIPTION: Kerbed and guttered bitumen access roads.

CONDITION:	Good to fair.	
HISTORY:	Formed roads overlay what appear to be pathways in 1930 aerial photo.	
REFERENCES:	1991 DPWS Heritage Study; Aerial photo.	
SIGNIFICANCE:	Significant as an adaptation of earlier path network however the introduction of vehicles is intrusive on the significance of the gardens.	
GUIDELINES:	Return to pedestrian use and resurface with suitable material, such as gravel.

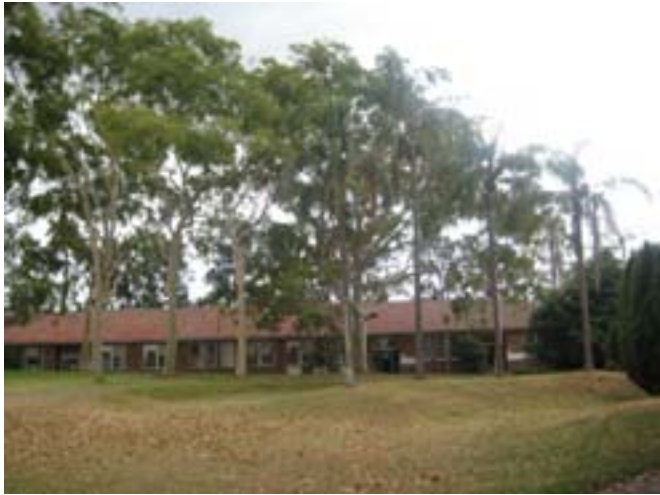
ZONE 7 – BROUGHTON HALL		
ITEM No. 11H ORIGINAL NAME: CURRENT USE:	CONSTRUCTION DATE: Planted 1980s ARCHITECT / BUILDER:	HERITAGE LISTINGS: <input type="checkbox"/> National Estate <input checked="" type="checkbox"/> S170 List <input type="checkbox"/> National Trust <input type="checkbox"/> Leichhardt LEP <input type="checkbox"/> State Heritage Register
BUILDING: LOCATION:	11H RECENT PLANTINGS GRID: D-E, 6-7 ZONE: 7	
DESCRIPTION: Individuals and rows of a variety of Eucalypts and Melaleucas. The planting layout and species selection do not relate to earlier plantings.

CONDITION:	Good	
HISTORY:	1980s plantings.	
REFERENCES:	1991 DPWS Heritage Study.	
SIGNIFICANCE:	Intrudes on significant character of Estate and clinic gardens.	
GUIDELINES:	Preferably remove. Future planting or development should reinforce significant character and fabric.

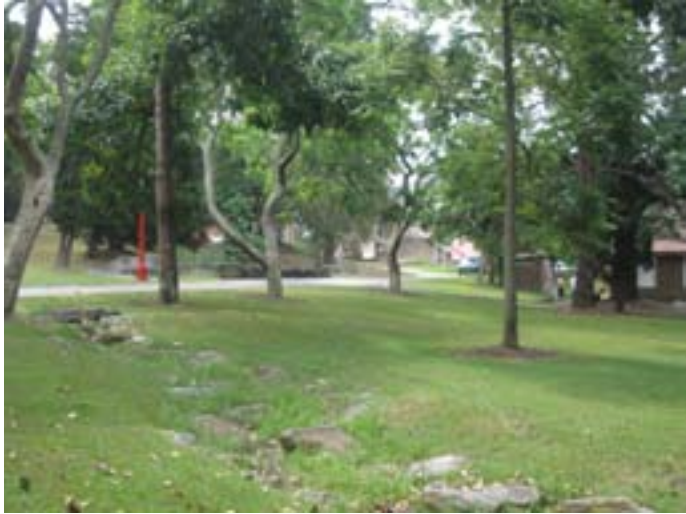
ITEM: LOCATION:	11J TREE GROUPS AND ROWS – 1930s GRID: D7 ZONE: 7	
DESCRIPTION: Row of Raphis Palms, Jacarandas, Illawarra Flame and Hoop Pine around a lawn area and a small rock edged stream.

CONDITION:	Good	
HISTORY:	Tree rows installed in 1930s overlaying original garden. Rainforest tree groups, some likely to be Estate plantings and others added in early Clinic years with additional rainforest species added in 1980s.	
REFERENCES:	1991 DPWS Heritage Study; Aerial photo 1930	
SIGNIFICANCE:	Significant as planting of early days of the clinic demonstrating early 1900s planting design – particularly the use of trees with bright flowers and the adaptation of older gardens to institutional use and concept of gardens are therapy. The stream is significant as a reflection of original water course and as a water theme used throughout the therapeutic gardens.	
GUIDELINES:	Maintain. Any future plantings should reflect significant character and fabric of layers of early Estate and Clinic gardens as separate layers of planting design.

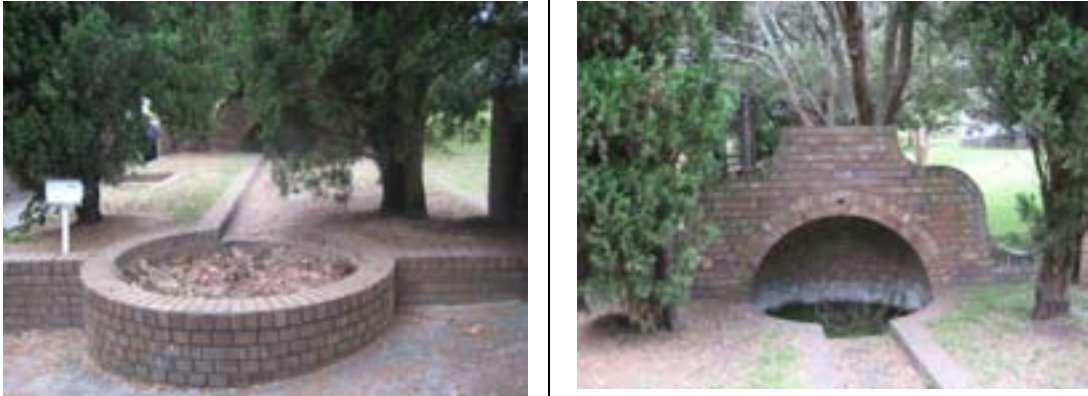
ITEM: LOCATION:	110 FORMAL POND GRID: D8 ZONE: 7	
DESCRIPTION: Symmetrical geometric pond and garden with end wall forming vault over circular pond with single spout – all in brick. End wall extends to form brick arch to residential garden.

CONDITION:	Intact	
HISTORY:	Probably built in 1930s. Pond design reflects the influence of Edna Walling's formal pond designed by Evan Jones – Clinic superintendent. Planting of Jacaranda and Illawarra Flame trees reflects fashion to introduce bold colour and feature trees.	
REFERENCES:	1991 DPWS Heritage Study; Aerial photo 1930.	
SIGNIFICANCE:	Significant as representative example of 1930s garden design and as the use of gardens and particularly water features as a therapeutic device. Intruded upon by Building B129.	
GUIDELINES:	Preserve and maintain planting. Future planting should reflect original design concept. Incorporate into future developments. Future development should maintain the integrity of the original 1930s design and its contextual relationship to the Lily-pilly row and formal walk.

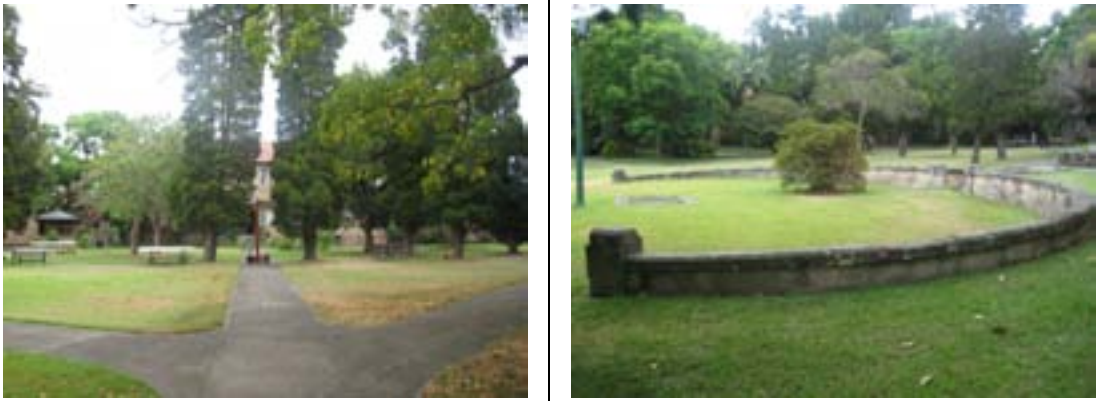
ITEM: LOCATION:	11P FORMAL GEOMETRIC GARDENS GRID: C8-9 ZONE: 7	
DESCRIPTION: <p>Geometric symmetrical path network set in lawn pivoted about a central section that formerly contained a circular pond (since removed) with formal central axis path studded with red painted light posts and cypress avenue. Stair and ½ elliptical low wall in lawn.</p>

CONDITION:	Intact	
HISTORY:	Diagonal paths established first in the 1920s linking Buildings B127, B121 and B193 to Broughton Hall. Formal axis and avenue trees and central pond and low wall and steps probably added in late 1930s when the naturalistic garden was built (1938). The path layout is a reflection of the building layout.	
REFERENCES:	1991 DPWS Heritage Study; Aerial photo 1930.	
SIGNIFICANCE:	Significant as representative example of 1920s / 1930s formal institutional garden and as one of 3 theme gardens designed by Evan Jones – Clinic Superintendent of therapeutic gardens.

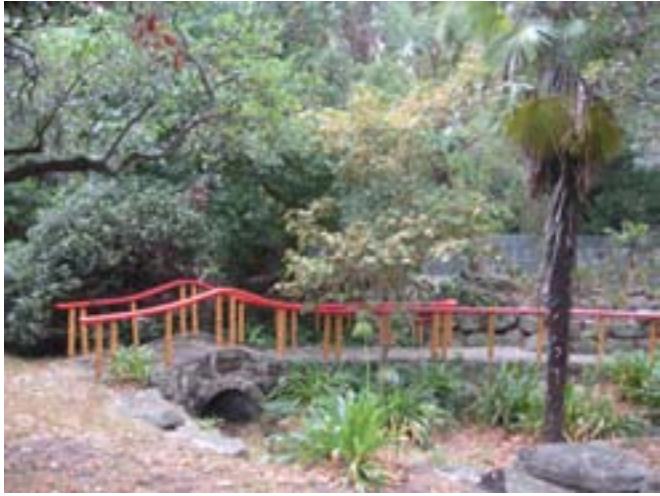
ITEM: LOCATION:	11Q NATURALISTIC GARDEN GRID: C-D 7-8 ZONE: 7	
DESCRIPTION: Naturalistic, gardens built as a series of bridges, pathways, gardens and secluded lawns edged in bush rock all focused on a small stream flowing over bedrock and designed around several Hoop Pines from the original Kalouan estate garden. The main bridge is a concrete construction formed and painted to resemble an oriental bamboo bridge. Planting includes both nature and exotic plants.

CONDITION:	Substantially intact – much of the stonework and bridges in need of maintenance.	
HISTORY:	Laid out in the late 1930s.	
REFERENCES:	1991 DPWS Heritage Study; Site investigations (path dated 1938)	
SIGNIFICANCE:	Significant as representative example of 1930s institutional theme garden and as one of 3 theme gardens designed by Evan Jones – Clinic superintendent of therapeutic gardens. Intruded upon by Building B129.	
GUIDELINES:	Maintain and preserve. Conserve 'bamboo' bridge. Maintain significant character of garden in any future development.

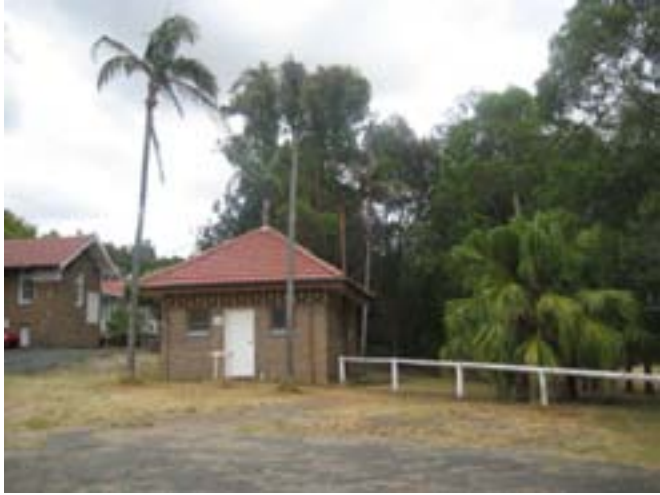
ITEM: LOCATION:	71 PALM GROUP GRID: ZONE: 7
DESCRIPTION: Group of Bangalow palms located around amenities block.

CONDITION:	Fair to poor. One tree has apparently died.
HISTORY:	Planted between 1918 and 1930s as part of extensive formal gardens to Building B502.
REFERENCES:	1991 DPWS Heritage Study; Aerial photos 1930 and 1952. Powell.
SIGNIFICANCE:	No evidence of heritage significance as integrity of original design has been lost. However the palms are sympathetic with significant fabric in adjoining Broughton Hall gardens.
GUIDELINES:	Replace dead tree. Incorporate into new development or transplant into Broughton Hall gardens or area of similar significance.
