## **ZONE 2 MANNING STREET PRECINCT**

**INVENTORY OF INDIVIDUAL ITEMS**

CALLAN PARK  
CONSERVATION MANAGEMENT PLAN

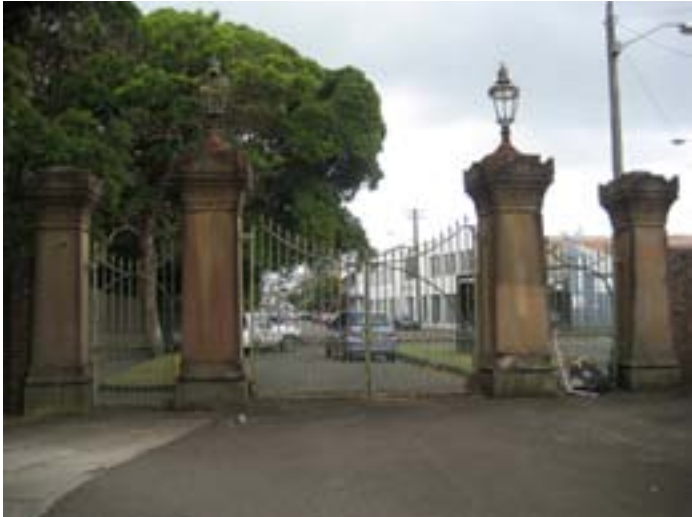
<b>ZONE 2 – MANNING STREET PRECINCT</b>	
<p><b>ITEM No.</b></p> <p><b>ORIGINAL NAME:</b> Item 99, Main Entrance Gates</p> <p><b>CURRENT USE:</b> -</p>	<p><b>CONSTRUCTION DATE:</b> 1878 / 1879?</p> <p><b>ARCHITECT / BUILDER:</b> Architect, James Barnet Builder, Frederick Lemm</p> <p><b>HERITAGE LISTINGS:</b>  <input checked="" type="checkbox"/> National Estate  <input checked="" type="checkbox"/> S170 List  <input checked="" type="checkbox"/> National Trust  <input checked="" type="checkbox"/> Leichhardt LEP  <input type="checkbox"/> State Heritage Inventory</p>
<p><b>BUILDING:</b></p> <p><b>LOCATION:</b></p>	<p><b>MAIN ENTRANCE GATES</b></p> <p>GRID: L8-9 ZONE: 2</p>
<p><b>DESCRIPTION:</b></p> <p>Former main gates now disused. Four carved sandstone posts made from large blocks of stone. Heavy wrought iron gates. Centre posts have fine gas lanterns with decorative metalwork.</p>

<p><b>CONDITION:</b></p>	<p>Poor. Sandstone pillars damaged and weathered. Iron elements require repair, fabric missing. Lanterns in particularly poor condition with former extant curved glass now missing.</p>

<p><b>HISTORY:</b></p>	<p>Built (1879?) 1878 by Frederick Lemm adjoining the Gate Lodge (B394) and relocated to present position following road widening for tram in 1912.</p>
<p><b>REFERENCES:</b></p>	<p>Leong (88)</p>
<p><b>SIGNIFICANCE:</b></p>	<p>Exceptional. Part of original 1880s design though relocated. Demonstrate fine craftsmanship in stone work, ironwork and lanterns.</p>
<p><b>GUIDELINES:</b></p>	<p>Retain and conserve according to Burra Charter principles.</p>

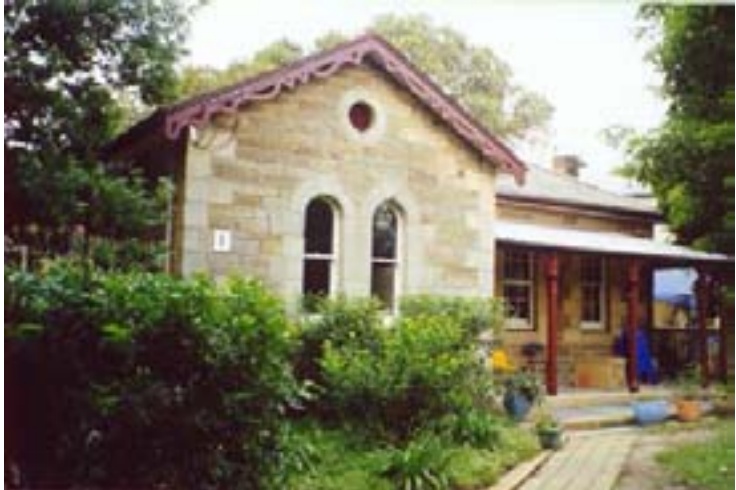
<b>ZONE 2 – MANNING STREET PRECINCT</b>		
<p><b>ITEM No. B302</b></p> <p><b>ORIGINAL NAME:</b> Gate Lodge, Building R1</p> <p><b>CURRENT USE:</b> Child care facilities</p>	<p><b>CONSTRUCTION DATE:</b> 1878, additions 1901 &amp; 1956</p> <p><b>ARCHITECT / BUILDER:</b> James Barnet. Builder, Frederick Lemm.</p>	<p><b>HERITAGE LISTINGS:</b></p> <p><input checked="" type="checkbox"/> National Estate</p> <p><input checked="" type="checkbox"/> S170 List</p> <p><input checked="" type="checkbox"/> National Trust</p> <p><input checked="" type="checkbox"/> Leichhardt LEP</p> <p><input type="checkbox"/> State Heritage Inventory</p>
<p><b>BUILDING:</b></p> <p><b>LOCATION:</b></p>	<p><b>B302 ROZELLE CHILD CARE CENTRE</b></p> <p>GRID: L8 ZONE: 2</p>	
<p><b>DESCRIPTION:</b></p> <p>Single storey stone cottage similar in style and detailing to Kirkbride Block. Traditional house plan. Slate roof with terracotta ridge capping, decorative timber work to barge board and verandah columns and brackets, double hung multi-paned timber windows. Systematically adapted.</p> <p>Single storey blonde brick masonry extension constructed at rear, with vinyl tile roof and aluminium windows, is unsympathetic in size and materials.</p>

<p><b>CONDITION:</b></p>	<p>Fair, largely intact. Evidence of unskilled repairs, including cement re-pointing especially around windows and large addition to rear, detract from original.</p>	
<p><b>HISTORY:</b></p>	<p>Built 1878 (date stone on building) as part of original design for site and preceding the commencement of the main block. Designed as gate lodge and to accommodate 6 patients.</p> <p>Additional bedroom added to Lodge c.1901. Extensions to east 1956.</p>	
<p><b>REFERENCES:</b></p>	<p>Leong (46) MH2/380, JTCW</p>	
<p><b>SIGNIFICANCE:</b></p>	<p>Exceptional. Part of Barnet's original design. Excellent design and workmanship. Indicates former location of gate.</p> <p>Addition is intrusive.</p>	
<p><b>GUIDELINES:</b></p>	<p>Conserve according to the principles of the Burra Charter (including adaptation). Minor repairs to stonework should be undertaken.</p>

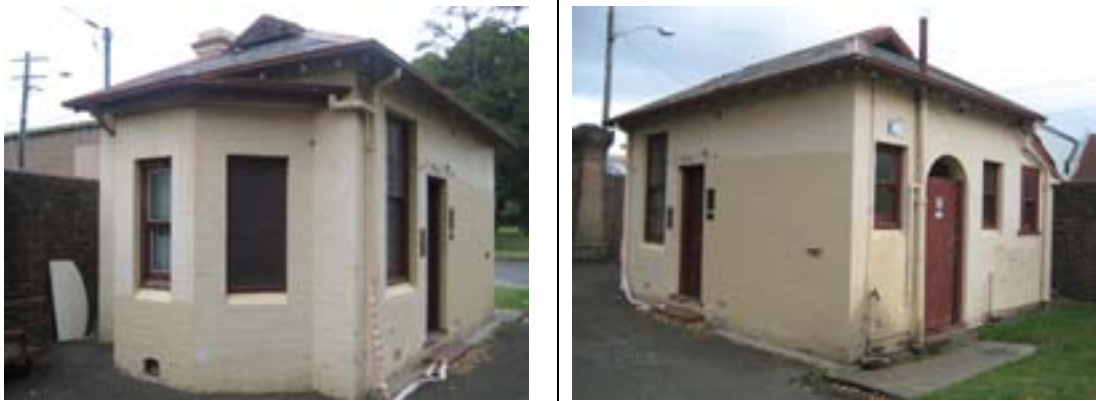
<b>ZONE 2 – MANNING STREET PRECINCT</b>		
<b>ITEM No. B394</b>  <b>ORIGINAL NAME:</b> Gate House (South Lodge), Building 99A  <b>CURRENT USE:</b> Police Box	<b>CONSTRUCTION DATE:</b> 1912  <b>ARCHITECT / BUILDER:</b> Unknown	<b>HERITAGE LISTINGS:</b> <input type="checkbox"/> National Estate <input checked="" type="checkbox"/> S170 List <input type="checkbox"/> National Trust <input type="checkbox"/> Leichhardt LEP <input type="checkbox"/> State Heritage Inventory
<b>BUILDING:</b>	<b>B394 GATE HOUSE</b>	
<b>LOCATION:</b>	GRID: L8 ZONE: 2	
<b>DESCRIPTION:</b> Small painted brick building with hipped slate roof – gablets at ridge ends. Timber framed windows. Exposed rafter ends. Facetted bay on eastern side. Contains a watch room and toilets. Plaques mounted next to door on northern side commemorate the establishment of the Leichhardt Beat Police Rozelle Hospital Gatehouse by Lord Mayor Larry Hand on 29 August 1994.

<b>CONDITION:</b>	Average generally. Poor (roof) – slates are loose and later ridge capping is patchy and intrusive. Some movement evident in brickwork. Damaged threshold.	
<b>HISTORY:</b>	Built 1912 when gate relocated due to widening of Balmain Road.	
<b>REFERENCES:</b>	Leong (87), JTCW	
<b>SIGNIFICANCE:</b>	Moderate. Evidence of relocation of road.	
<b>GUIDELINES:</b>	Retain and conserve according to Burra Charter principles. Undertake maintenance to repair deteriorating fabric.

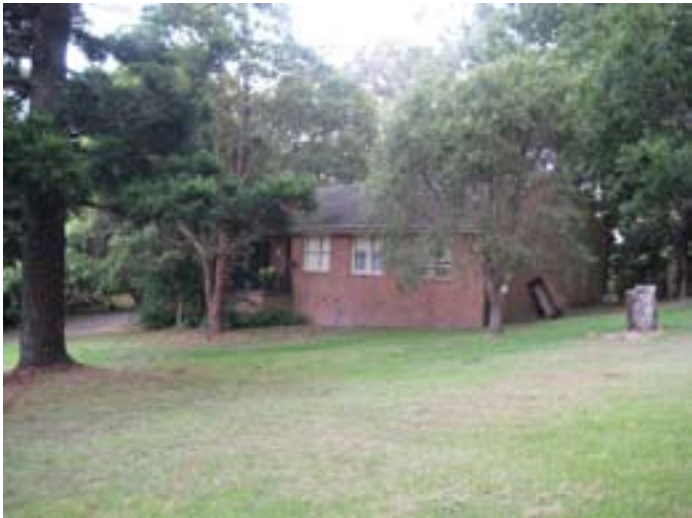
<b>ZONE 2 – MANNING STREET PRECINCT</b>		
<p><b>ITEM Nos.</b> B397 and B398</p> <p><b>ORIGINAL NAME:</b> Residences</p> <p><b>CURRENT USE:</b> Residential accommodation</p>	<p><b>CONSTRUCTION DATE:</b> c.1960-65</p> <p><b>ARCHITECT / BUILDER:</b> Unknown</p>	<p><b>HERITAGE LISTINGS:</b></p> <p><input type="checkbox"/> National Estate</p> <p><input type="checkbox"/> S170 List</p> <p><input type="checkbox"/> National Trust</p> <p><input type="checkbox"/> Leichhardt LEP</p> <p><input type="checkbox"/> State Heritage Inventory</p>
<p><b>BUILDING:</b></p>	<p><b>B397 AND B398</b></p>	
<p><b>LOCATION:</b></p>	<p>GRID: L6-7 ZONE: 2</p>	
<p><b>DESCRIPTION:</b></p> <p>Light yellow – brown brick houses with pitched tiled roofs and brick gables. Simple rectangular plan. Similar to residences B492 and B493.</p>

<p><b>CONDITION:</b></p>	<p>Good</p>	
<p><b>HISTORY:</b></p>	<p>Built c1960</p>	
<p><b>REFERENCES:</b></p>	<p>Leong (80)</p>

<p><b>SIGNIFICANCE:</b></p>	<p>Intrusive to significance and character of zone.</p>	
<p><b>GUIDELINES:</b></p>	<p>Retain, recycle, replace or preferably remove as practicable. New development should be compatible with nearby significant items including B399 (Moodie Street Residence), brick fence on Moodie Street and fig trees, and must conform to the requirements of the Callan Park Act. If removed record prior to demolition.</p>

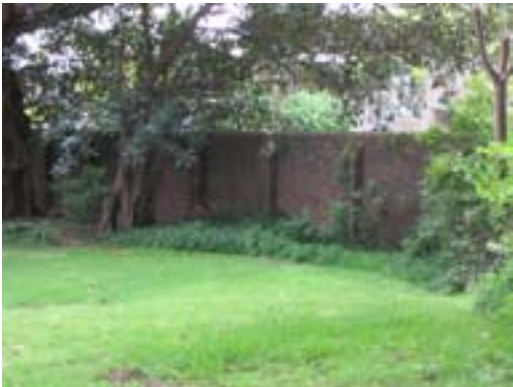
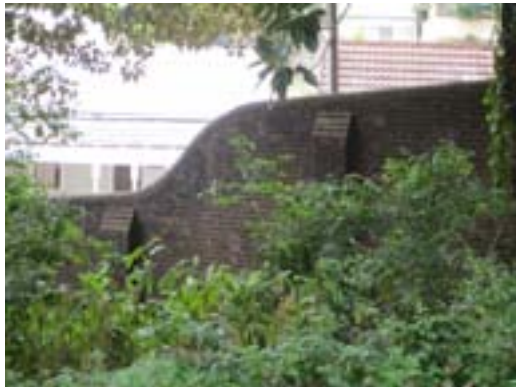
ZONE 2 – MANNING STREET PRECINCT		
<p><b>ITEM No. 1A</b></p> <p><b>ORIGINAL NAME:</b> Boundary wall</p> <p><b>CURRENT USE:</b> Boundary wall</p>	<p><b>CONSTRUCTION DATE:</b> Circa 1890-1903</p> <p><b>ARCHITECT / BUILDER:</b></p>	<p><b>HERITAGE LISTINGS:</b></p> <p><input type="checkbox"/> National Estate</p> <p><input type="checkbox"/> S170 List</p> <p><input type="checkbox"/> National Trust</p> <p><input type="checkbox"/> Leichhardt LEP</p> <p><input type="checkbox"/> State Heritage Inventory</p>
<p><b>ITEM:</b></p>	<p><b>1A BOUNDARY WALL ON MANNING STREET</b></p>	
<p><b>LOCATION:</b></p>	<p>GRID: L6-8 ZONE: 2</p>	
<p><b>DESCRIPTION:</b></p> <p>Buttressed brick wall with bullnose brick coping. Approx 2.0 m high. Curved sections accommodate changes in topography. Intrusive later openings.</p>		
<div style="display: flex; justify-content: space-around;">

</div>		
<p><b>CONDITION:</b></p>	<p>Substantially intact</p>

<p><b>HISTORY:</b></p>	<p>Section south from Manning Street. Residence shown on 1897 plan, possibly built earlier in association with fig planting. Section north of residence added by 1903.</p>	
<p><b>REFERENCES:</b></p>	<p>1991 DPWS Heritage Study. Site Plan 1897</p>	
<p><b>SIGNIFICANCE:</b></p>	<p>Significant as an original and major element in the asylum design representing the need for separation from the general community.</p>	
<p><b>GUIDELINES:</b></p>	<p>Conserve, Normal maintenance required especially repointing and replacing existing opening intrusive modern style gates with gates sympathetic to the period of the wall.</p>

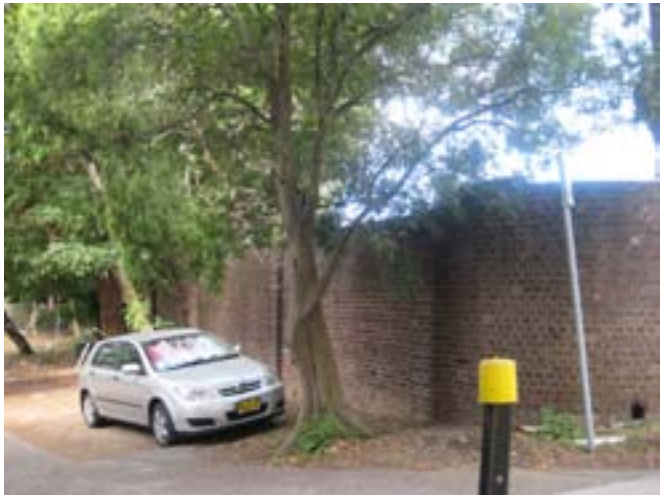
<b>ZONE 2 – MANNING STREET PRECINCT</b>		
<p><b>ITEM No. 1B</b></p> <p><b>ORIGINAL NAME:</b> Boundary wall</p> <p><b>CURRENT USE:</b> Boundary wall</p>	<p><b>CONSTRUCTION DATE:</b> circa 1960 (low section)</p> <p><b>ARCHITECT / BUILDER:</b></p>	<p><b>HERITAGE LISTINGS:</b></p> <p><input type="checkbox"/> National Estate</p> <p><input type="checkbox"/> S170 List</p> <p><input type="checkbox"/> National Trust</p> <p><input type="checkbox"/> Leichhardt LEP</p> <p><input type="checkbox"/> State Heritage Inventory</p>
<p><b>ITEM:</b></p> <p><b>LOCATION:</b></p>	<p><b>1B BOUNDARY WALL ON BALMAIN ROAD</b></p> <p>GRID: L8-K9 ZONE: 2</p>	
<p><b>DESCRIPTION:</b></p> <p>Brick wall approximately 0.5 metres high with section approx 2.0 metres high east of the Cecily Street entrance and at the gateway opposite Alberto Street</p>

<p><b>CONDITION:</b></p>	<p>Intact</p>	
<p><b>HISTORY:</b></p>	<p>Original high timber paling boundary fence was replaced when boundary wall built and gates relocated. Wall height reduced in 1950s or 60s following a Royal Commission.</p>

<p><b>REFERENCES:</b></p>	<p>1991 DPWS Heritage Study. Plans 1912. Photos 1903</p>	
<p><b>SIGNIFICANCE:</b></p>	<p>Existing low wall is significant because it represents the design intent of the original wall/fence ie enclosing the hospital. The high sections of wall are significant as early replacements of the original fence.</p>	
<p><b>GUIDELINES:</b></p>	<p>Preserve high sections adjoining the Main Gates and at the entrance opposite Alberto Street. Preserve existing wall or construct new wall or fence to maintain the original design intent of a strong boundary definition and physical barrier.</p>

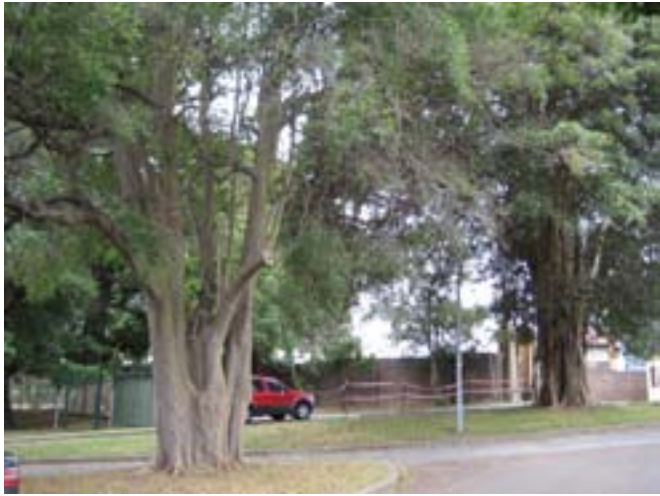
<b>ZONE 2 – MANNING STREET PRECINCT</b>		
<b>ITEM Nos.</b> 1F	<b>CONSTRUCTION DATE:</b>	<b>HERITAGE LISTINGS:</b> <input type="checkbox"/> National Estate <input type="checkbox"/> S170 List <input type="checkbox"/> National Trust <input type="checkbox"/> Leichhardt LEP <input type="checkbox"/> State Heritage Inventory
<b>ORIGINAL NAME:</b>	<b>ARCHITECT / BUILDER:</b>	
<b>CURRENT USE:</b>	<b>1F BOUNDARY PLANTATION ON BALMAIN ROAD</b>	
<b>ITEM:</b>	GRID: L8-9 ZONE: 2 & 3	
<b>LOCATION:</b>		
<b>DESCRIPTION:</b> Double row of Port Jackson Figs and Brush Box.

<b>CONDITION:</b>	Fair to good.	
<b>HISTORY:</b>	Likely that Port Jackson Figs at 12 m centres added in 1890s to original Moore plantings of Pines and Moreton Bay Figs in 'spiny' formation (triangular or alternating row layout). Moore's plantation removed by 1912 tram line and remaining Port Jackson Fig row added	
<b>REFERENCES:</b>	1991 DPWS Heritage Study. Craig Burton, c.1920 photo panorama

<b>SIGNIFICANCE:</b>	Significant because it represents the design intent of the original palntation, to provide visual screening and a parkland setting.	
<b>GUIDELINES:</b>	Over time replace dying trees with Port Jackson Fig and some Radiata Pines throughout to reinstate height. Improve vigour of existing trees and carry out tree surgery. Further research recommended.

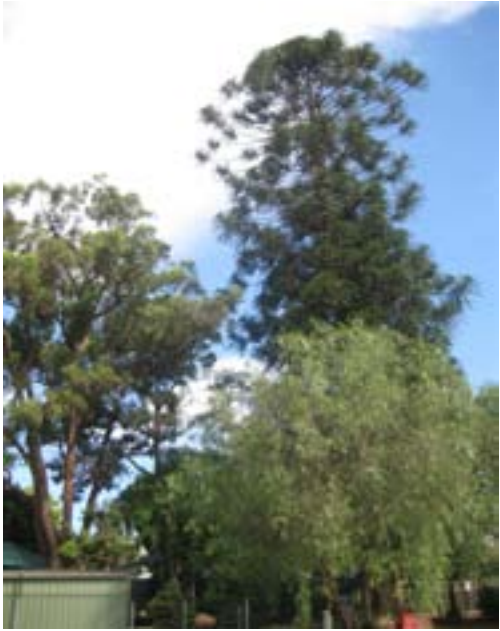
<b>ZONE 2 – MANNING STREET PRECINCT</b>		
<b>ITEM No.</b> 1H  <b>ORIGINAL NAME:</b>  <b>CURRENT USE:</b>	<b>CONSTRUCTION DATE:</b> 1880S-1900s  <b>DESIGNER / BUILDER:</b> <b>Charles Moore</b>	<b>HERITAGE LISTINGS:</b> <input type="checkbox"/> National Estate <input type="checkbox"/> S170 List <input type="checkbox"/> National Trust <input type="checkbox"/> Leichhardt LEP <input type="checkbox"/> State Heritage Inventory
<b>ITEM:</b>  <b>LOCATION:</b>	<b>1H TREE GROUPS c.1880s</b>  GRID: L8 ZONE: 2	
<b>DESCRIPTION:</b>  Mixed species tree group near children's playground associated with B302. Species include Hoop Pine, Bunya Pine, Port Jackson Fig, Water Gum, Brush Box, Illawarra Flame, Plum Pine, Rose Apple and Jacaranda.

<b>CONDITION:</b>	Fair to good.	
<b>HISTORY:</b>	Garden bed laid out by Charles Moore. Originally planted with lawn borders, shrubs and trees with likely additions of Brush Box and Figs in 1890s and Jacaranda and Hoop Pine and possibly other trees added in the mid to late 1900s.

<b>REFERENCES:</b>	1991 DPWS Heritage Study. Site Inspection, 1897 site plan, Plate 66L Thesis.	
<b>SIGNIFICANCE:</b>	Significant as surviving element of original design, representative of the species selection of Charles Moore and of his interest in Australian rain forest species. The proximity of nureses' home intrudes on integrity of group relative to main gardens.	
<b>GUIDELINES:</b>	Maintain older trees and remove younger plantings which are intrusive of character or growth of older trees. Future development should preserve the integrity of these trees as a group. Further research recommended.

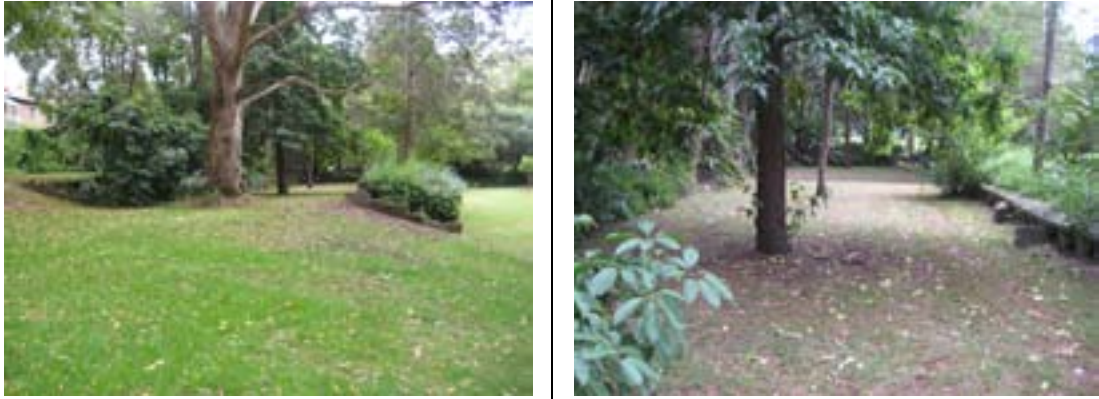
<b>ZONE 2 – MANNING STREET PRECINCT</b>	
<b>ITEM No. 1M</b>  <b>ORIGINAL NAME:</b>  <b>CURRENT USE:</b>	<b>CONSTRUCTION DATE:</b> 1930s to 1960s  <b>ARCHITECT / BUILDER:</b>  <b>HERITAGE LISTINGS:</b> <input type="checkbox"/> National Estate <input type="checkbox"/> S170 List <input type="checkbox"/> National Trust <input type="checkbox"/> Leichhardt LEP <input type="checkbox"/> State Heritage Inventory
<b>ITEM:</b>  <b>LOCATION:</b>	<b>1M FORMAL GARDEN</b>  GRID: L7 ZONE: 2
<b>DESCRIPTION:</b>  Lawn and garden terraces edged in stone, symmetrically laid out about a central path and stairs.

<b>CONDITION:</b>	Remaining area is substantially intact.
<b>HISTORY:</b>	Remaining portion of much larger garden possibly with tennis court built for the use of nurses in the 1930s and expanded up until the 1950s – 1960s buildings reduced it to current size.
<b>REFERENCES:</b>	1991 DPWS Heritage Study. 1952 aerial photo, 1930 aerial photo.

<b>SIGNIFICANCE:</b>	Some significance as a 1930-1950 formal garden built in relation to the nurses home and still used by nurses, however, its integrity is diminished by the imposition of later buildings. Minor intrusion on the Victorian picturesque gardens.
<b>GUIDELINES:</b>	Maintain as a discreet precinct within the Victorian picturesque gardens. If future development removes the earlier 1930s nurses' home or dramatically alters the use of the building, the integrity of the significance may alter. Photographically record the gardens prior to removal or alteration.
