## ZONE 7 BROUGHTON HALL

**ZONE 7 BROUGHTON HALL**  
**INVENTORY OF INDIVIDUAL ITEMS**

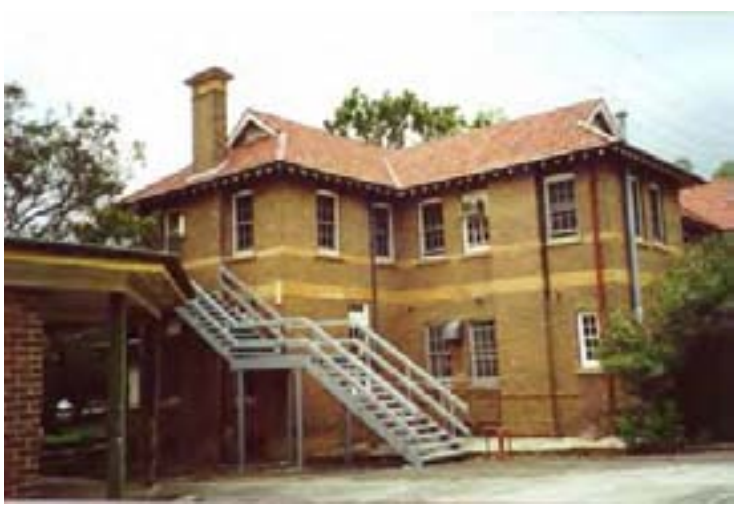
<b>ZONE 7 – BROUGHTON HALL</b>		
<p><b>ITEM No.</b> B121</p> <p><b>ORIGINAL NAME:</b> Ward 2 Dormitory Block, Building 14 Ward 24</p> <p><b>CURRENT USE:</b> WHOS</p>	<p><b>CONSTRUCTION DATE:</b> c. 1920</p> <p><b>ARCHITECT / BUILDER.</b> NSW Government Architect's Office under George Mc Rae.</p>	<p><b>HERITAGE LISTINGS:</b></p> <p><input type="checkbox"/> National Estate</p> <p><input checked="" type="checkbox"/> S170 List</p> <p><input type="checkbox"/> National Trust</p> <p><input type="checkbox"/> Leichhardt LEP</p> <p><input type="checkbox"/> State Heritage Register</p>
<p><b>BUILDING:</b></p> <p><b>LOCATION:</b></p>	<p><b>B121- WARD 24</b></p> <p>GRID: C8-9 ZONE: 7</p>	
<p><b>CONDITION:</b></p>	<p>Fair to good, intact with minor additions including enclosed verandah.</p>	
<p><b>DESCRIPTION:</b></p> <p>Two storey building with Federation era aesthetic. Brick walls with stone string course and sills, complex terracotta tiled roof with gablet vents and rafters exposed in eaves. Arched opening to entrance. Multi-paned double hung windows and extensive verandah on garden side with fine turned timber columns.</p>

<p><b>HISTORY:</b></p>	<p>Built c. 1920. Drawing signed by G. M. Blair 1908 and passed by G. M. Blair 13 September 1918. 1908 is well prior to government use of site, so the building may have been intended for elsewhere.</p>	
<p><b>REFERENCES:</b></p>	<p>Leong (67). MHI/628-9, JTCW</p>	
<p><b>SIGNIFICANCE:</b></p>	<p>High. One of most important elements of the Broughton Hall group, enclosing garden and consistent in materials, design and scale. Finely crafted and designed building. Accomplished example of type. Note that external metal stairs are intrusive.</p>	
<p><b>GUIDELINES:</b></p>	<p>Retain and conserve according to Burra Charter principles (including adaptive reuse). Respect group values in any work. If practicable, remove unsympathetic verandah enclosure. General maintenance required, including rainwater goods. Remove redundant services from external walls.</p> <p>The design of the external fire stairs should be integrated with the building as appropriate for intended use.</p>

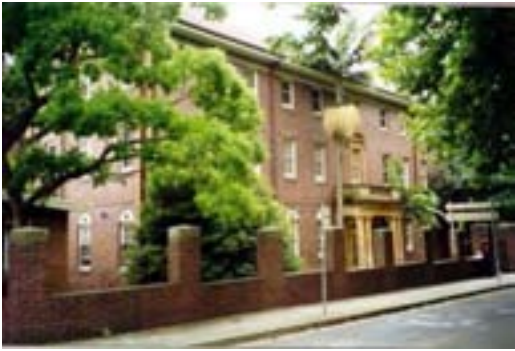
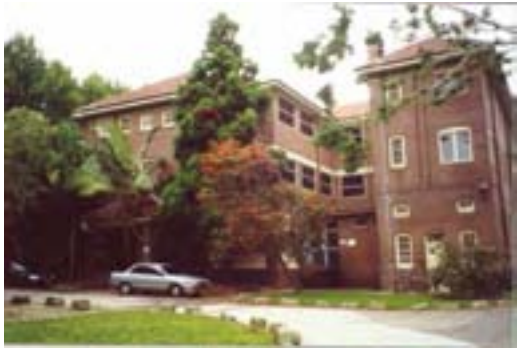
<b>ZONE 7 – BROUGHTON HALL</b>		
<p><b>ITEM No.</b> B125</p> <p><b>ORIGINAL NAME:</b> Administration Block and Nurses' Quarters (later Domestic Services, Chaplains, Nurses' Home, Outdoor Supervisor), Building 10, 11 and 13 Broughton Hall Offices</p> <p><b>CURRENT USE:</b> Mental Health Co-ordinating Council offices</p>	<p><b>CONSTRUCTION DATE:</b> c. 1927-29</p> <p><b>ARCHITECT / BUILDER:</b> Unknown (probably NSW Government Architect's Office under Richard Wells).</p>	<p><b>HERITAGE LISTINGS:</b></p> <p><input type="checkbox"/> National Estate</p> <p><input checked="" type="checkbox"/> S170 List</p> <p><input type="checkbox"/> National Trust</p> <p><input type="checkbox"/> Leichhardt LEP</p> <p><input type="checkbox"/> State Heritage Register</p>
<b>BUILDING:</b>	<b>B125 MENTAL HEALTH CO-ORDINATING COUNCIL</b>	
<b>LOCATION:</b>	GRID: C9 ZONE: 7	
<b>DESCRIPTION:</b>		
<p>Three storey brick building with hipped terracotta tiled roof. Georgian Revival detailing with rendered arch over ground floor windows with medallion. Finely detailed classical sandstone porch to street frontage. Symmetrically composed. Fence designed with building but metal panels now removed.</p>

</div>		
<b>CONDITION:</b>	<p>Good, largely intact.</p> <p>Note some bricks and copings have been removed from the surrounding wall in addition to all iron panels between piers.</p>	
<b>HISTORY:</b>	Built c. 1927 – 29	
<b>REFERENCES:</b>	Leong (68), MHI/146-7, JTCW	
<b>SIGNIFICANCE:</b>	High. Part of Broughton Hall Group. Forms corner to enclosure of gardens. Group of consistent design, materials and scale.	
<b>GUIDELINES:</b>	<p>Conserve and adapt according to Burra Charter principles. Routine maintenance required. Reconstruct missing elements such as windows and repair fabric to match existing. Remove redundant services from external wall surfaces.</p> <p>Reconstruct missing elements of the enclosing walls along Church Street and Glover Street.</p>

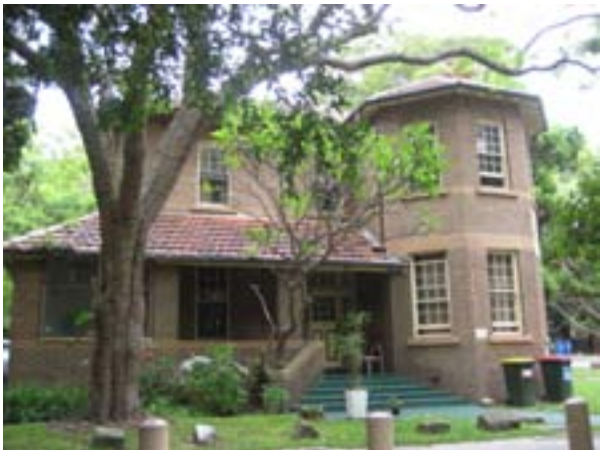
<b>ZONE 7 – BROUGHTON HALL</b>		
<p><b>ITEM No.</b> 126</p> <p><b>ORIGINAL NAME:</b> Medical Superintendent's Quarters, Building 9</p> <p><b>CURRENT USE:</b> WHOS – music therapy</p>	<p><b>CONSTRUCTION DATE:</b> c.1920</p> <p><b>ARCHITECT / BUILDER:</b> <b>NSW Government</b> <b>Architect's Office under</b> Gorrie McLeish Blair</p>	<p><b>HERITAGE LISTINGS:</b></p> <p><input type="checkbox"/> National Estate</p> <p><input checked="" type="checkbox"/> S170 List</p> <p><input type="checkbox"/> National Trust</p> <p><input type="checkbox"/> Leichhardt LEP</p> <p><input type="checkbox"/> State Heritage Register</p>
<p><b>BUILDING:</b></p>	<p><b>B126 TREE TOPS</b></p>	
<p><b>LOCATION:</b></p>	<p>GRID: C9 ZONE: 7</p>	
<p><b>DESCRIPTION:</b></p> <p>Two storey Federation period house. Brick with stone string course and sills, hipped terracotta tiled roof with rafters exposed at eaves. Projecting bay and verandah facing garden, multi-paned double hung timber windows.</p>

<p><b>CONDITION:</b></p>	<p>Fair and generally intact, including internally, with minor alterations. Sections of roofing and rainwater goods deteriorating.</p> <p>Note some bricks and stone cappings have been removed from the surrounding wall in addition to all iron panels between piers.</p>	
<p><b>HISTORY:</b></p>	<p>Built c. 1920. Drawings dated 1918 and signed design architect, G. M. Blair, Principal Design Architect 1.12.18. Built in different location to that shown on original site plan.</p>	
<p><b>REFERENCES:</b></p>	<p>Leong (72), MH1/145, JTCW</p>	
<p><b>SIGNIFICANCE:</b></p>	<p>High. Part of Broughton Hall Group. With other buildings forms "wall" enclosing gardens. Part of group with consistent design, scale and materials. Well built example.</p>	
<p><b>GUIDELINES:</b></p>	<p>Retain and conserve according to Burra Charter principles. Undertake repairs to deteriorating roof areas and rainwater goods. Initiate a regular maintenance program. Reinstate open verandahs.</p>

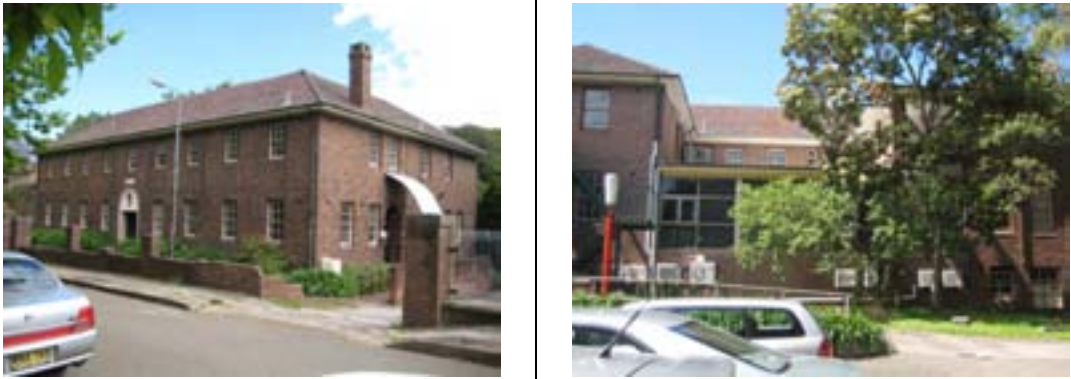
<b>ZONE 7 – BROUGHTON HALL</b>		
<p><b>ITEM No.</b> B127</p> <p><b>ORIGINAL NAME:</b> Occupation Therapy Unit &amp; Nurses Quarter (later Health Surveyors), Building 8 Library and Education Centre</p> <p><b>CURRENT USE:</b> NSW Ambulance</p>	<p><b>CONSTRUCTION DATE:</b> 1932-33</p> <p><b>ARCHITECT / BUILDER:</b> Unknown but probably NSW Government Architect's Office under Edwin Smith.</p>	<p><b>HERITAGE LISTINGS:</b></p> <p><input type="checkbox"/> National Estate</p> <p><input checked="" type="checkbox"/> S170 List</p> <p><input type="checkbox"/> National Trust</p> <p><input type="checkbox"/> Leichhardt LEP</p> <p><input type="checkbox"/> State Heritage Register</p>
<p><b>BUILDING:</b></p>	B127	
<p><b>LOCATION:</b></p>	GRID: C-D9 ZONE: 7	
<p><b>DESCRIPTION:</b></p> <p>Two storey brick building with hipped terracotta tiled roof and enclosed verandah on garden frontage. Cement rendered arch containing decorative cartouche to main entry off Church Street.</p>

<p><b>CONDITION:</b></p>	<p>Good, intact (minor alterations). Intrusive canopy on eastern side.</p> <p>Note some bricks and stone cappings have been removed from the surrounding wall in addition to all iron panels between piers.</p>	
<p><b>HISTORY:</b></p>	Built 1932-3	
<p><b>REFERENCES:</b></p>	Leong (73), MH1/16, JTCW	
<p><b>SIGNIFICANCE:</b></p>	Moderate. Part of Broughton Hall Group. With other buildings forms "wall" enclosing gardens. Part of group with consistent design scale and materials. Well built and designed, symmetrically composed.	
<p><b>GUIDELINES:</b></p>	<p>Retain and conserve according to Burra Charter principles. Remove intrusive accretions such as the awning on the eastern side and verandah enclosures. Initiate a regular maintenance program. Remove plant growing in chimney. Relocate air conditioning equipment to a less intrusive location.</p> <p>Reconstruct missing elements of the enclosing boundary wall along Church Street.</p>

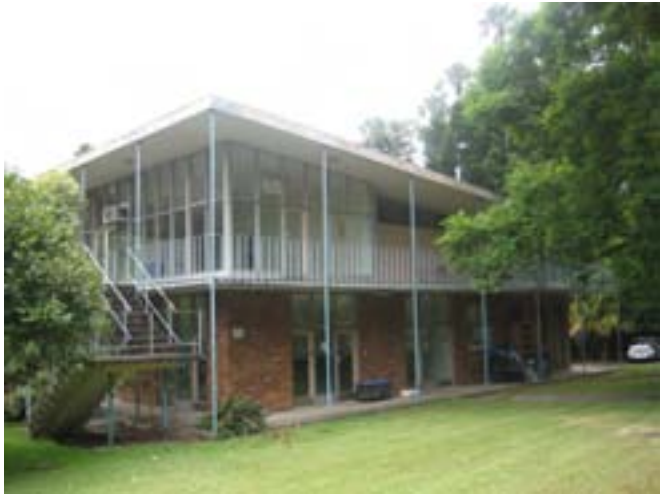
<b>ZONE 7 – BROUGHTON HALL</b>		
<p><b>ITEM No.</b> B129</p> <p><b>ORIGINAL NAME:</b> Canteen, Building 16 Daintree House, Jacaranda Lodge, and staff amenities</p> <p><b>CURRENT USE:</b></p>	<p><b>CONSTRUCTION DATE:</b> c. 1960</p> <p><b>ARCHITECT / BUILDER:</b> Unknown</p>	<p><b>HERITAGE LISTINGS:</b></p> <p><input type="checkbox"/> National Estate</p> <p><input type="checkbox"/> S170 List</p> <p><input type="checkbox"/> National Trust</p> <p><input type="checkbox"/> Leichhardt LEP</p> <p><input type="checkbox"/> State Heritage Register</p>
<p><b>BUILDING:</b></p> <p><b>LOCATION:</b></p>	<p><b>B129 DAINTREE LODGE</b></p> <p>GRID: D8-9 ZONE: 7</p>	
<p><b>DESCRIPTION:</b></p> <p>Two storey brick building with extensive areas of glazing and low pitched “butterfly” profile roof. Siting disregards garden design and building inconsistent with group.</p>

<p><b>CONDITION:</b></p>	<p>Good</p>	
<p><b>HISTORY:</b></p>	<p>Built c. 1960</p>

<p><b>REFERENCES:</b></p>	<p>Leong (75), MH1/62-63, JTCW</p>	
<p><b>SIGNIFICANCE:</b></p>	<p>Low - characteristic post-World War II building showing Modernist architectural influence. Intrusive on original garden setting.</p>	
<p><b>GUIDELINES:</b></p>	<p>Retain, recycle or remove. If retained, conserve according to Burra Charter principles. If removed, return site to garden and record prior to removal.</p>

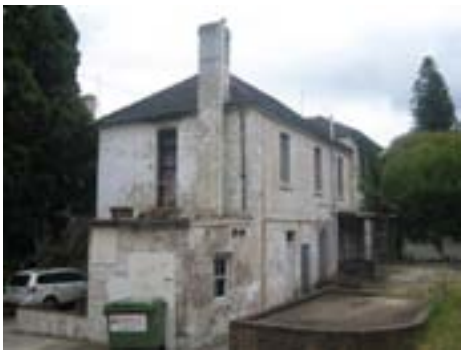
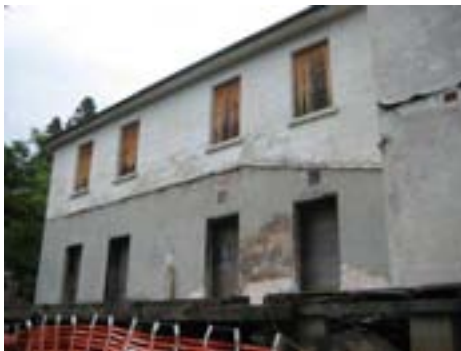
<b>ZONE 7 – BROUGHTON HALL</b>		
<p><b>ITEM No.</b> B130</p> <p><b>ORIGINAL NAME:</b> Broughton House (original homestead) later Rivendell, Building 6</p> <p><b>CURRENT USE:</b> Vacant</p>	<p><b>CONSTRUCTION DATE:</b> c. 1841-2</p> <p><b>ARCHITECT / BUILDER:</b> Built by John Ryan Brenan</p>	<p><b>HERITAGE LISTINGS:</b></p> <p><input type="checkbox"/> National Estate</p> <p><input checked="" type="checkbox"/> S170 List</p> <p><input type="checkbox"/> National Trust</p> <p><input type="checkbox"/> Leichhardt LEP</p> <p><input checked="" type="checkbox"/> State Heritage Register</p>
<p><b>BUILDING:</b></p> <p><b>LOCATION:</b></p>	<p><b>B130 BROUGHTON HOUSE (RIVENDELL)</b></p> <p>GRID: D9 ZONE: 7</p>	
<p><b>DESCRIPTION:</b></p> <p>Two storey painted rendered brick building, stone foundations, hipped roof now clad in concrete tiles (formerly slate), timber windows (boarded up) and may have retained fine internal joinery. Extensive alterations and additions (see Leong).</p>

</div>		
<p><b>CONDITION:</b></p>	<p>Very poor – extensively damaged by fire, many additions and alterations. Note some bricks and stone cappings have been removed from the surrounding wall in addition to all iron panels between piers.</p>	
<p><b>HISTORY:</b></p>	<p>Built by John Ryan Brenan c. 1841-2 as investment and sold soon after. Owned by Keep family 1864-1912 who added to, altered and developed the renowned gardens.</p>	
<p><b>REFERENCES:</b></p>	<p>Leong (77), PWD MH1/3, RGD DP 50893, SMH 31 December 1842, p4/c.</p>	
<p><b>SIGNIFICANCE:</b></p>	<p>High. Original building on the site which gave its name to the Psychiatric Clinic. Grand Victorian house with classical Georgian details historically linked to Garry Owen. Severe lack of integrity reduces significance. Part of Broughton Hall Group.</p>	
<p><b>GUIDELINES:</b></p>	<p>Retain and conserve the building according to the principles of the Burra Charter. A conservation management plan is required for the building. Urgent action includes the following:</p> <ul style="list-style-type: none"> <li>• ensure waterproofing and soundness of roof;</li> <li>• ensure discharging of stormwater away from foundations and repair of gutters, downpipes and stormwater drains,</li> <li>• vermin proofing and treatment of active termites by baiting.</li> </ul> <p>This should be done while decisions are being made about the building's future and use. NB: See Leong for detailed description and assessment.</p> <p>Reconstruct missing elements of the boundary wall along Church Street.</p>

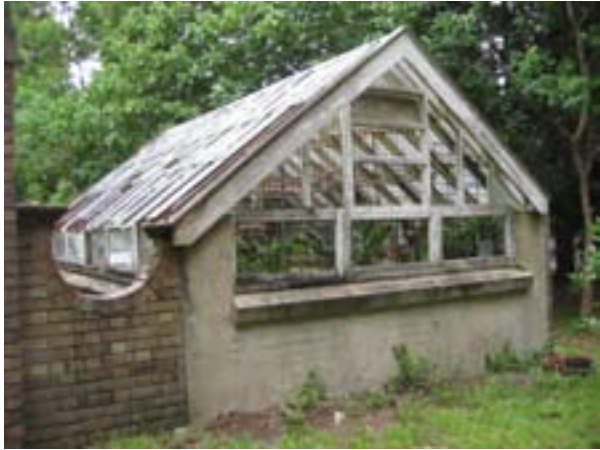
ZONE 7 – BROUGHTON HALL		
<b>ITEM No.</b> B134  <b>ORIGINAL NAME:</b> Glasshouse  <b>CURRENT USE:</b> Glasshouse	<b>CONSTRUCTION DATE:</b> After early 1930s  <b>ARCHITECT / BUILDER:</b>	<b>HERITAGE LISTINGS:</b> <input type="checkbox"/> National Estate <input type="checkbox"/> S170 List <input type="checkbox"/> National Trust <input type="checkbox"/> Leichhardt LEP <input type="checkbox"/> State Heritage Register
<b>BUILDING:</b> <b>LOCATION:</b>	<b>B134 GLASSHOUSE</b>  GRID: D8 ZONE: 7	
<b>DESCRIPTION:</b>  Rectilinear building with rendered brick base, timber framed windows and gabled glass roof. Roof glazing is supported by steel sections.

<b>CONDITION:</b>	Poor. Roof glazing has been broken in places and some glass is insecure.	
<b>HISTORY:</b>	Constructed after the formal pond attributed to Evan Jones, which was probably constructed during the 1930s.	
<b>REFERENCES:</b>		
<b>SIGNIFICANCE:</b>	Low.

<b>GUIDELINES:</b>	Retain, recycle or remove. If removed, record prior to demolition.

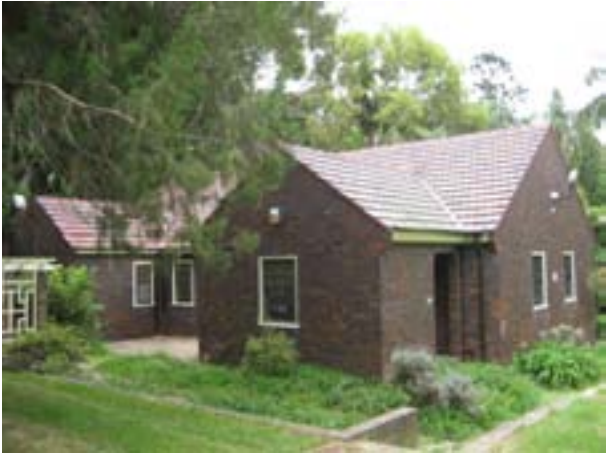
ZONE 7 – BROUGHTON HALL		
<p><b>ITEM No.</b> B135</p> <p><b>ORIGINAL NAME:</b> Medical Superintendent's Residence, Building R2</p> <p><b>CURRENT USE:</b> Offices</p>	<p><b>CONSTRUCTION DATE:</b> c.1933-35</p> <p><b>ARCHITECT / BUILDER:</b> NSW Government Architect's Office under Edwin Smith</p>	<p><b>HERITAGE LISTINGS:</b></p> <p><input type="checkbox"/> National Estate</p> <p><input type="checkbox"/> S170 List</p> <p><input type="checkbox"/> National Trust</p> <p><input type="checkbox"/> Leichhardt LEP</p> <p><input type="checkbox"/> State Heritage Register</p>
<p><b>BUILDING:</b></p> <p><b>LOCATION:</b></p>	<p><b>B135 THE ARBOUR</b></p> <p>GRID: D8 ZONE: 7</p>	
<p><b>DESCRIPTION:</b></p> <p>Single storey dwelling in dark brick with pitched tiled roof. Verandah on north façade has been partially and unsympathetically infilled. Fine brick detailing to gable ends (corbels) and window heads.</p>

<p><b>CONDITION:</b></p>	<p>Average to good. Joinery needs repairs, arch bars rusting.</p>	
<p><b>HISTORY:</b></p>	<p>Built 1933. Set in centre of part of estate garden shown fenced on very early plans.</p>	
<p><b>REFERENCES:</b></p>	<p>Leong (61), MH1/9, JTCW. Drawing dated 1931 signed by Edwin Smith (Government architect) and site plan shows summerhouses, rose pergolas and vinery and other buildings on site, and tennis court.</p>	
<p><b>SIGNIFICANCE:</b></p>	<p>Moderate. Part of the Broughton Hall group. Sitting reflects estate garden layout. Part of a group with consistent design, materials and scale. Well built example of its type, symmetrically composed.</p>	
<p><b>GUIDELINES:</b></p>	<p>Conserve according to Burra Charter principles. Remove verandah infill. Normal maintenance required along with joinery repair and painting and replacement of arch bars.</p>

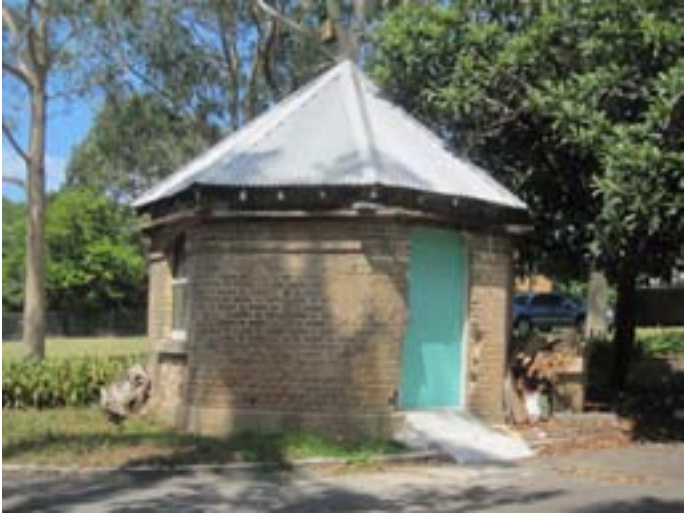
<b>ZONE 7 – BROUGHTON HALL</b>		
<b>ITEM No.</b> B137  <b>ORIGINAL NAME:</b> Summer House  <b>CURRENT USE:</b> WC.	<b>CONSTRUCTION DATE:</b> circa 1880s  <b>ARCHITECT / BUILDER:</b> Unknown	<b>HERITAGE LISTINGS:</b> <input type="checkbox"/> National Estate <input checked="" type="checkbox"/> S170 List <input type="checkbox"/> National Trust <input type="checkbox"/> Leichhardt LEP <input type="checkbox"/> State Heritage Register
<b>BUILDING:</b> <b>LOCATION:</b>	<b>B137 SUMMER HOUSE</b>  GRID: D8 ZONE: 7	
<b>DESCRIPTION:</b>  Octagonal summer house of finely detailed brick construction with corrugated iron roof - formerly slate or shingled (from spacing of battens). Single doorway opposite niche (false window). Two window openings on opposite sides. Boarded ceiling. Construction consistent with nineteenth century date.

<b>CONDITION:</b>	Fair.	
<b>HISTORY:</b>	Built as garden pavilion as part of early garden design. Extant before 1890. Inappropriately adapted as w.c. at beginning of 2011.

<b>REFERENCES:</b>	Dept of Lands Metropolitan Detail Series Leichhardt Sheet 57, 1890. Site inspection, MH1/9, and site plans 1931-51. Leong thesis (referred to as gate lodge).	
<b>SIGNIFICANCE:</b>	High. Only surviving built element of estate gardens.	
<b>GUIDELINES:</b>	Retain and conserve as landscape element according to Burra Charter principles. Enhance heritage significance by initiating sympathetic adaptive reuse and removing inappropriate w.c. installation. Reconstruct / install appropriate window and door fabric.

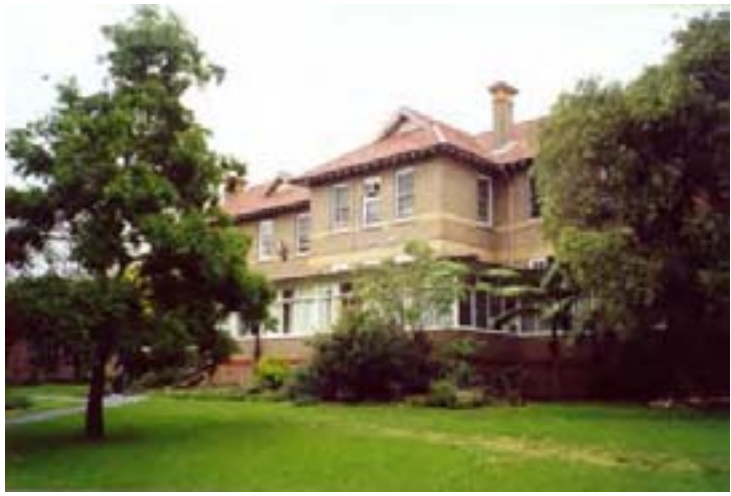
ZONE 7 – BROUGHTON HALL		
<p><b>ITEM No. B193</b></p> <p><b>ORIGINAL NAME:</b> Ward 3 Dormitory Block, Building 18</p> <p><b>CURRENT USE:</b> Patient accommodation</p>	<p><b>CONSTRUCTION DATE:</b> c.1920</p> <p><b>ARCHITECT / BUILDER:</b> Gorrie McLeish Blair</p>	<p><b>HERITAGE LISTINGS:</b></p> <p><input type="checkbox"/> National Estate</p> <p><input checked="" type="checkbox"/> S170 List</p> <p><input type="checkbox"/> National Trust</p> <p><input type="checkbox"/> Leichhardt LEP</p> <p><input type="checkbox"/> State Heritage Register</p>
<b>BUILDING:</b>	<b>B193 WARD 25</b>	
<b>LOCATION:</b>	GRID: C7-8 ZONE: 7	
<b>CONDITION:</b>	Fair to good, intact (minor additions)	
<p><b>DESCRIPTION:</b></p> <p>Two storey Federation period building. Brick walls with stone string course and sills, complex terracotta tiled roof with gablet vents and rafters exposed in eaves, arched opening to entrance. Multi-paned double hung windows and extensive verandah on garden side with fine turned timber columns. Verandah has been enclosed.</p>

<b>HISTORY:</b>	May have been built c. 1920. Drawing signed drawn by G. M. Blair 1908 and passed by G. M. Blair 13.9.18. 1908 is well prior to government use of site, the building may have been intended for elsewhere.	
<b>REFERENCES:</b>	Leong (65), MH1/628-9, JTCW	
<b>SIGNIFICANCE:</b>	High. One of the most important elements of Broughton Hall Group enclosing garden and consistent in materials, design and scale. Finely crafted and designed building. Accomplished example of type.	
<b>GUIDELINES:</b>	Conserve according to Burra Charter principles. Stormwater disposal requires attention. Reinstate verandahs, reconstruct original windows where these have been removed or modified as appropriate. Initiate regular maintenance program.

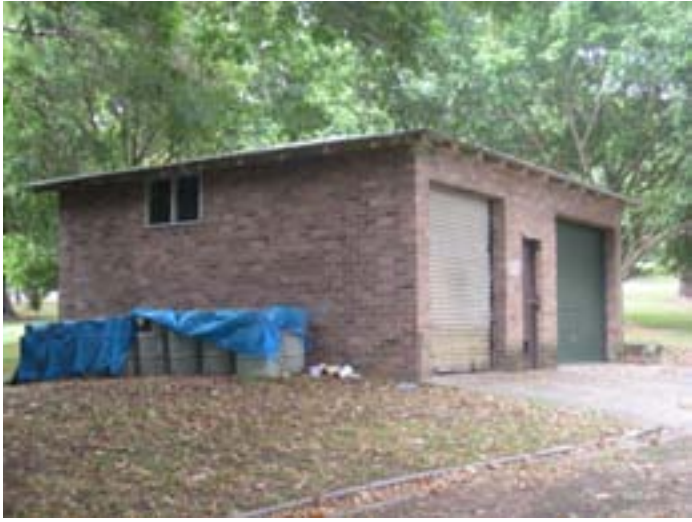
<b>ZONE 7 – BROUGHTON HALL</b>		
<b>ITEM No.</b> B196  <b>ORIGINAL NAME:</b> Storage, Building 21A  <b>CURRENT USE:</b> Storage	<b>CONSTRUCTION DATE:</b> c. 1931  <b>ARCHITECT / BUILDER:</b> Unknown	<b>HERITAGE LISTINGS:</b> <input type="checkbox"/> National Estate <input type="checkbox"/> S170 List <input type="checkbox"/> National Trust <input type="checkbox"/> Leichhardt LEP <input type="checkbox"/> State Heritage Register
<b>BUILDING:</b> <b>LOCATION:</b>	<b>B196 GARAGE, STORAGE</b>  GRID: D7 ZONE: 7	
<b>DESCRIPTION:</b>  Small brick shed with corrugated steel roof and two steel roller doors on the north elevation in Broughton Hall gardens. Exposed rafter ends.

<b>CONDITION:</b>	Poor	
<b>HISTORY:</b>	Unknown; c. 1931	
<b>REFERENCES:</b>	Inspection JTCW	
<b>SIGNIFICANCE:</b>	Intrusive in landscaped setting.	
<b>GUIDELINES:</b>	The building should be removed and the Broughton Hall garden restored. Record prior to removal.

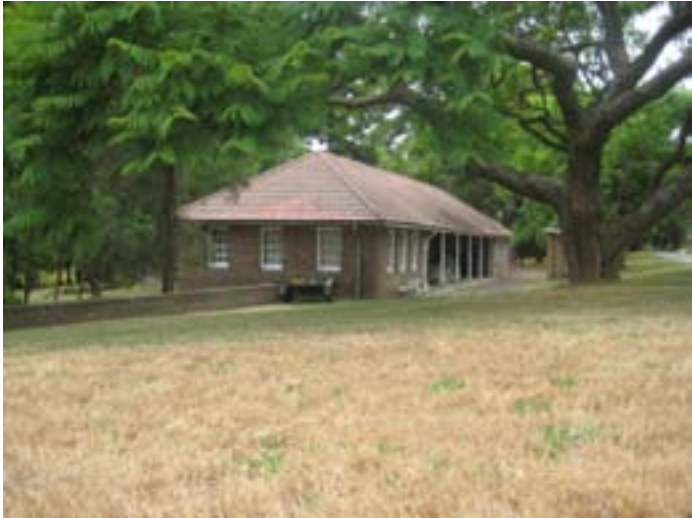
<b>ZONE 7 – BROUGHTON HALL</b>		
<b>ITEM No.</b> B198  <b>ORIGINAL NAME:</b> Workshop/Store, Building 21  <b>CURRENT USE:</b> Workshop	<b>CONSTRUCTION DATE:</b> c. 1937  <b>ARCHITECT / BUILDER:</b> Unknown	<b>HERITAGE LISTINGS:</b> <input type="checkbox"/> National Estate <input checked="" type="checkbox"/> S170 List <input type="checkbox"/> National Trust <input type="checkbox"/> Leichhardt LEP <input type="checkbox"/> State Heritage Register
<b>BUILDING:</b>  <b>LOCATION:</b>	<b>B198 WORKSHOP</b>  GRID: D7 ZONE: 7	
<b>DESCRIPTION:</b>  Small single storey brick building in Broughton Hall Gardens. Terracotta tiled hipped roof and recessed verandah on west façade. Isolated from other buildings.

<b>CONDITION:</b>	Average. Roof and windows in need of maintenance.	
<b>HISTORY:</b>	c. 1937	
<b>REFERENCES:</b>	Leong (60) JTCW	
<b>SIGNIFICANCE:</b>	Low. Minimal heritage significance.	
<b>GUIDELINES:</b>	Retain, recycle, or remove as practicable. If replaced have regard to setting in Broughton Hall Gardens. General maintenance required if retained. If removed record prior to demolition.

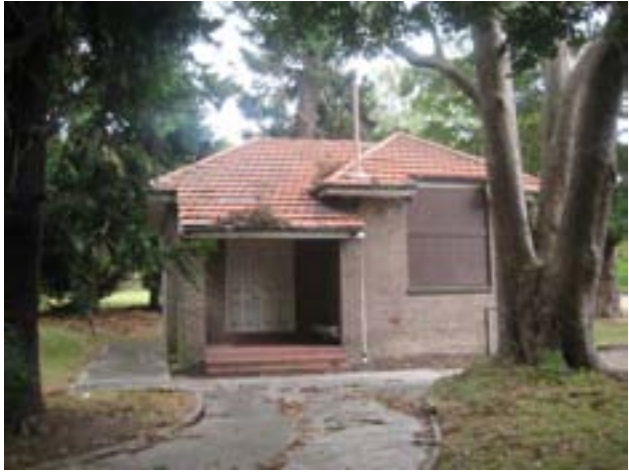
<b>ZONE 7 – BROUGHTON HALL</b>		
<p><b>ITEM No.</b> B199</p> <p><b>ORIGINAL NAME:</b> Mortuary, Chapel, Building 22</p> <p><b>CURRENT USE:</b> Disused</p>	<p><b>CONSTRUCTION DATE:</b> c. 1927</p> <p><b>ARCHITECT / BUILDER:</b> Unknown</p>	<p><b>HERITAGE LISTINGS:</b></p> <p><input type="checkbox"/> National Estate</p> <p><input checked="" type="checkbox"/> S170 List</p> <p><input type="checkbox"/> National Trust</p> <p><input type="checkbox"/> Leichhardt LEP</p> <p><input type="checkbox"/> State Heritage Register</p>
<p><b>BUILDING:</b></p> <p><b>LOCATION:</b></p>	<p><b>B199 BROUGHTON HALL CHAPEL</b></p> <p>GRID: D7 ZONE: 7</p>	
<p><b>DESCRIPTION:</b></p> <p>Small brick and tile building with windows boarded up on the east façade and bricked in on the north façade (also door). Verandah on east side.</p>

<p><b>CONDITION:</b></p>	<p>Poor. Roof is deteriorating.</p>	
<p><b>HISTORY:</b></p>	<p>Built c. 1927, altered 1960.</p>

<p><b>REFERENCES:</b></p>	<p>Leong (57), MH1/159</p>	
<p><b>SIGNIFICANCE:</b></p>	<p>Low. Minimal heritage significance.</p>	
<p><b>GUIDELINES:</b></p>	<p>Retain, recycle or remove as practicable. If replaced have regard to garden setting and record prior to demolition. Normal maintenance required.</p>

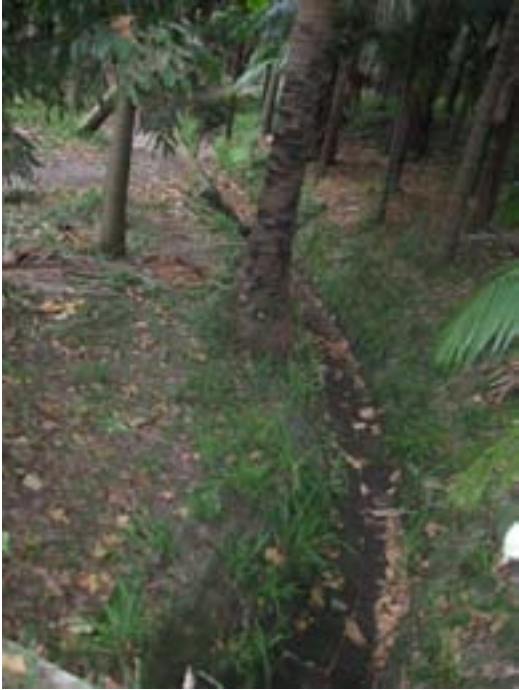
<b>ZONE 7 – BROUGHTON HALL</b>	
<b>ITEM No. 11C</b> <b>ORIGINAL NAME:</b> <b>CURRENT USE:</b>	<b>CONSTRUCTION DATE:</b> <b>ARCHITECT / BUILDER:</b>
<b>HERITAGE LISTINGS:</b> <input type="checkbox"/> National Estate <input checked="" type="checkbox"/> S170 List <input type="checkbox"/> National Trust <input type="checkbox"/> Leichhardt LEP <input type="checkbox"/> State Heritage Register	
<b>ITEM:</b> <b>LOCATION:</b>	<b>11C STONE LINED CREEK</b> GRID: D7-8 ZONE: 7
<b>DESCRIPTION:</b> Creek lined with battered sandstone block walls.

<b>CONDITION:</b>	Intact.
<b>HISTORY:</b>	Believed formed in mid to late 1800s.
<b>REFERENCES:</b>	1991 DPWS Heritage Study.
<b>SIGNIFICANCE:</b>	Significant as represents natural spring fed watercourse and as an element of early garden design.
<b>GUIDELINES:</b>	Preserve. Conserve according to Burra Charter principles.

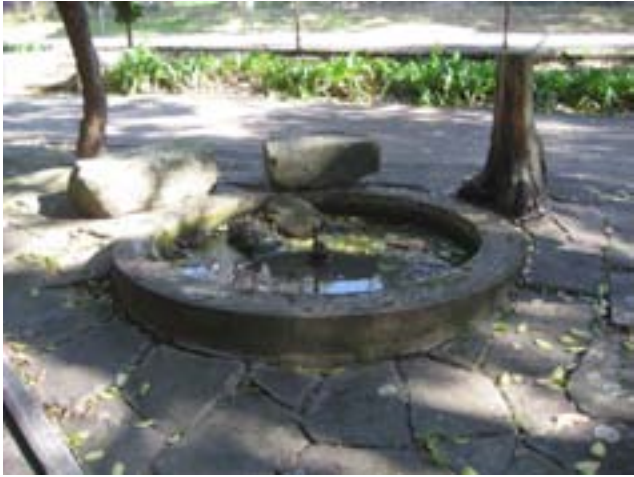
<b>ZONE 7 – BROUGHTON HALL</b>	
<p><b>ITEM No. 11E</b></p> <p><b>ORIGINAL NAME:</b> Circular Stone Pond</p> <p><b>CURRENT USE:</b> Disused</p>	<p><b>CONSTRUCTION DATE:</b> Late nineteenth century</p> <p><b>ARCHITECT / BUILDER:</b> <b>Unknown</b></p> <p><b>HERITAGE LISTINGS:</b></p> <p><input type="checkbox"/> National Estate</p> <p><input checked="" type="checkbox"/> S170 List</p> <p><input type="checkbox"/> National Trust</p> <p><input type="checkbox"/> Leichhardt LEP</p> <p><input type="checkbox"/> State Heritage Register</p>
<p><b>ITEM:</b></p> <p><b>LOCATION:</b></p>	<p><b>11E CIRCULAR STONE POND</b></p> <p>GRID: D8 ZONE: 7</p>
<p><b>DESCRIPTION:</b></p> <p>Small circular pond built of individually shaped stone blocks. Formerly about two courses high, now one course high above pavement level. Single central water spout.</p>

<p><b>CONDITION:</b></p>	<p>Fair only. Appears to have had top course of stone removed.</p>

<p><b>HISTORY:</b></p>	<p>Believed to have been constructed in mid to late nineteenth century as part of the original Estate garden.</p>
<p><b>REFERENCES:</b></p>	<p>1991 DPWS Heritage Study; Powell.</p>
<p><b>SIGNIFICANCE:</b></p>	<p>Significant as a garden element from the early estate garden. Has the potential to be a fine example of its kind.</p>
<p><b>GUIDELINES:</b></p>	<p>Preserve. Restore missing stone. Where practicable upgrade existing surrounds to form a sympathetic context for the original character of the pond.</p>

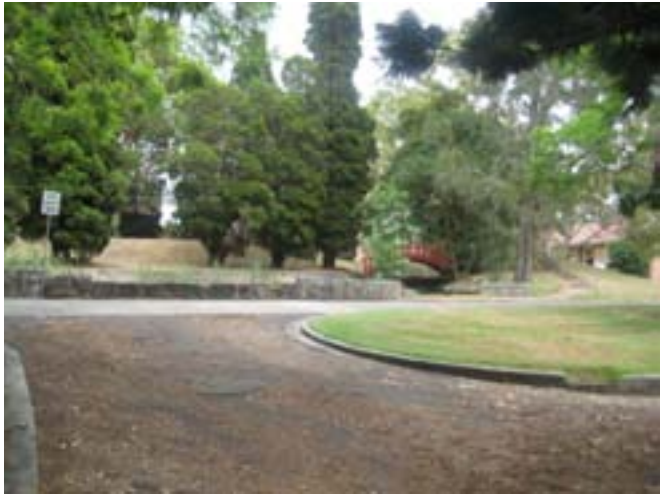
<b>ZONE 7 – BROUGHTON HALL</b>		
<b>ITEM No. 11G</b> <b>ORIGINAL NAME:</b> <b>CURRENT USE:</b>	<b>CONSTRUCTION DATE:</b> <b>ARCHITECT / BUILDER:</b>	<b>HERITAGE LISTINGS:</b> <input type="checkbox"/> National Estate <input checked="" type="checkbox"/> S170 List <input type="checkbox"/> National Trust <input type="checkbox"/> Leichhardt LEP <input type="checkbox"/> State Heritage Register
<b>ITEM:</b> <b>LOCATION:</b>	<b>11G ROAD NETWORK</b> GRID: D7-9 ZONE: 7	
<b>DESCRIPTION:</b> Kerbed and guttered bitumen access roads.

<b>CONDITION:</b>	Good to fair.	
<b>HISTORY:</b>	Formed roads overlay what appear to be pathways in 1930 aerial photo.	
<b>REFERENCES:</b>	1991 DPWS Heritage Study; Aerial photo.	
<b>SIGNIFICANCE:</b>	Significant as an adaptation of earlier path network however the introduction of vehicles is intrusive on the significance of the gardens.	
<b>GUIDELINES:</b>	Return to pedestrian use and resurface with suitable material, such as gravel.

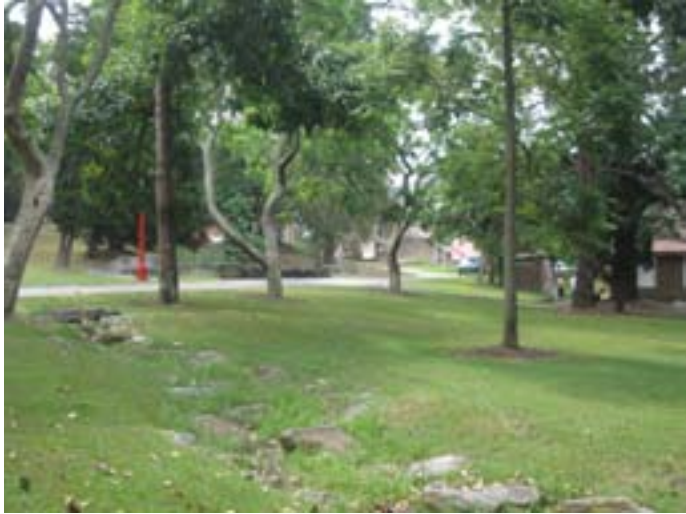
<b>ZONE 7 – BROUGHTON HALL</b>		
<b>ITEM No. 11J</b> <b>ORIGINAL NAME:</b> <b>CURRENT USE:</b>	<b>CONSTRUCTION DATE:</b> <b>ARCHITECT / BUILDER:</b>	<b>HERITAGE LISTINGS:</b> <input type="checkbox"/> National Estate <input checked="" type="checkbox"/> S170 List <input type="checkbox"/> National Trust <input type="checkbox"/> Leichhardt LEP <input type="checkbox"/> State Heritage Register
<b>ITEM:</b> <b>LOCATION:</b>	<b>11J TREE GROUPS AND ROWS – 1930s</b> GRID: D7 ZONE: 7	
<b>DESCRIPTION:</b> Row of Raphis Palms, Jacarandas, Illawarra Flame and Hoop Pine around a lawn area and a small rock edged stream.

<b>CONDITION:</b>	Good	
<b>HISTORY:</b>	Tree rows installed in 1930s overlaying original garden. Rainforest tree groups, some likely to be Estate plantings and others added in early Clinic years with additional rainforest species added in 1980s.	
<b>REFERENCES:</b>	1991 DPWS Heritage Study; Aerial photo 1930

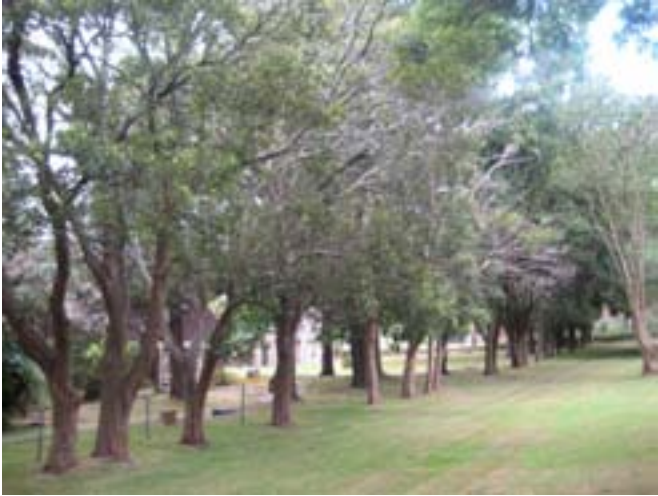
ZONE 7 – BROUGHTON HALL		
<b>ITEM No. 11L</b> <b>ORIGINAL NAME:</b> <b>CURRENT USE:</b>	<b>CONSTRUCTION DATE:</b> <b>ARCHITECT / BUILDER:</b>	<b>HERITAGE LISTINGS:</b> <input type="checkbox"/> National Estate <input checked="" type="checkbox"/> S170 List <input type="checkbox"/> National Trust <input type="checkbox"/> Leichhardt LEP <input type="checkbox"/> State Heritage Register
<b>ITEM:</b> <b>LOCATION:</b>	<b>11L LILY PILLY ROW</b> GRID: D8 ZONE: 7	
<b>DESCRIPTION:</b> Row of <i>Syzygium luehmannii</i> , Small Leaved Lilly pilly.

<b>CONDITION:</b>	Good	
<b>HISTORY:</b>	Assumed planted as part of 1930s garden development along edge of Estate garden however 1930s aerial photo shows shorter row of trees in this location and plantings of this species appear within 1890s plantings at Callan Park Asylum.	
<b>REFERENCES:</b>	Aerial photo 1930 – 1991 DPWS Heritage Study.	
<b>SIGNIFICANCE:</b>	Significant as a fine example of 1930s design element and major component of significant 1930s formal garden layout and sympathetic development of the earlier Estate garden.

<b>GUIDELINES:</b>	Maintain. Incorporate into any future developments.

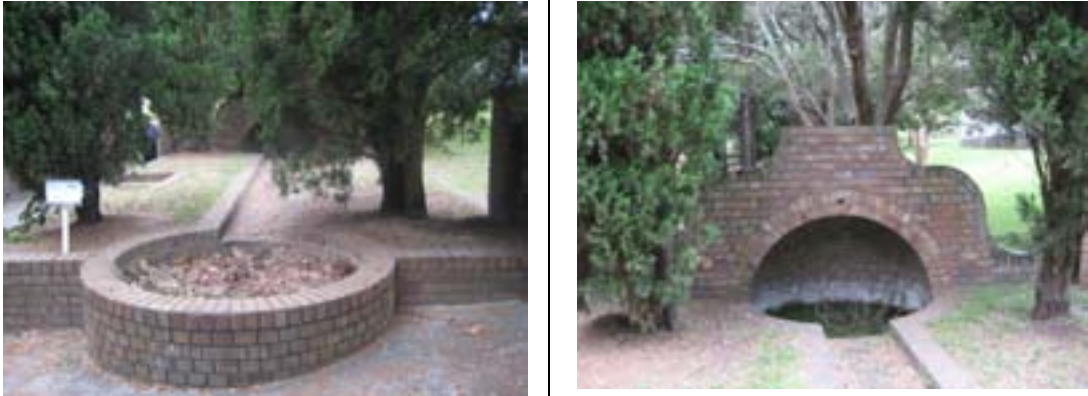
<b>ZONE 7 – BROUGHTON HALL</b>		
<b>ITEM No. 110</b> <b>ORIGINAL NAME:</b> <b>CURRENT USE:</b>	<b>CONSTRUCTION DATE:</b> 1930s  <b>ARCHITECT / BUILDER:</b> <b>Probably designed by Evan Jones.</b>	<b>HERITAGE LISTINGS:</b> <input type="checkbox"/> National Estate <input checked="" type="checkbox"/> S170 List <input type="checkbox"/> National Trust <input type="checkbox"/> Leichhardt LEP <input type="checkbox"/> State Heritage Register
<b>ITEM:</b> <b>LOCATION:</b>	<b>110 FORMAL POND</b> GRID: D8 ZONE: 7	
<b>DESCRIPTION:</b> Symmetrical geometric pond and garden with end wall forming vault over circular pond with single spout – all in brick. End wall extends to form brick arch to residential garden.

<b>CONDITION:</b>	Intact	
<b>HISTORY:</b>	Probably built in 1930s. Pond design reflects the influence of Edna Walling's formal pond designed by Evan Jones – Clinic superintendent. Planting of Jacaranda and Illawarra Flame trees reflects fashion to introduce bold colour and feature trees.

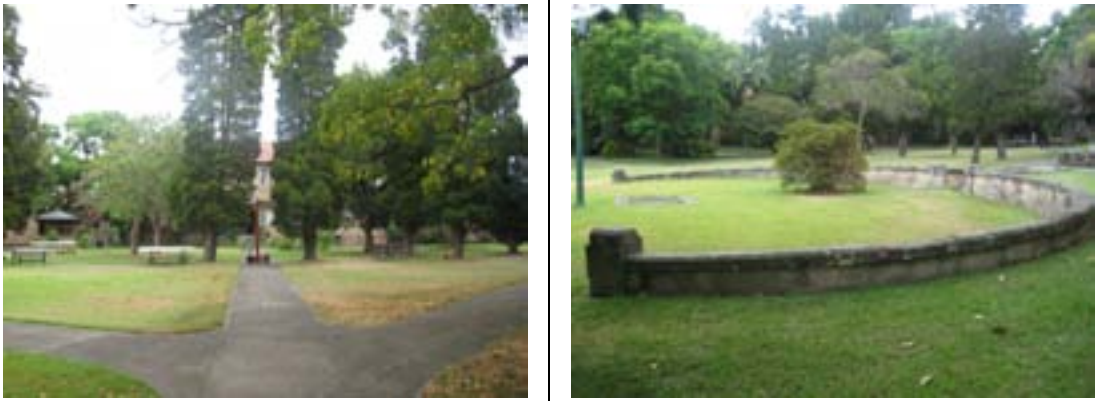
<b>ZONE 7 – BROUGHTON HALL</b>		
<b>ITEM No. 11P</b> <b>ORIGINAL NAME:</b> <b>CURRENT USE:</b>	<b>CONSTRUCTION DATE:</b> 1920s-1930s.  <b>ARCHITECT / BUILDER:</b>	<b>HERITAGE LISTINGS:</b> <input type="checkbox"/> National Estate <input checked="" type="checkbox"/> S170 List <input type="checkbox"/> National Trust <input type="checkbox"/> Leichhardt LEP <input type="checkbox"/> State Heritage Register
<b>ITEM:</b> <b>LOCATION:</b>	<b>11P FORMAL GEOMETRIC GARDENS</b> GRID: C8-9 ZONE: 7	
<b>DESCRIPTION:</b> <p>Geometric symmetrical path network set in lawn pivoted about a central section that formerly contained a circular pond (since removed) with formal central axis path studded with red painted light posts and cypress avenue. Stair and ½ elliptical low wall in lawn.</p>

<b>CONDITION:</b>	Intact	
<b>HISTORY:</b>	Diagonal paths established first in the 1920s linking Buildings B127, B121 and B193 to Broughton Hall. Formal axis and avenue trees and central pond and low wall and steps probably added in late 1930s when the naturalistic garden was built (1938). The path layout is a reflection of the building layout.

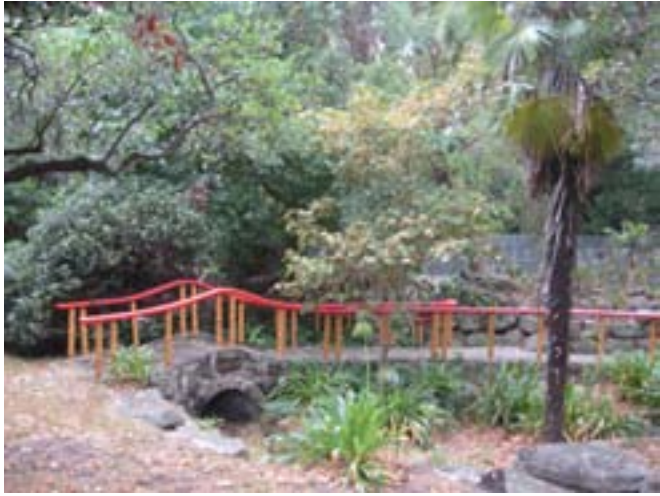
<b>ZONE 7 – BROUGHTON HALL</b>		
<b>ITEM No. 11Q</b> <b>ORIGINAL NAME:</b> <b>CURRENT USE:</b>	<b>CONSTRUCTION DATE:</b> Late 1930s  <b>ARCHITECT / BUILDER:</b>	<b>HERITAGE LISTINGS:</b> <input type="checkbox"/> National Estate <input checked="" type="checkbox"/> S170 List <input type="checkbox"/> National Trust <input type="checkbox"/> Leichhardt LEP <input type="checkbox"/> State Heritage Register
<b>ITEM:</b> <b>LOCATION:</b>	<b>11Q NATURALISTIC GARDEN</b> GRID: C-D 7-8 ZONE: 7	
<b>DESCRIPTION:</b> Naturalistic, gardens built as a series of bridges, pathways, gardens and secluded lawns edged in bush rock all focused on a small stream flowing over bedrock and designed around several Hoop Pines from the original Kalouan estate garden. The main bridge is a concrete construction formed and painted to resemble an oriental bamboo bridge. Planting includes both nature and exotic plants.

<b>CONDITION:</b>	Substantially intact – much of the stonework and bridges in need of maintenance.

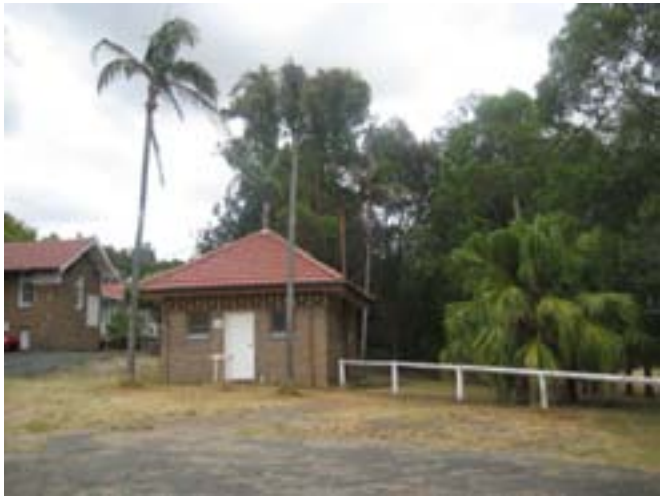
<b>ZONE 7 – BROUGHTON HALL</b>	
<b>ITEM No. 71</b> <b>ORIGINAL NAME:</b> <b>CURRENT USE:</b>	<b>CONSTRUCTION DATE:</b> Planted between 1918 and 1930s.  <b>ARCHITECT / BUILDER:</b>
<b>HERITAGE LISTINGS:</b> <input type="checkbox"/> National Estate <input checked="" type="checkbox"/> S170 List <input type="checkbox"/> National Trust <input type="checkbox"/> Leichhardt LEP <input type="checkbox"/> State Heritage Register	
<b>ITEM:</b> <b>LOCATION:</b>	<b>71 PALM GROUP</b> GRID: ZONE: 7
<b>DESCRIPTION:</b> Group of Bangalow palms located around amenities block.

<b>CONDITION:</b>	Fair to poor. One tree has apparently died.
<b>HISTORY:</b>	Planted between 1918 and 1930s as part of extensive formal gardens to Building B502.
<b>REFERENCES:</b>	1991 DPWS Heritage Study; Aerial photos 1930 and 1952. Powell.
<b>SIGNIFICANCE:</b>	No evidence of heritage significance as integrity of original design has been lost. However the palms are sympathetic with significant fabric in adjoining Broughton Hall gardens.

<b>GUIDELINES:</b>	Replace dead tree. Incorporate into new development or transplant into Broughton Hall gardens or area of similar significance.
